SEISMIC EVALUATION

Wilshire Center

10920 Wilshire
Los Angeles, CA

Nabih Youssef Associates
Structural Engineers
550 South Hope Street, Suite 1700
Los Angeles, California 90071
NYA Job # 19287.00

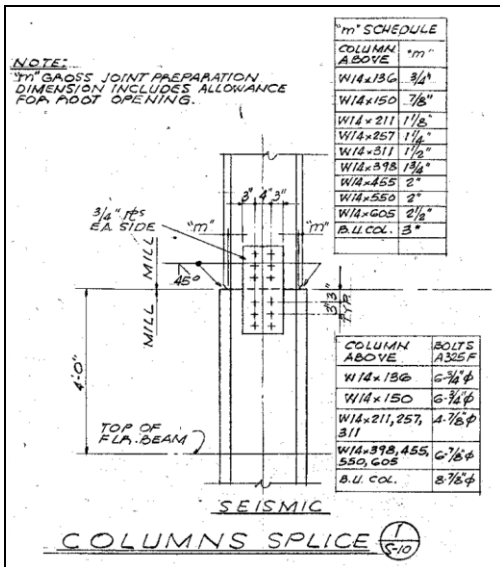
Figure 2.2 - Column Splice Detail

The moment frame beams are W36 sections and the columns are W14 sections and built-up I-shapes spliced with partial penetration welds at the flanges and bolted web. Figure 2.2 shows a detail of the column splice connection. The beams and columns consist of ASTM A36 steel. The proportioning of the frame members typically do not satisfy strong column-weak beam joint checks.

The column splice connections have inadequate shear strength to develop the full flexural capacity of the columns.

- Enhance all column splice connections for shear by fillet welding around existing 3/4" splice plate. There are 12 moment frame columns per floor. Columns are spliced at every other floor, thus there are 9 floors at which splices occur for a total of 108 splice connections. Figure 5.4 shows a conceptual detail for the column splice connection retrofit.

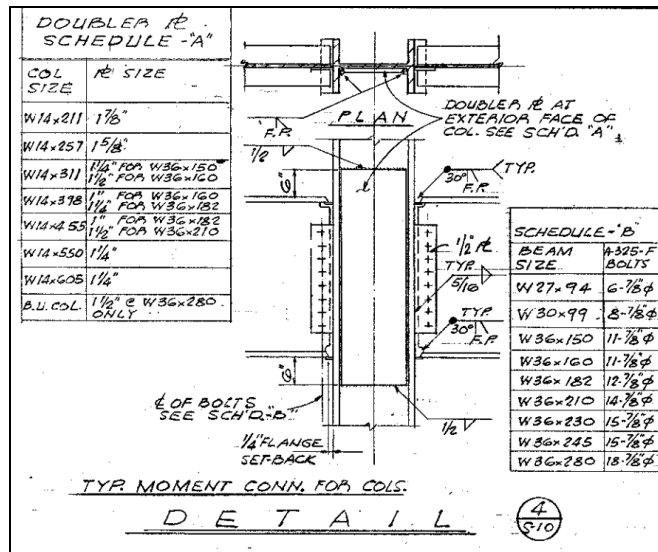
Figure 2.3 - Moment Connection Detail

The moment frames have beam-to-column-flange connections that are typical "pre-Northridge" welded moment connection which consists of field-welded full-penetration joints of beam flange to column flange with bolted shear tab. Figure 2.3 shows a detail of the beam-to-column-flange connection.

The results indicate that the moment frame beams and columns provide adequate performance at BSE-1E and BSE-2E hazards. The results also indicate that the welded beam-to-column moment connections and column splice connections have DCRs > 1.0. Table 4.4 provides a summary of member demand-to-capacity ratios.

- Retrofit all beam-to-column welded moment connections using proprietary slotted beam web connection by Seismic Structural Design Associates, Inc. (SSDA) or welded haunch at bottom flange. There are 24 beam-to-column moment connections per floor, and all connections from 2nd floor through the roof level (17 floors) require retrofit for a total of 408 connections. Figure 5.1 shows the location of the beam-to-column moment connections on the framing plan for the typical floor. Figure 5.2 shows a conceptual detail for the retrofit of the beam-to-column moment connection using SSDA slotted beam web. Figure 5.3 shows a conceptual detail for the retrofit of the beam-to-column moment connection using welded haunch at bottom flange.

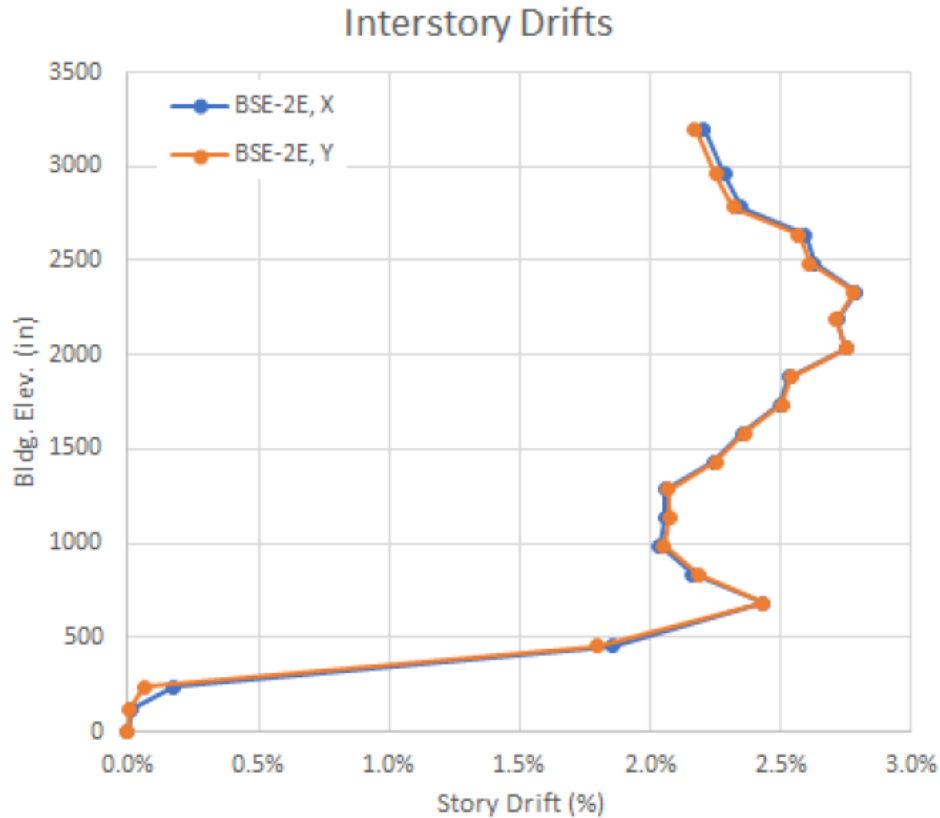
Figure 4.5 - Maximum Inter-Story Drift for BSE-2E

Global inter-story drift response results indicate potential soft story condition at the base of the tower. Figure 4.5 shows a plot of the maximum inter-story drift for the BSE-2E hazard. The maximum drifts are between 2.5%-2.8%.
