Re: *University of California Seismic Rating for 1072 Gayley Avenue, Los Angeles*

Nabih Youssef & Associates (NYA) have performed an Independent Review of the two-story office and retail building located at 1072 Gayley Avenue in Los Angeles. The review consisted of a site visit to observe the existing condition of the exposed structural elements, review of available structural drawings, limited calculations and identification of potential falling hazards that pose a significant life or safety risk to occupants.

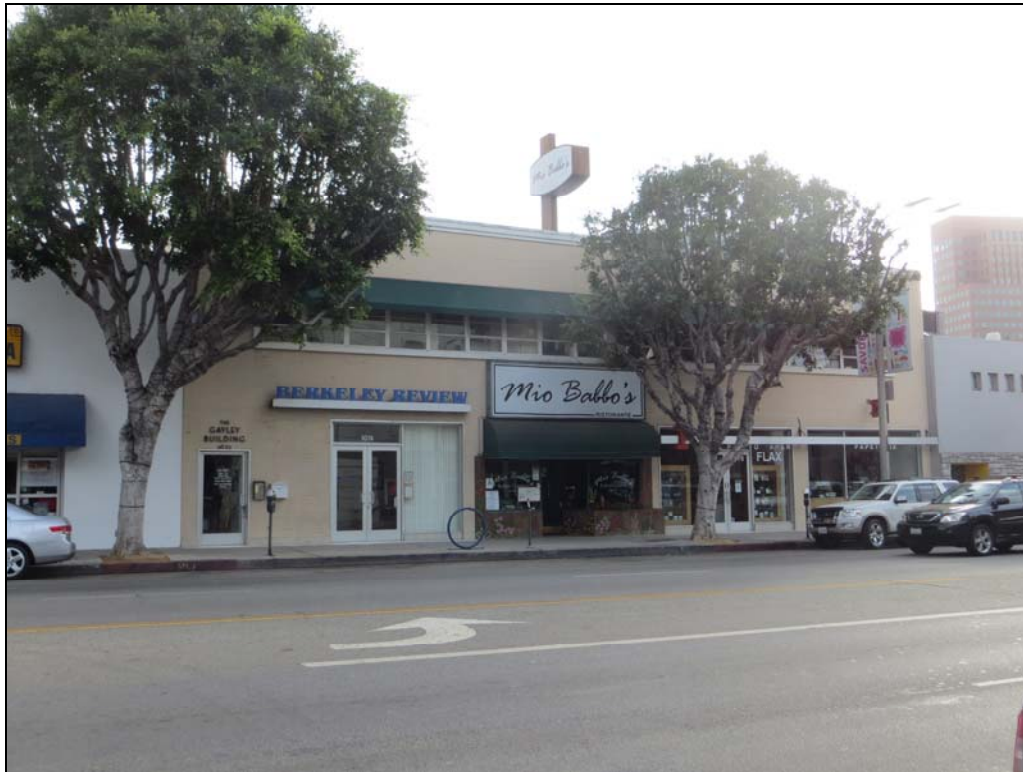
The exterior of the building consists of painted masonry with signage and awnings that appear to be in good condition and positively connected to the exterior wall of the building

Photo 1 – Gayley Avenue Elevation

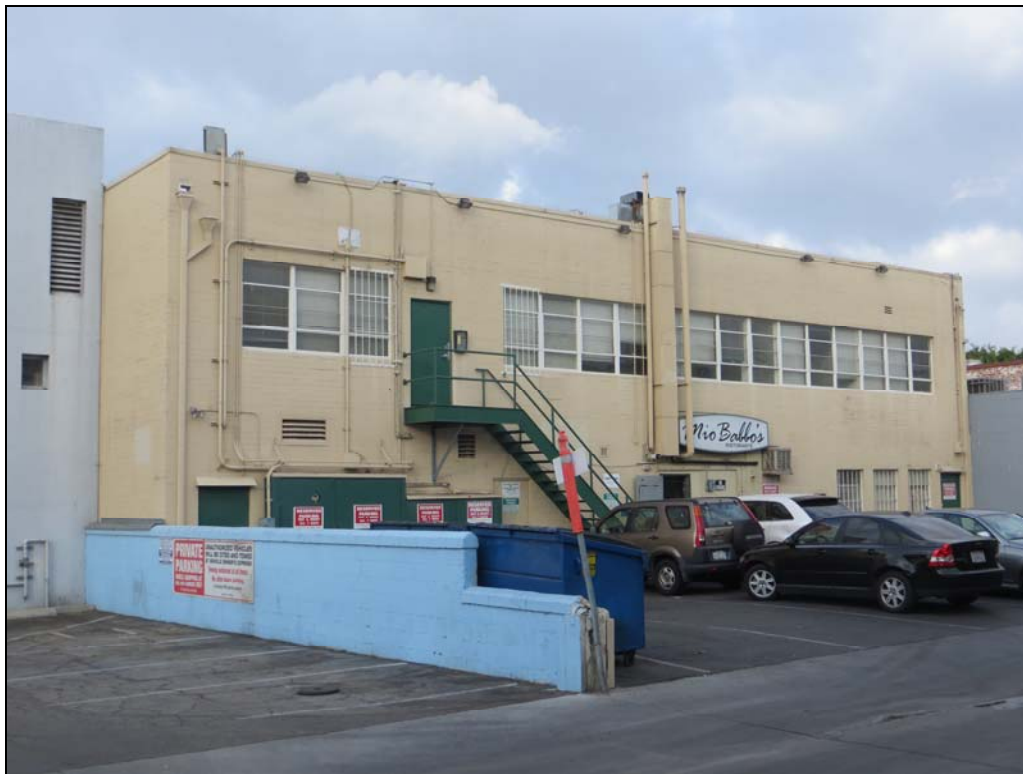
Photo 2 – East Elevation

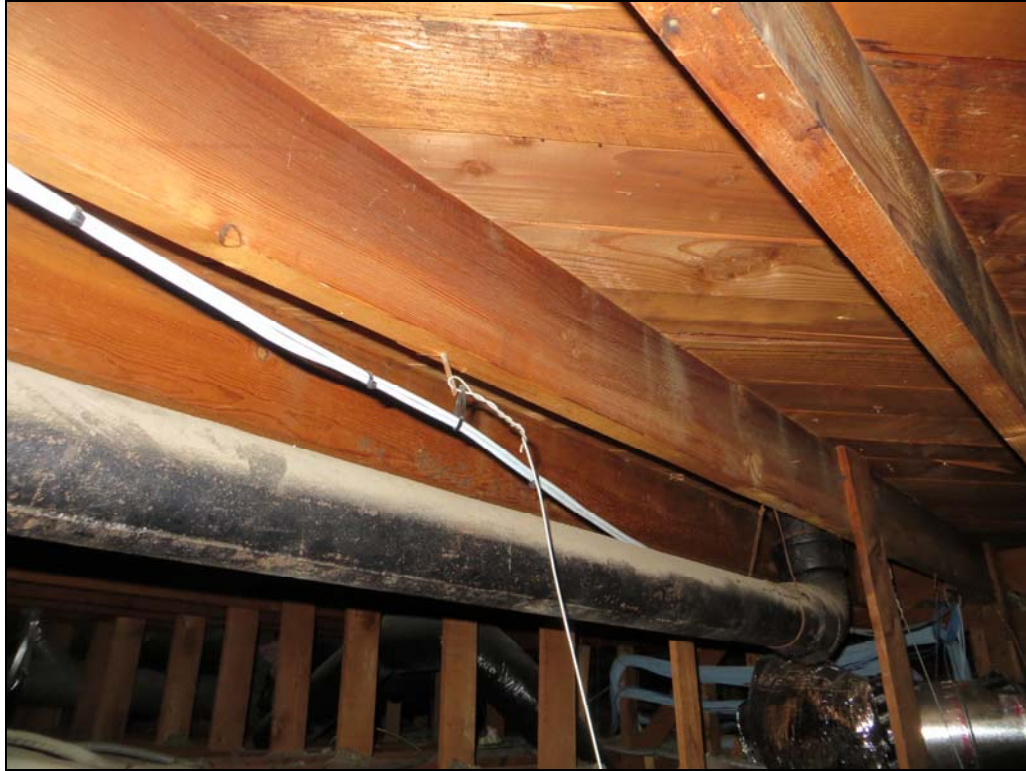
The roof and floor are constructed of 1" diagonal sheathing supported by 2x6 sawn lumber joists spanning to wood beams and concrete masonry walls. The wood beams are supported by wood columns. The foundation was not observed, however, buildings of similar construction and vintage typically have strip footings under perimeter walls and concrete spread footings under columns.

Photo 4 – Typical Wood Framing

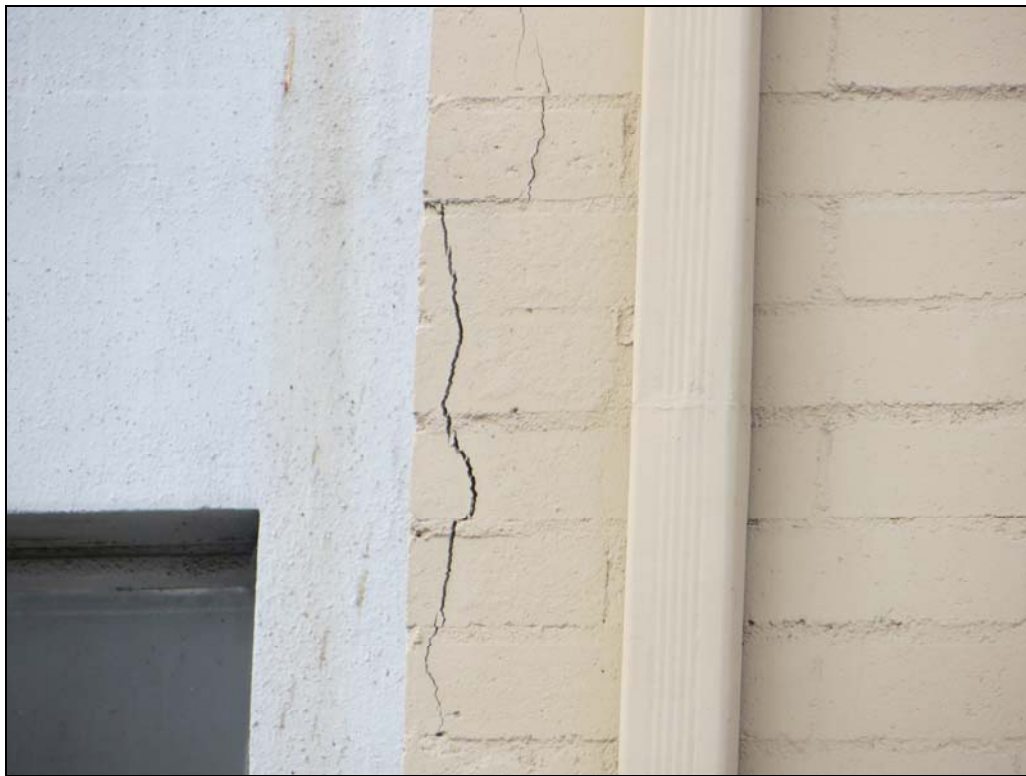
A site visit was performed by Maurizio Trevellin of NYA on October 9, 2013, to observe the condition and characteristics of the building. Observations were limited to visible areas of the structure. The building appeared to be in good condition. Minor cracks were observed in the concrete masonry walls at the northwest, northeast and southeast corners of the building. The cracks do not appear to be seismic in nature, but due to corrosion of steel reinforcement.

Photo 4 – Crack in Masonry Wall at Northwest Corner
