Re: *University of California Seismic Rating for 1083 Gayley Avenue, Los Angeles*

Nabih Youssef Associates (NYA) have performed an Independent Review of the 4-story office building with partial penthouse located at 1083 Gayley Avenue. The review consisted of a site visit to observe the existing condition of the exposed structural elements, review of structural drawings, identification of potential falling hazards that pose a significant life or safety risk to occupants, and a seismic risk assessment.

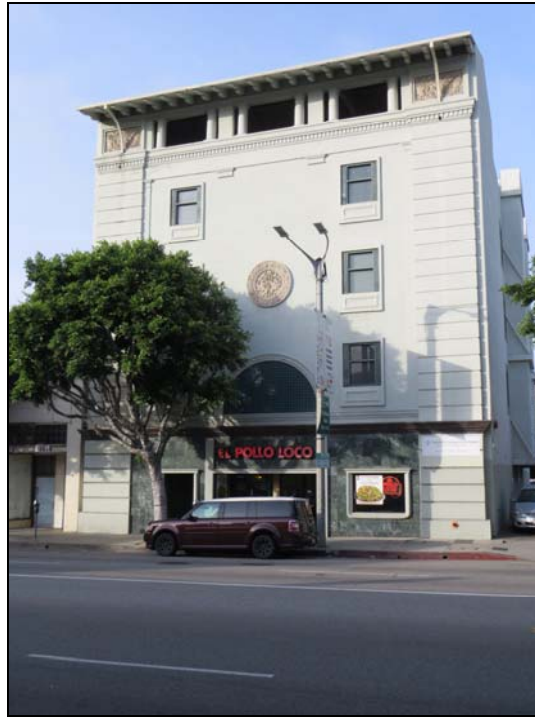
Photo 1 – East Elevation

The exterior of the building consists of exposed concrete and glazed windows. Sheet metal vents run vertically along the north and west elevation of the building. The vents appear to be adequately anchored to the building. The penthouse roof overhangs the east elevation of the building. The overhang is constructed of cast-in-place concrete, is in good condition and does not pose a significant falling hazard.
