October 21, 2019

Subject: 10861 Weyburn Ave, Los Angeles, CA 90024
Seismic Screening Report
JLA Job no. 19001-09

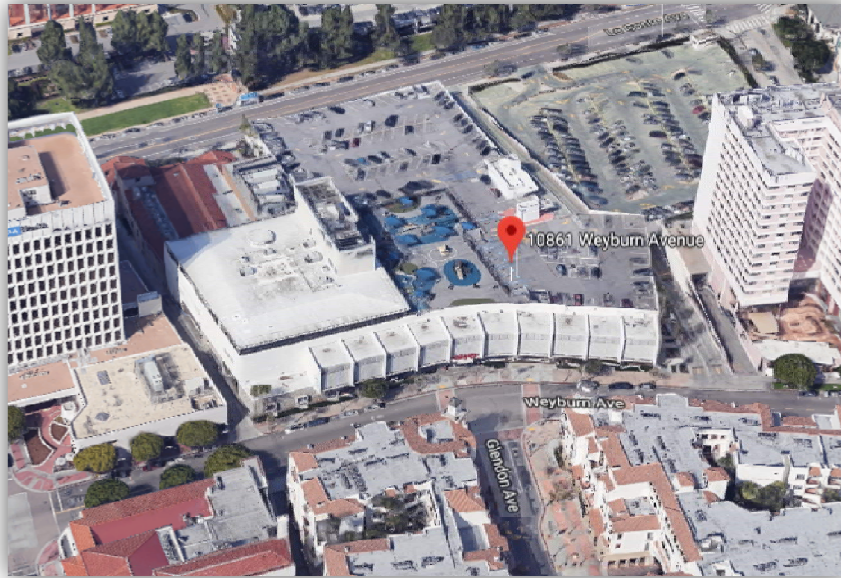
Figure 1 – View of Overall Subject Existing Building Site

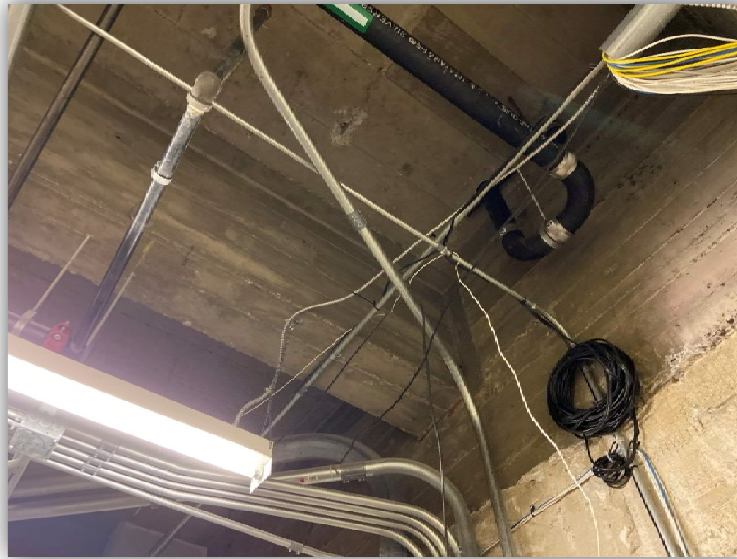
In general the accessible and exposed structural elements appeared to be in good condition considering the age of the building. See Figures 2 & 3 below for photos showing the accessible representative framing conditions.

Figure 2 – Concrete Beam to Exterior Concrete Wall at Roof Framing

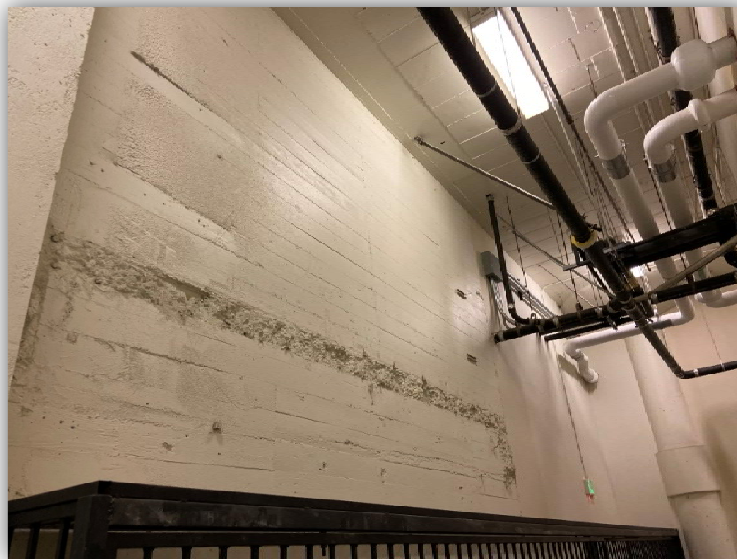
Figure 3 – Exterior Concrete Shear Wall at 1st Floor (view from interior)
