January 10, 2015

Subject: 11303 Washington Blvd., Los Angeles, CA
Seismic Screening Report
JLA Job #14110-17

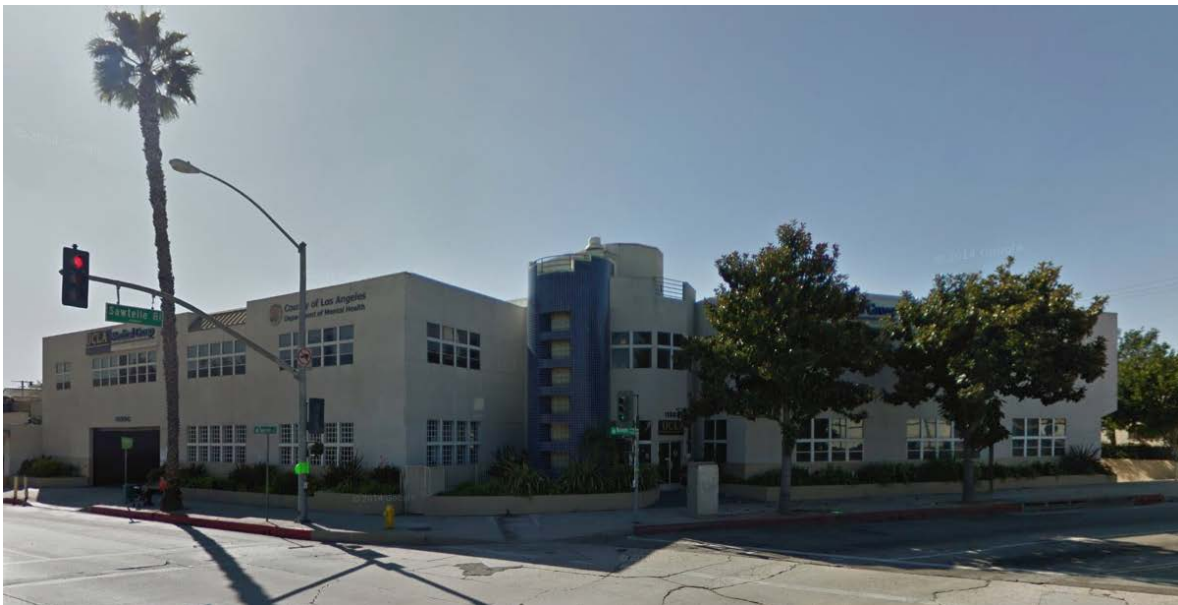
Figure 1 – South east elevation of 11303 Washington Boulevard in Los Angeles, CA.
