April 24, 2014

Subject: 11633 San Vicente Blvd, Los Angeles, CA

Seismic Screening Report JLA Job no. 14110-09

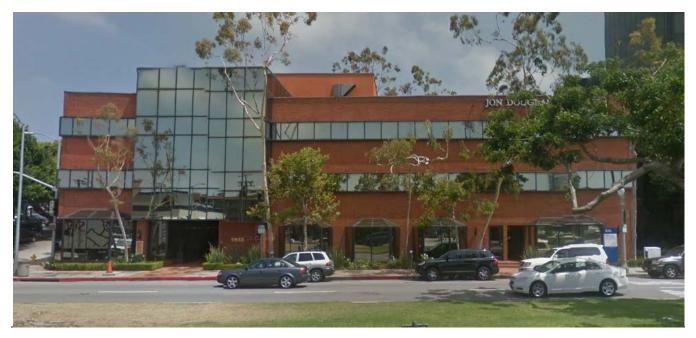
Figure 1 – North Elevation of 11633 San Vicente Blvd in Los Angeles, CA.
