May 29, 2019

Subject: 1187 Coast Village Rd, Santa Barbara, CA 93108
Seismic Screening Report
JLA Job no. 19001-04

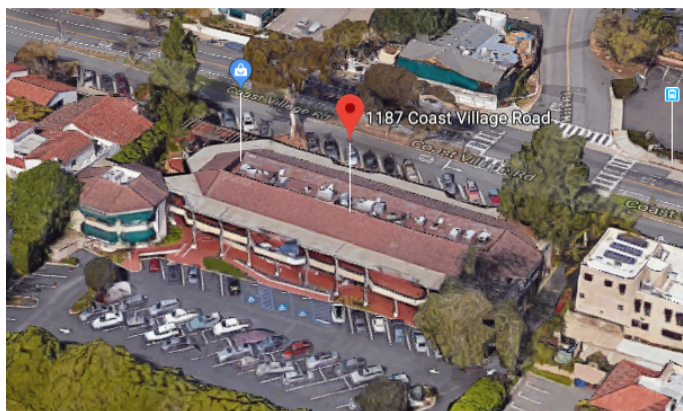
Figure I – View of Overall Subject Existing Building Site
