April 22, 2020

Subject: 141 Triunfo Canyon Rd, Westlake Village, CA 91361  
Seismic Screening Report  
JLA Job no. 19001-03

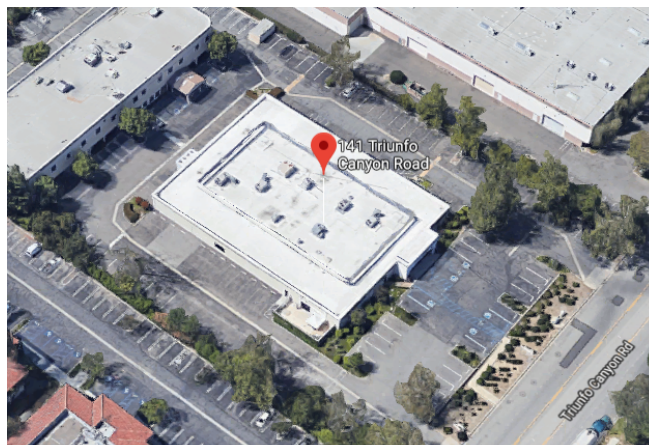
Figure 1 – Overall Building View
