**Re: *University of California Seismic Rating for 1919 Santa Monica Boulevard, Santa Monica***

Nabih Youssef Associates (NYA) have performed an Independent Review of the 4-story medical office building located at 1919 Santa Monica Boulevard in Santa Monica. The review consisted of a site visit to observe the existing condition of the exposed structural elements, identification of potential falling hazards that pose a significant life or safety risk to occupants, a review of structural drawings and an ASCE 41-13 Tier 1 evaluation.

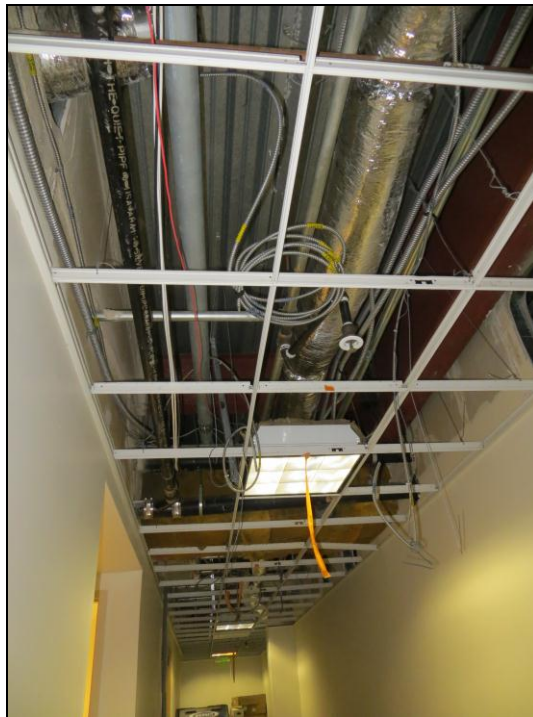
Photo 10 – Typical Piping and Ductwork

Mechanical and electrical equipment were observed to be generally anchored and piping systems generally braced. The cladding consists of pre-cast concrete panels (spandrel and column covers) and ribbon windows. There is a glass masonry wall (full height of building) at the entrance. The walls span floor to floor and are secured at top and bottom with steel angles and closure plates. Steel T vertical supports are also embedded in the wall and connected to the top and bottom floor slabs. No falling hazards were observed on the exterior of the building.
