September 12, 2019

Subject: 2020 Santa Monica Blvd, Santa Monica, CA 90404
Seismic Screening Report
JLA Job no. 19001-07

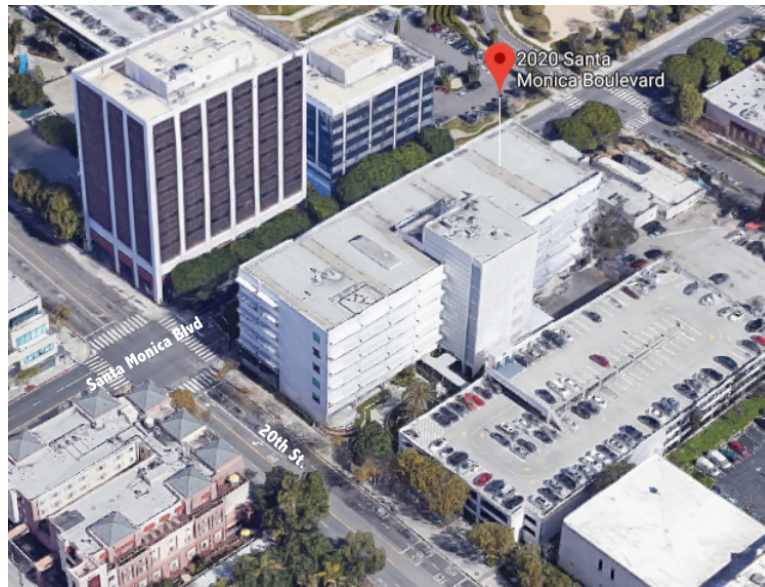
The building is rectangular in plan measuring approximately 96 feet by 281 feet. There is a partial basement at the lowest level, enclosed by concrete retaining walls. The roof contains a partial penthouse that extends above the main stair and elevator core. See Figure 1 on the next page for a photo of the subject existing building site.

Figure 1 – View of Overall Subject Existing Building Site
