Re: *University of California Seismic Rating for 21650 Oxnard Street, Woodland Hills*

Nabih Youssef Associates (NYA) have performed an Independent Review of the Warner Center Tower 3, a 25-story office building located at 21650 Oxnard Street in Woodland Hills. The review consisted of a site visit to observe the existing condition of the exposed structural elements, identification of potential falling hazards that pose a significant life or safety risk to occupants, a review of structural drawings including steel frame repair drawings and an ASCE 41-13 Tier 1 evaluation.

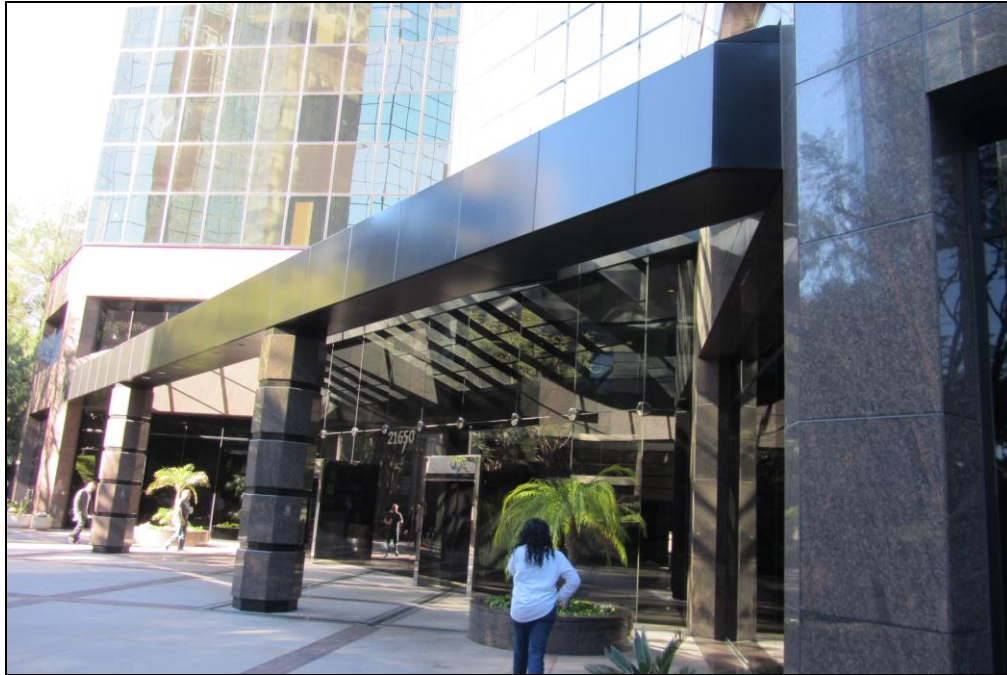
Photo 3 – Main Entrance

Mechanical and electrical equipment were observed to be generally anchored and piping systems generally braced. The curtain wall system of the building consists of stone veneer at the lower four floors and an aluminum mullion system with laminated glass above. There is a skylight over the main building entrance. No falling hazards were observed on the exterior of the building.

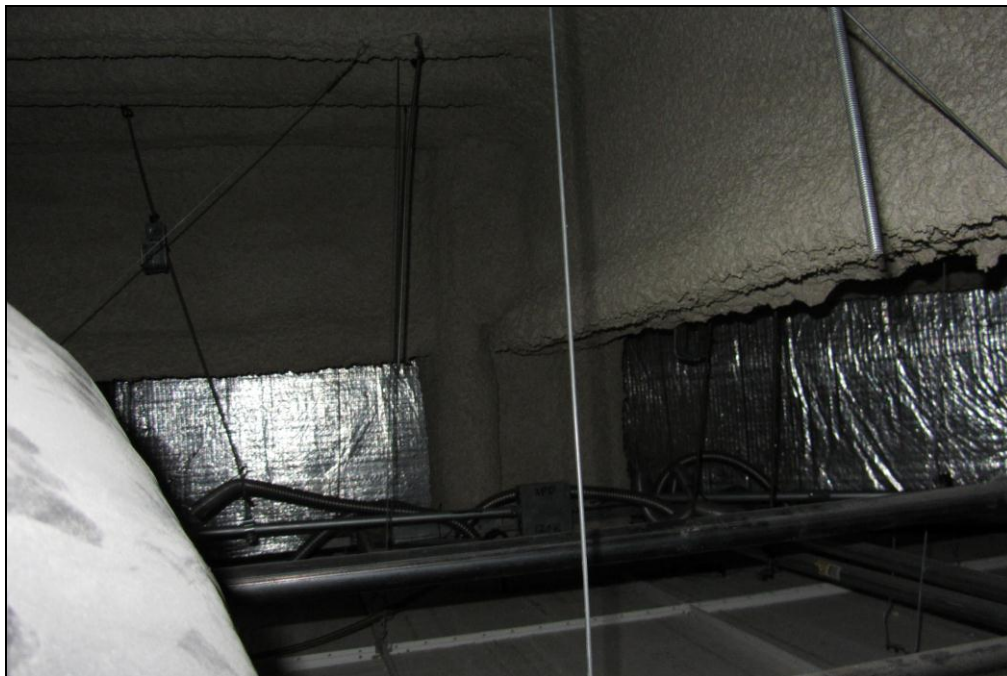
Photo 4 – Typical Beam to Column Connection

The lateral-force-resisting system consists of the metal deck and concrete fill roof and floors acting as structural diaphragms to transfer seismic inertial forces to the distributed welded steel moment frames. The typical moment frame connection consists of field-welded full-penetration joints of the frame beam flanges to the columns flanges. This connection detail is the typical "pre-Northridge" type connection that was standard practice at the time of construction.

- Moment Resisting Connections – Moment connections do not develop the strength of adjoining members. This is common for pre-Northridge connections. The moment connections were inspected after the 1994 Northridge Earthquake and damaged/defective connections were repaired.
