Subject: 2211 Michigan Ave, CA 90404

Seismic Screening Report JLA Job no. 19001-00

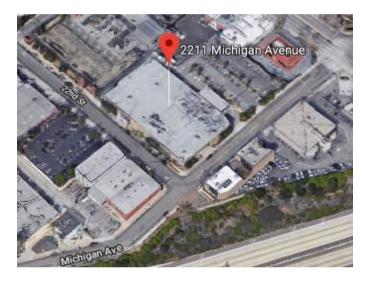
Figure I – Overall Building View

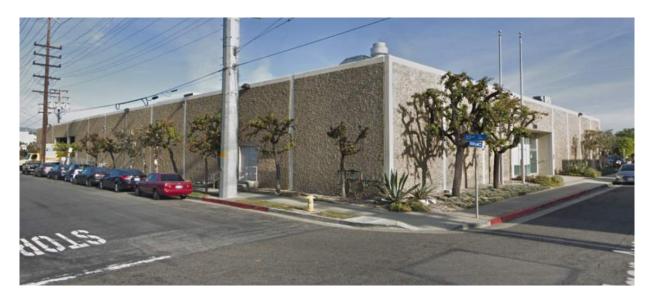
Figure 2 – Building Exterior (view from southern corner, intersection of Michigan Ave & 2nd St)

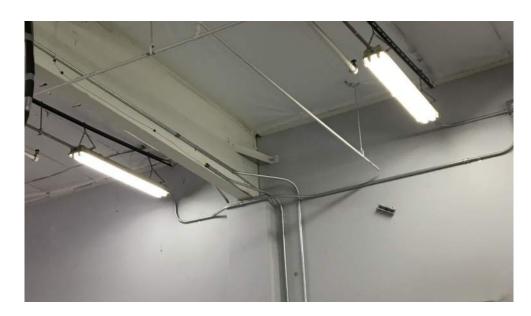
Figure 3 – Main girder to wall connection & anchorage

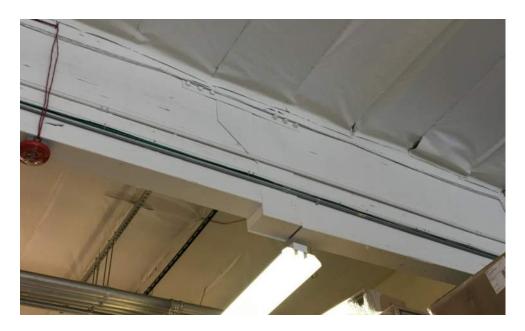
Figure 4 —Main girder continuity tie

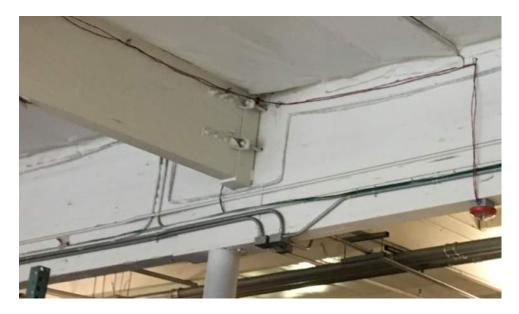
Figure 5 – Purlin to girder connection & continuity ties
