Re: *University of California Seismic Rating for Frances Goldwyn Lodge, Woodland Hills*

Nabih Youssef Associates (NYA) have performed an Independent Review of the Frances Goldwyn Lodge on the Motion Picture and TV Fund campus located at 23388 Mulholland Drive in Woodland Hills. The review consisted of a site visit to observe the existing condition of the exposed structural elements, identification of potential falling hazards that pose a significant life or safety risk to occupants, and a seismic risk assessment.

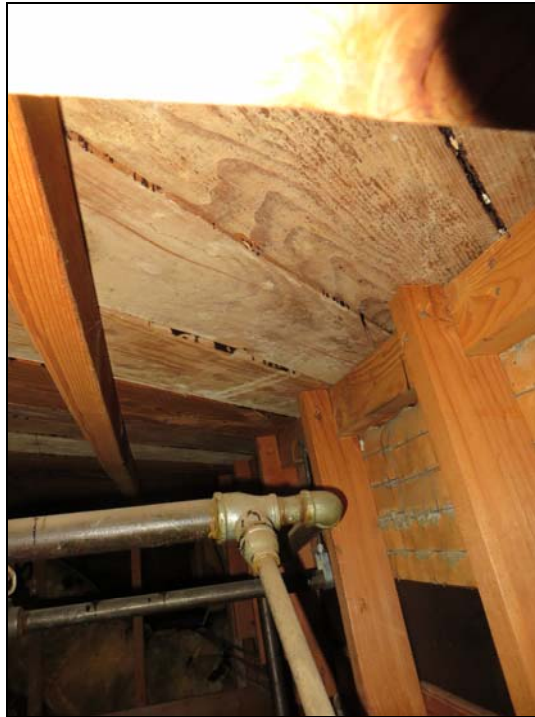
The building has a complete load path to transfer seismic forces to the foundations. There are no significant strength or stiffness discontinuities in the walls. There appears to be an adequate amount of walls which provide strength and redundancy to resist expected seismic force, and limit diaphragm spans. The diagonal sheathing appears to have adequate strength to transfer the expected seismic forces to the masonry walls.

Photo 3 – Diagonal Sheathing

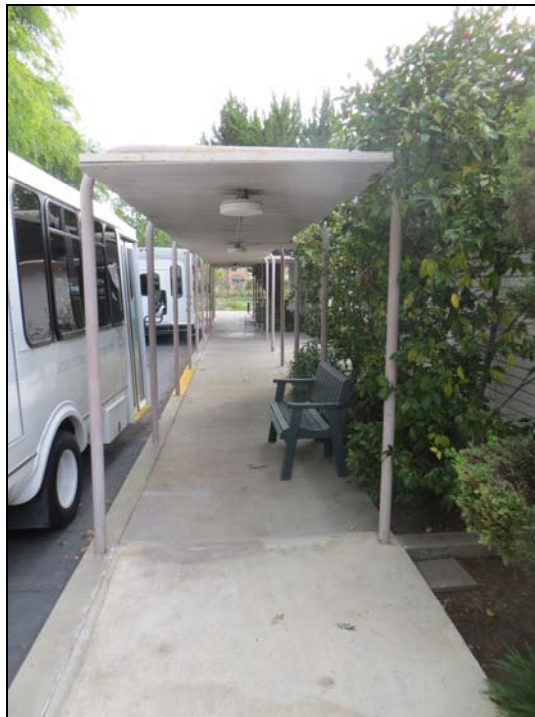
The exterior of the building consists of exposed masonry and stucco finished walls. There is a canopy structure over the walk way at the north end of the building. The canopy structure consists of steel pipe frames supporting a metal deck roof. The canopy does not appear to pose a significant falling hazard.

Photo 4 – Walkway Canopy
