Re: *University of California Seismic Rating for 25775 McBean Parkway, Valencia*

Nabih Youssef Associates (NYA) have performed an Independent Review of the 2-story medical office building located at 25775 McBean Parkway in Valencia. The review consisted of a site visit to observe the existing condition of the exposed structural elements, identification of potential falling hazards that pose a significant life or safety risk to occupants, and a seismic risk assessment. Structural drawings were not available for review.

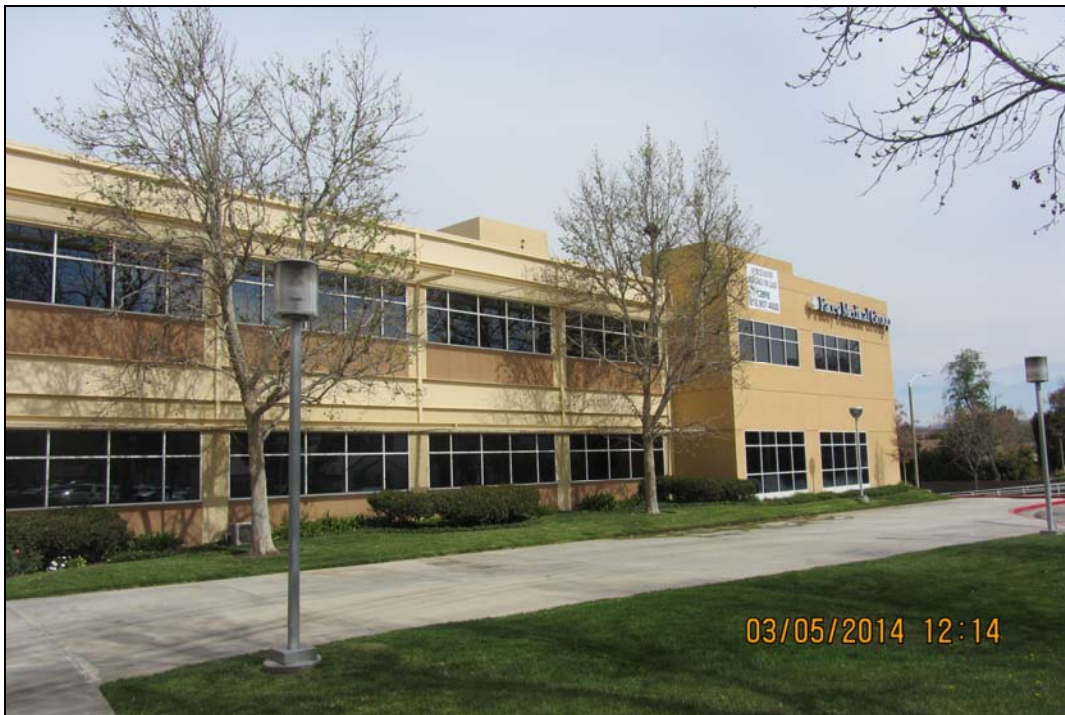
Photo 2 – South Elevation

The exterior of the building consists of stucco plaster finish with ribbon windows and storefront glass system at the lobby entrance. A steel framed screen awning was observed along the south elevation of the building. The steel frame appears to be adequately attached to the building structure. A steel framed canopy was observed over a building entrance. The canopy was supported by concrete columns and appears to be adequately anchored to the building structure. No falling hazards were observed.

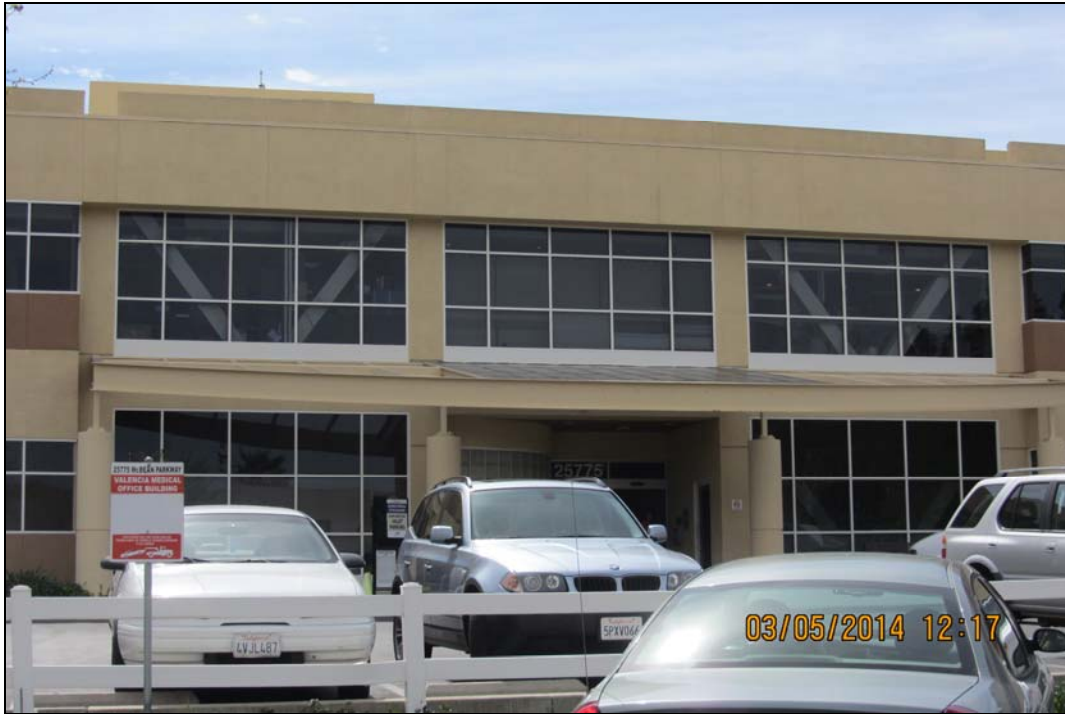
The lateral-force-resisting system consists of the plywood roof and floor acting as structural diaphragms to transfer seismic inertial forces to concentric steel braced frames that are typically continuous to the foundation.

Photo 3 – Steel Braced Frames

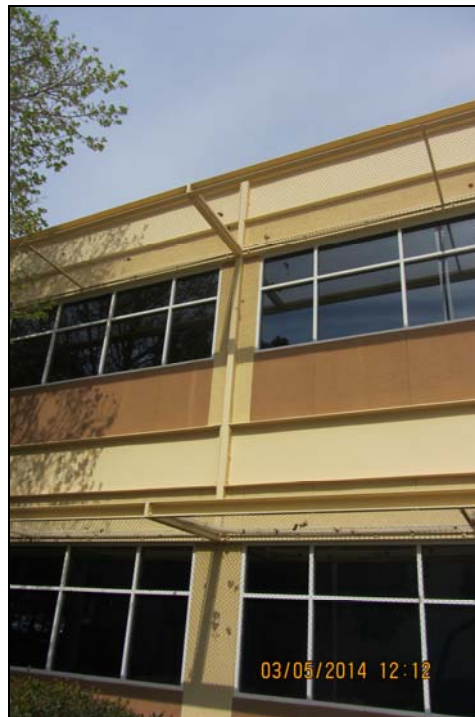
Photo 4 – Steel Framed Screen Awning
