Re: *University of California Seismic Rating for 30601 Agoura Road, Agoura Hills*

Nabih Youssef Associates (NYA) have performed an Independent Review of the 2-story office building located at 30601 Agoura Road in Agoura Hills. The review consisted of a site visit to observe the existing condition of the exposed structural elements, identification of potential falling hazards that pose a significant life or safety risk to occupants, and a seismic risk assessment. Structural drawings were not available for review.

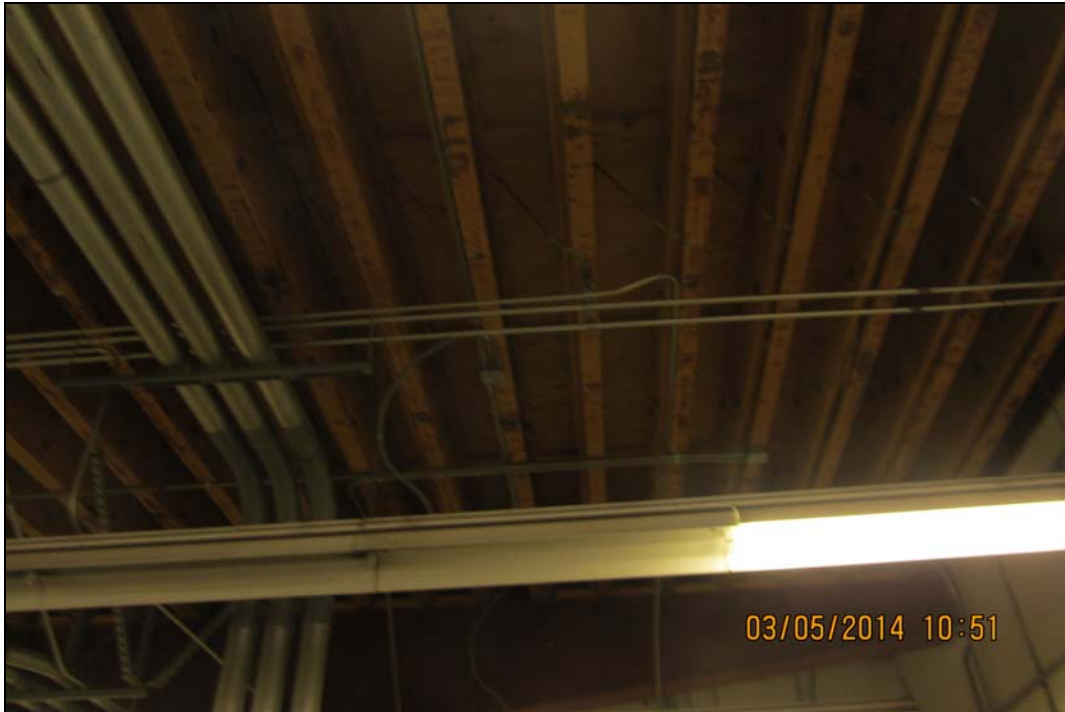
Photo 3 – Typical Floor Framing

The roof and floor appear to be constructed of plywood sheathing spanning to manufactured wood joists that are supported by steel wide flange beams and steel angles at perimeter walls. The steel beams are likely supported by steel columns that are continuous to the foundation. The foundation system could not be observed, but buildings of similar construction typically have concrete spread footing supporting interior columns and concrete strip footing supporting perimeter walls. A reinforced concrete slab-on-grade forms the first floor.

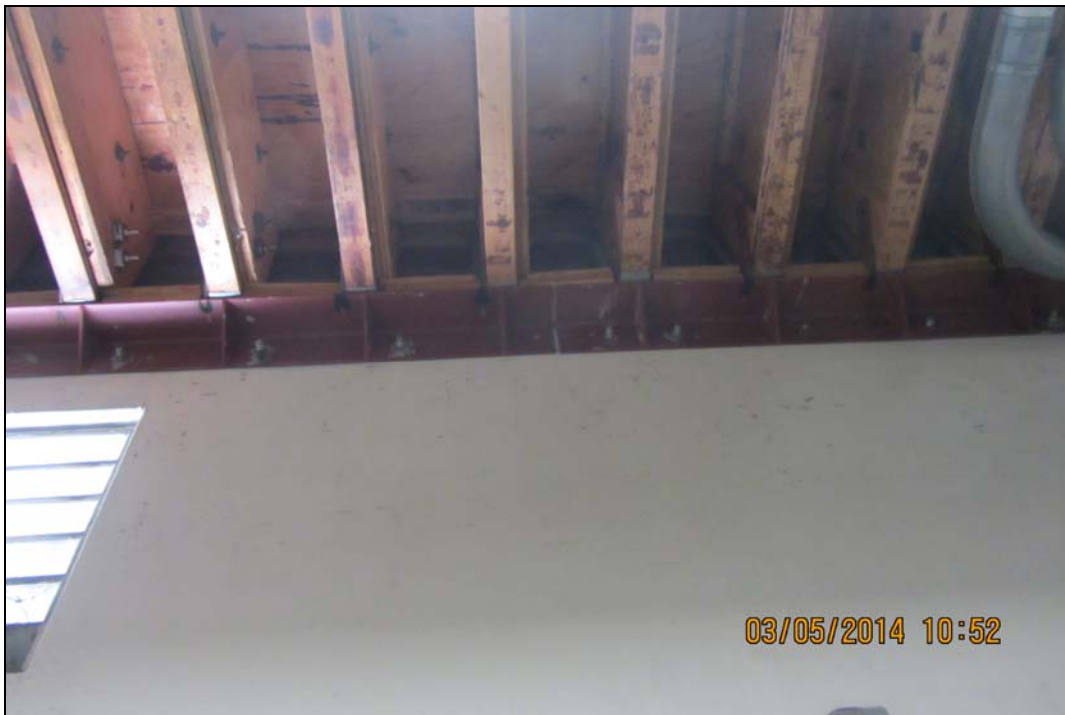
Photo 4 – Typical Joist to Wall Connection

The building has a complete load path to transfer seismic forces to the foundations. Steel straps welded to the steel ledger angles and bolted to the wood floor and roof joists were observed. These straps provide positive out-of-plane anchorage of the wall to floor and roof diaphragms. The lateral system is regular in-plan and vertically with no strength or stiffness discontinuities. The roof and floor diaphragms likely have adequate strength to transfer seismic forces to the perimeter walls given shape and depth of the roof and floor diaphragms with no large openings.
