**Re:** *University of California Seismic Rating for 335 North La Brea Avenue, Los Angeles*

Nabih Youssef Associates (NYA) have performed an Independent Review of the single-story office building located at 335 North La Brea Avenue in Los Angeles. The review consisted of a site visit to observe the existing condition of the exposed structural elements, identification of potential falling hazards that pose a significant life or safety risk to occupants, and a seismic risk assessment.

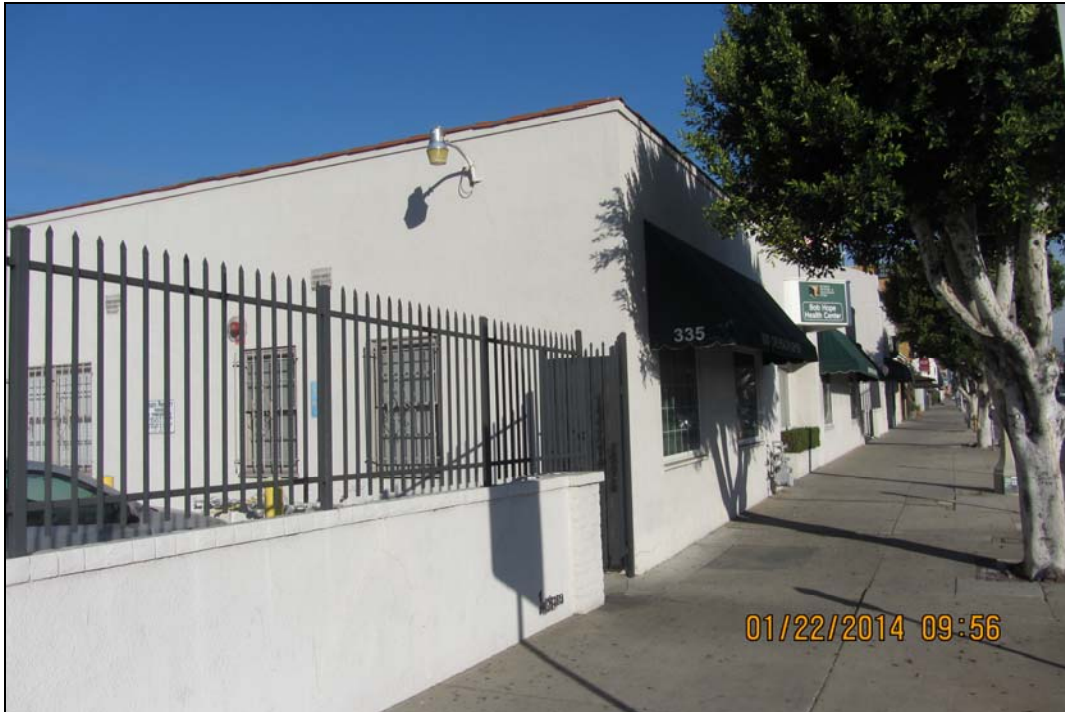
Photo 1 – Southeast Elevation

The exterior of the building consists of stucco finish. A fabric canopy and signage was observed over the rear and main entrances to the building, respectively. The canopy and signage appeared to be in good condition, adequately anchored and does not pose a significant potential falling hazard.

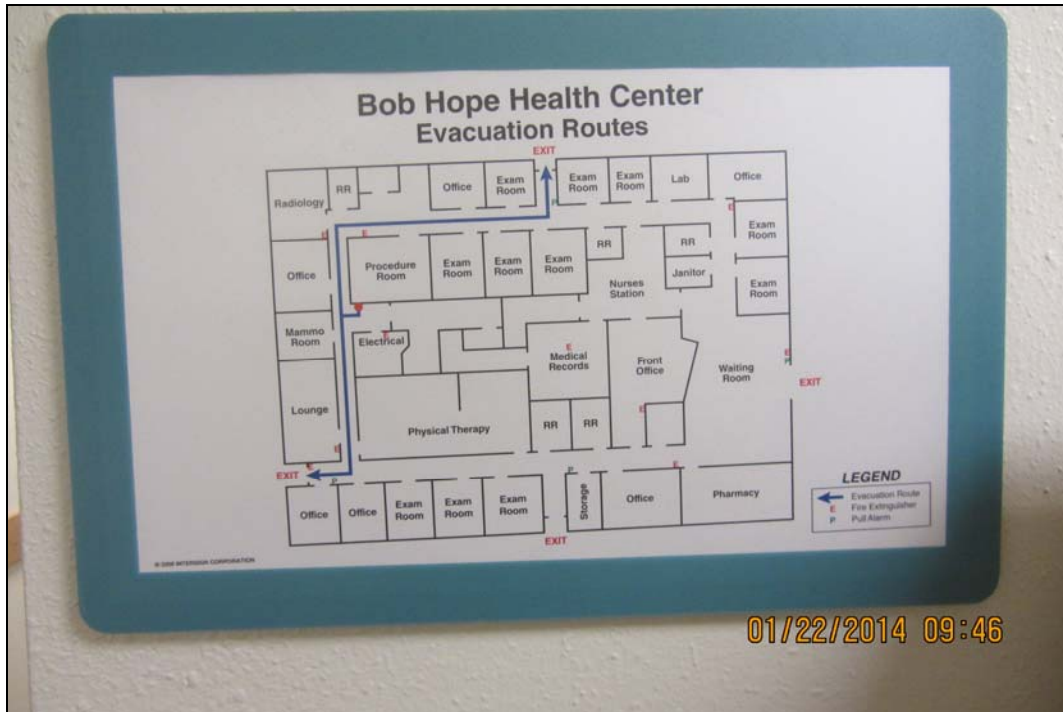
Photo 3 – Building Plan

The single-story building is rectangular-shaped in-plan with approximately 8,400 sf. The building appears to have been constructed in the 1950s or 1960s. Structural drawings were not available for review.

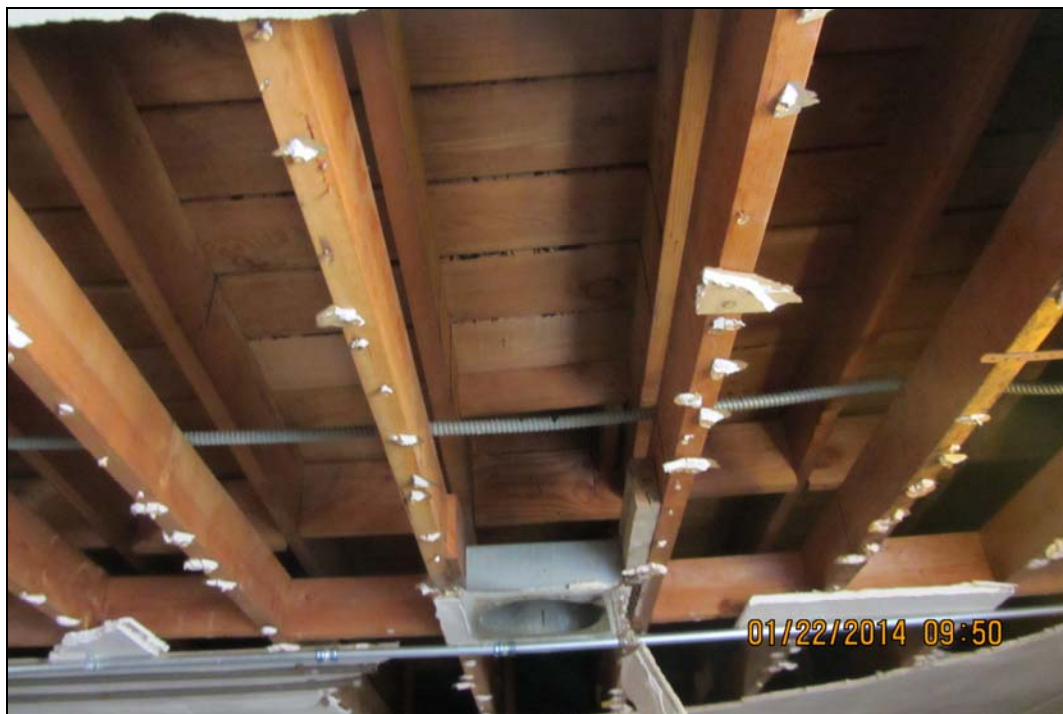
Photo 4 – Wood Framed Roof

The straight sheathed wood roof is supported by interior and perimeter bearing wood stud walls. The foundation was not observed, however, buildings of similar construction and vintage typically have strip footings under perimeter walls and concrete slab-on-grade under interior walls.
