Re: *University of California Seismic Rating for 3691 Lenawee Avenue, Los Angeles*

Nabih Youssef Associates (NYA) have performed an Independent Review of the single-story warehouse and office building located at 3691 Lenawee Avenue in Los Angeles. The review consisted of a site visit to observe the existing condition of the exposed structural elements, identification of potential falling hazards that pose a significant life or safety risk to occupants, and a review of seismic retrofit drawings.

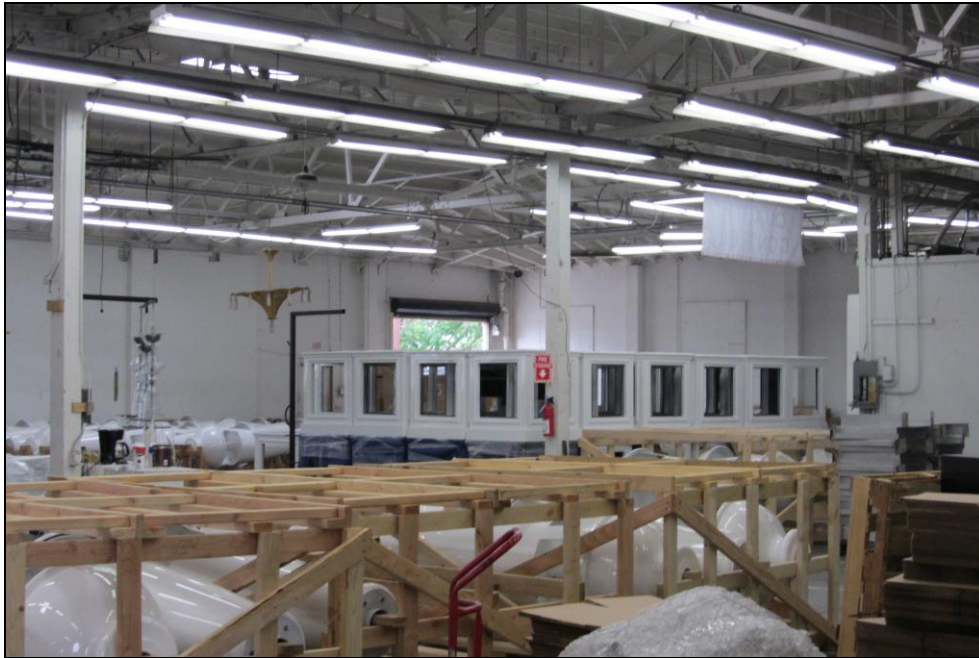
Photo 5 – Wood Posts and Roof Framing

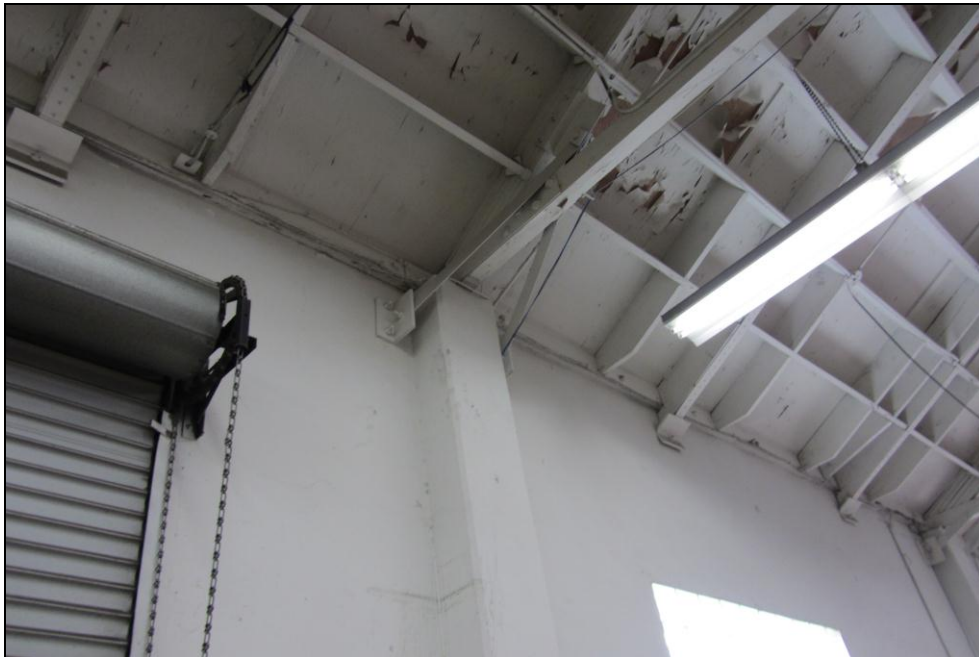
The 2001 seismic retrofit was in compliance with the City of Los Angeles Division 91 requirements which provide minimum standards to reduce risk of life loss or injury. The retrofit consisted of providing out-of-plane anchorage of the wall panels to the roof diaphragm and continuity ties.

Photo 6 – Out-of-Plane Wall Anchors at Pilaster

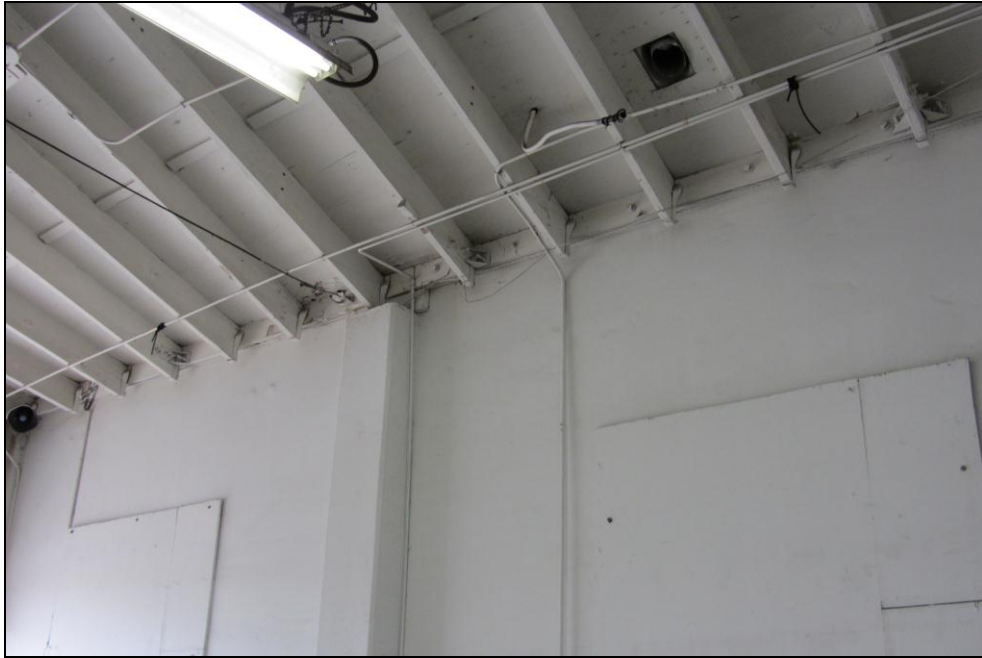
Photo 7 – Out-of-Plane Wall Anchors at Rafters

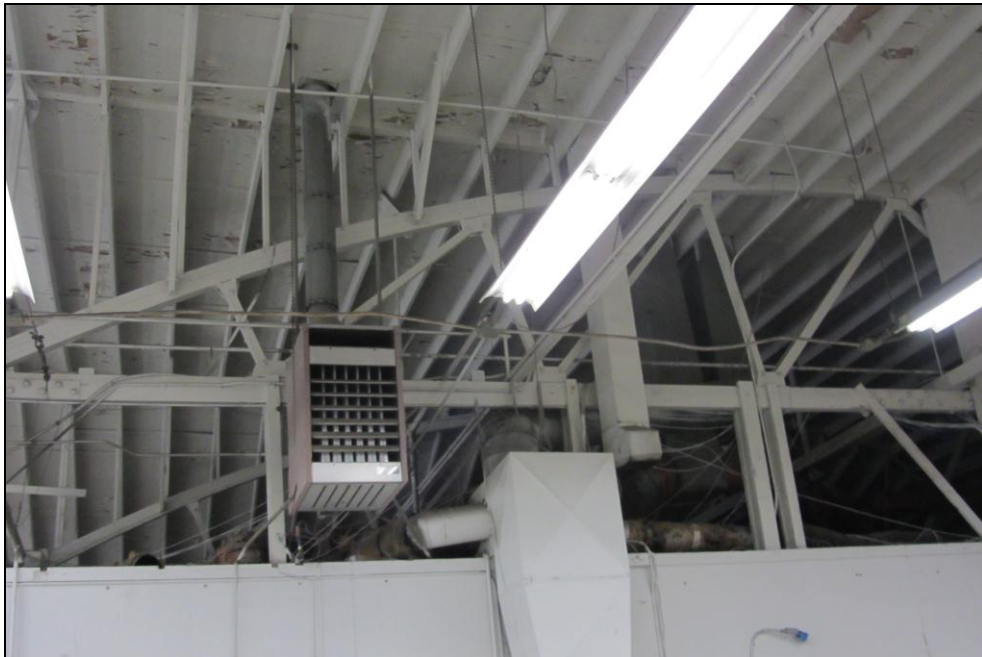
AC units were observed to be hung from the roof framing in the warehouse area, no seismic bracing was observed. It is recommended that these units be braced. The exterior of the building consists of painted concrete walls with no ornamentation. No falling hazards were observed on the exterior of the building.

Photo 8 – Unbraced Hanging AC Unit
