March 19, 2018

**Re: *University of California Seismic Rating for 4343 Lankershim Boulevard***

Nabih Youssef Associates (NYA) have performed an Independent Review of the 3-story office building located at 4343 Lankershim Boulevard in North Hollywood. The review consisted of a site visit to observe the existing condition of the exposed structural elements, identification of potential falling hazards that pose a significant life or safety risk to occupants, a review of structural drawings and an ASCE 41-13 Tier 1 and deficiency only Tier 2 evaluation.

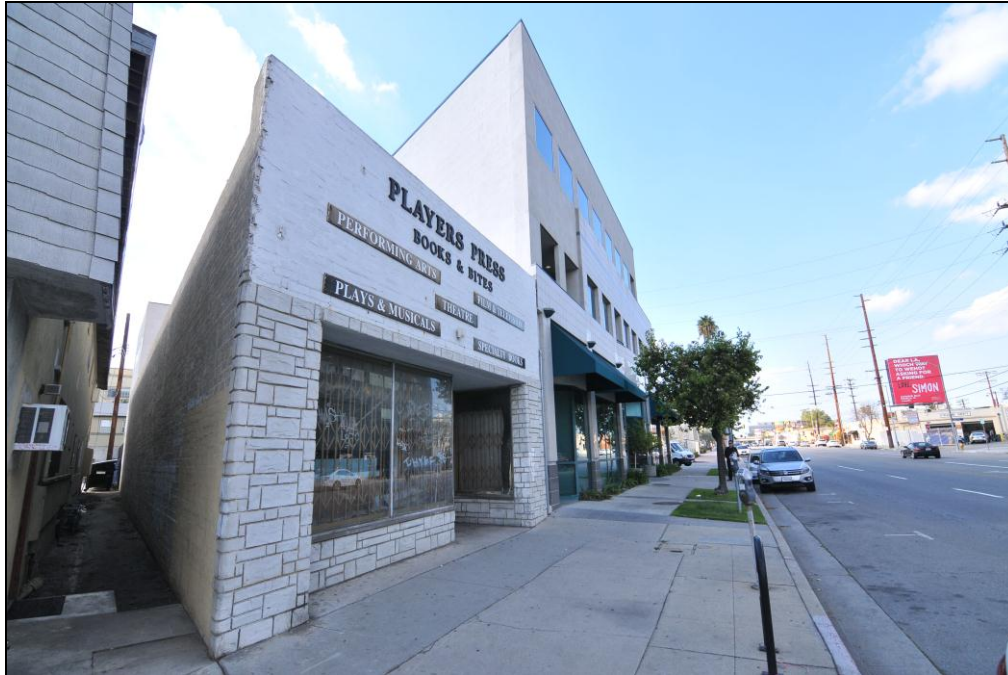
Photo 5 – Adjacent Building

- **Adjacent Building** – Per architectural drawings, there is a one inch separation from the single-story masonry building to the south. The roof of the adjacent building does not appear to align with the 2<sup>nd</sup> floor. There is a 10½" thick reinforced concrete wall along the interface with the adjacent building at the first floor. The wall appears to have adequate strength to resist pounding from the adjacent building.

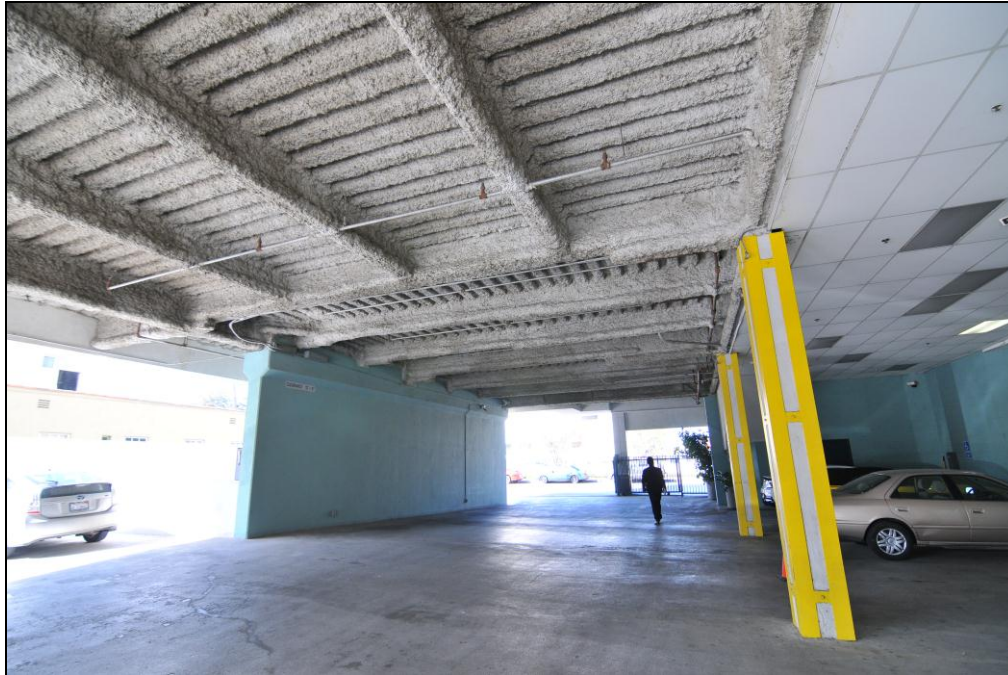
Photo 7 – Typical Steel Framing and Concrete Shear Wall

- **Torsion** – Reinforced CMU and concrete wall along grid line E are stiffer than the steel moment frames resulting in torsional response. Effect was considered in the LDP analysis.

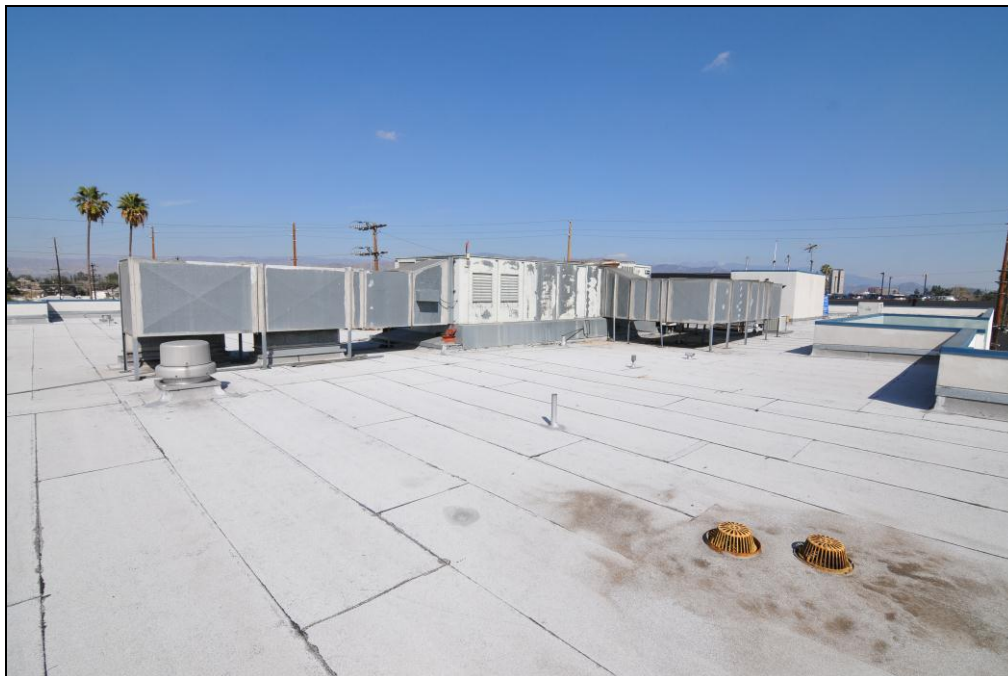
Photo 8 – HVAC Units on Roof

Mechanical and electrical equipment were observed to be generally anchored and piping systems generally braced. The curtain wall system of the building consists of stucco finish and an aluminum mullion system with laminated glass. No falling hazards were observed on the exterior of the building.
