**Re: *University of California Seismic Rating for The Bloc – 750 West 7<sup>th</sup> Street, Los Angeles***

Nabih Youssef Associates (NYA) have performed an Independent Review of The Bloc hotel tower located at 750 West 7<sup>th</sup> Street in Los Angeles. The review consisted of a site visit to observe the existing condition of the exposed structural elements, identification of potential falling hazards that pose a significant life or safety risk to occupants, a review of available structural drawings and an ASCE 41-13 Tier 1 and deficiency only Tier 2 evaluation.

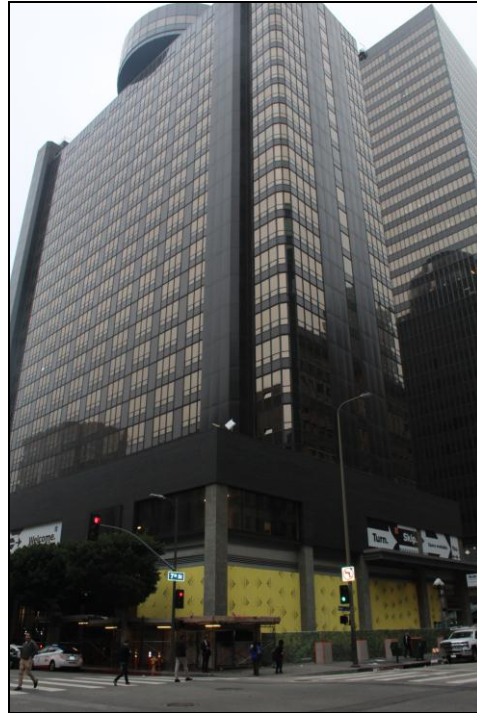
Photo 1 – Northeast Elevation

A site visit was performed by Alejandro Pena of NYA on December 13, 2016, to observe the condition and characteristics of the building. Observations were limited to visible areas of the structure. The building structures appeared to be in general conformance with the available structural drawings, no significant structural alterations were observed. The buildings generally appeared to be in good condition and there were no obvious signs of structural distress.

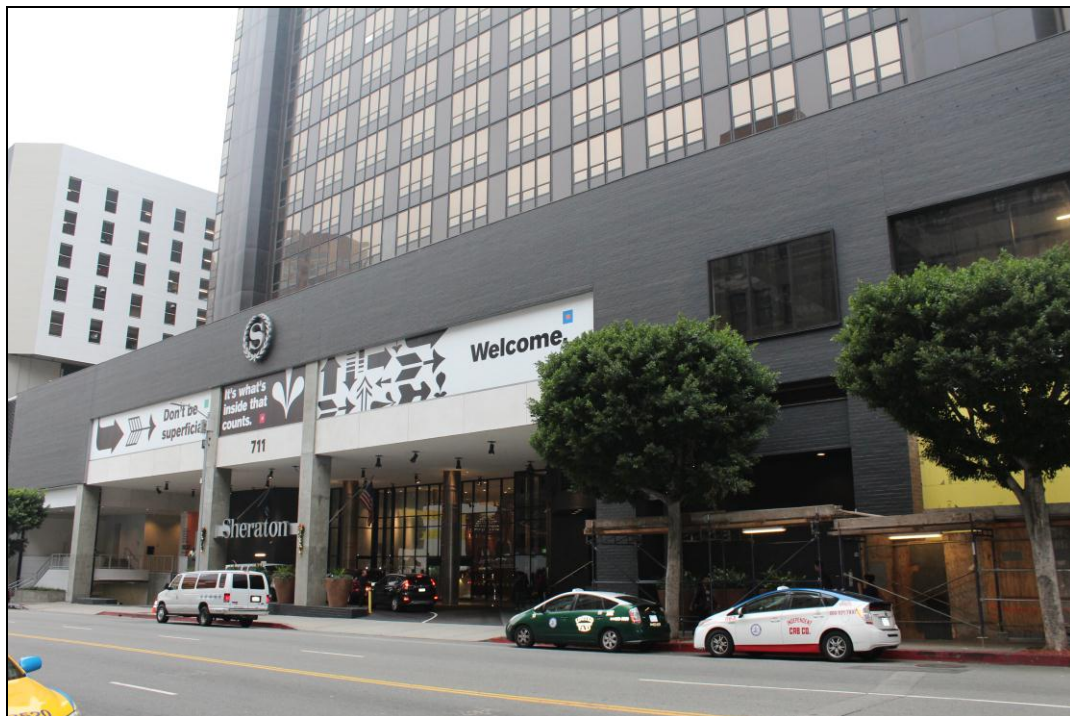
Photo 2 – East Elevation (Low-Rise)

- Adjacent Building – Clear distance between the low roof of the hotel tower and the adjacent retail/parking structure is 6", which is less than 4% of the height of the retail/parking structure. Columns of the low-rise portion of the hotel tower and the retail/parking structure are located several feet away from the separation joint. Thus, impact between buildings would likely result in localized damage and not compromise the structural integrity of the buildings.

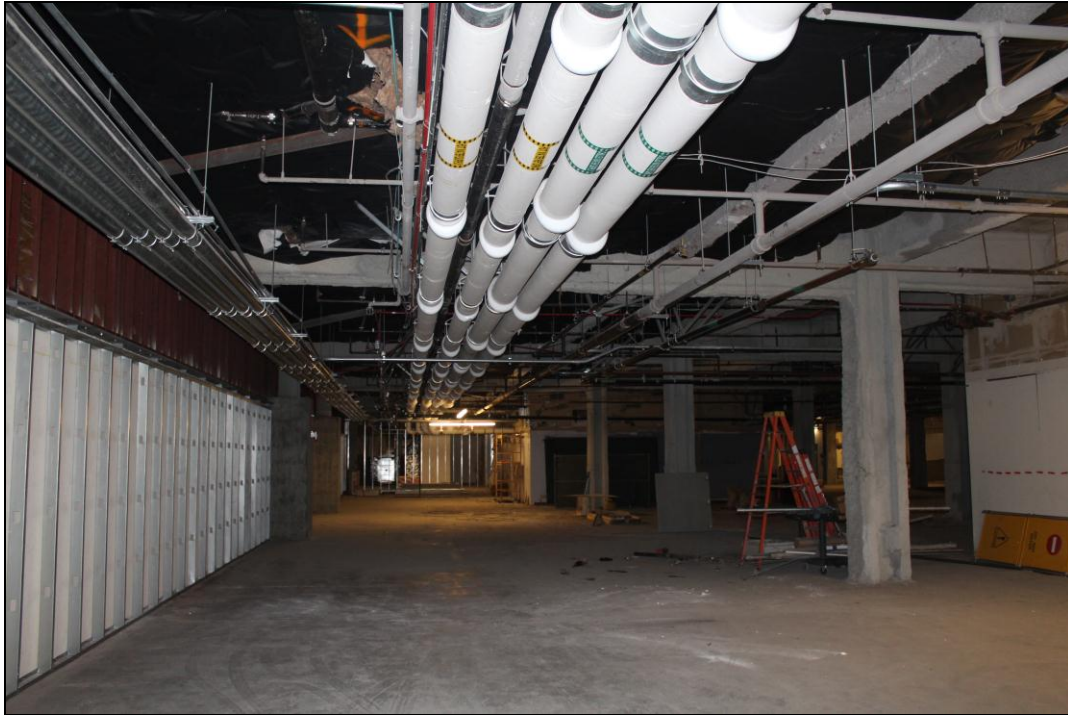
Photo 3 – Braced Piping

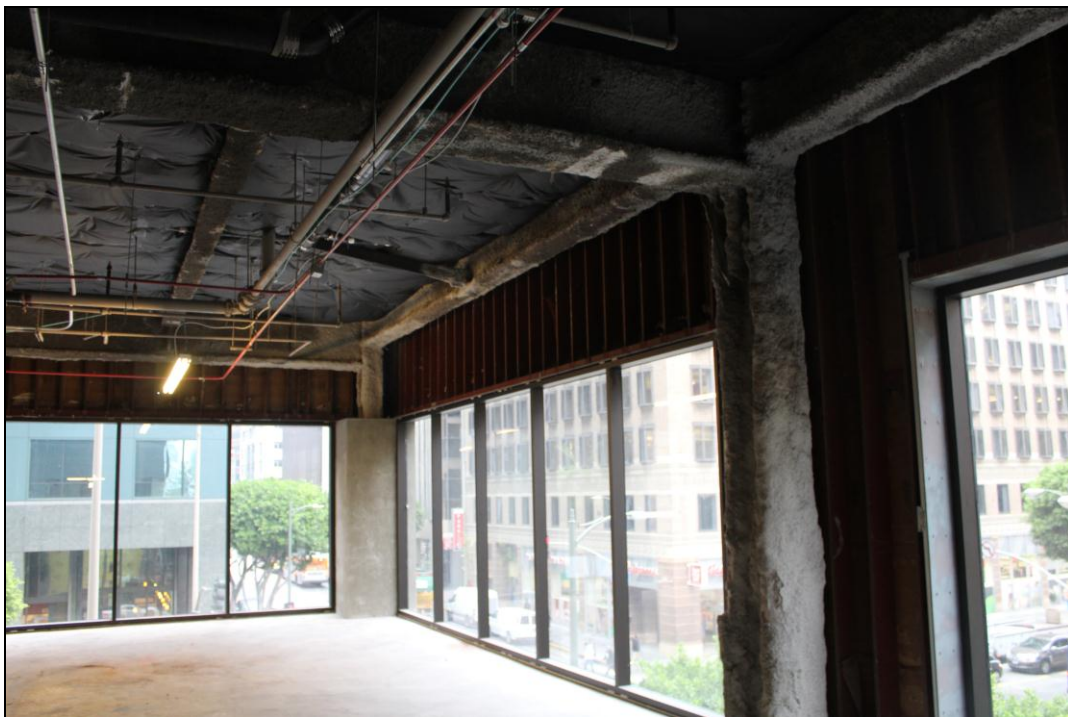
Photo 4 – Typical Steel Framing
