March 28, 2015

**Re: *University of California Seismic Rating for Leasing – Oak Hills Medical Plaza
7345 Medical Center Drive (14211.00)***

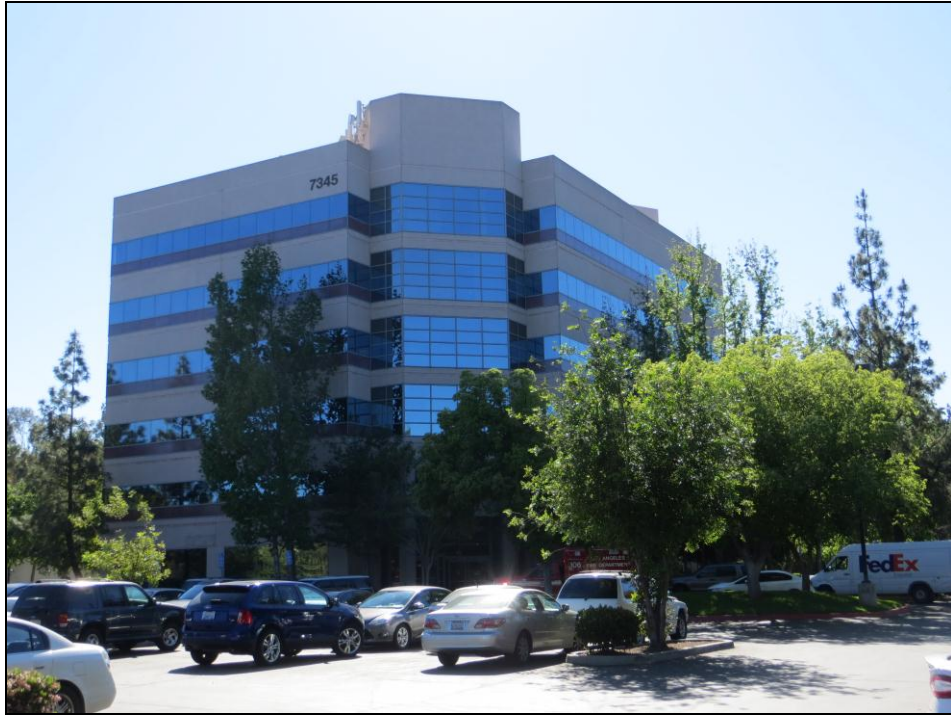
Photo 1 – Northeast Elevation

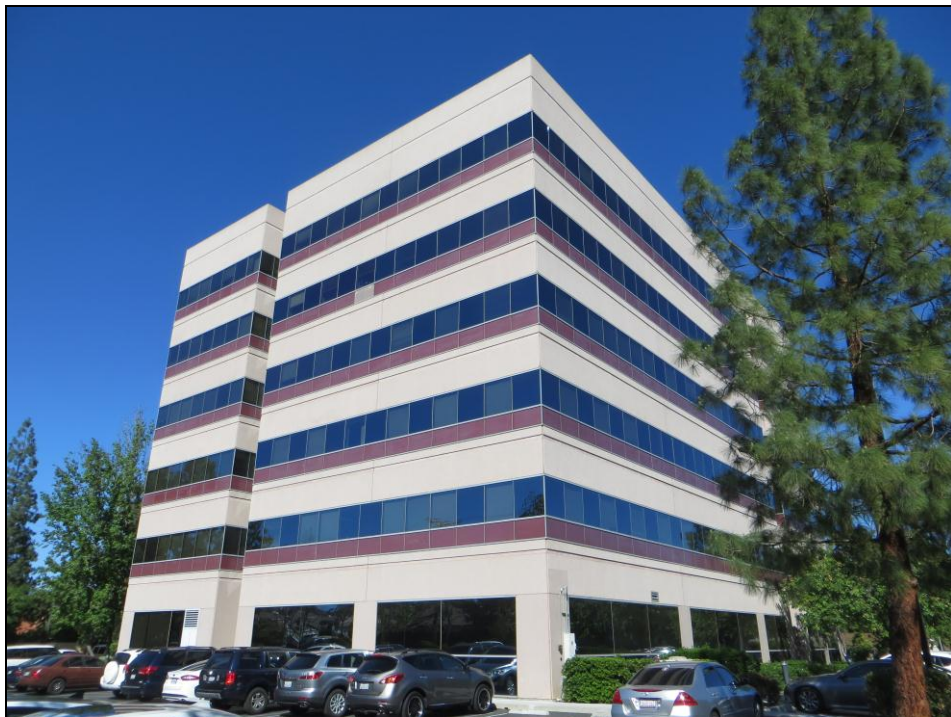
Photo 2 – Southwest Elevation

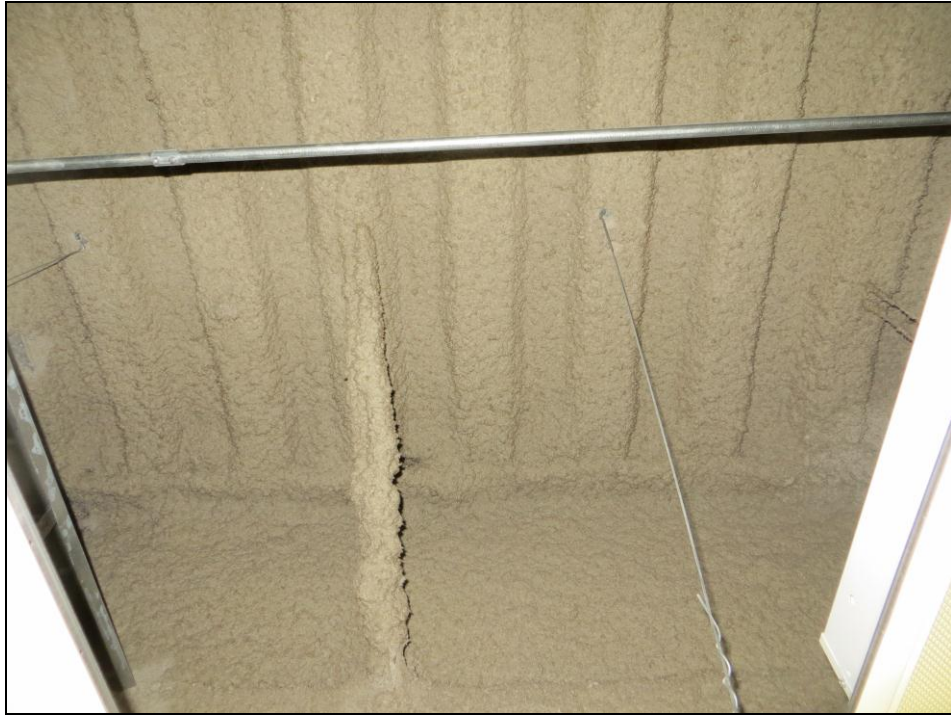
Photo 3 – Metal Deck and Steel Framing

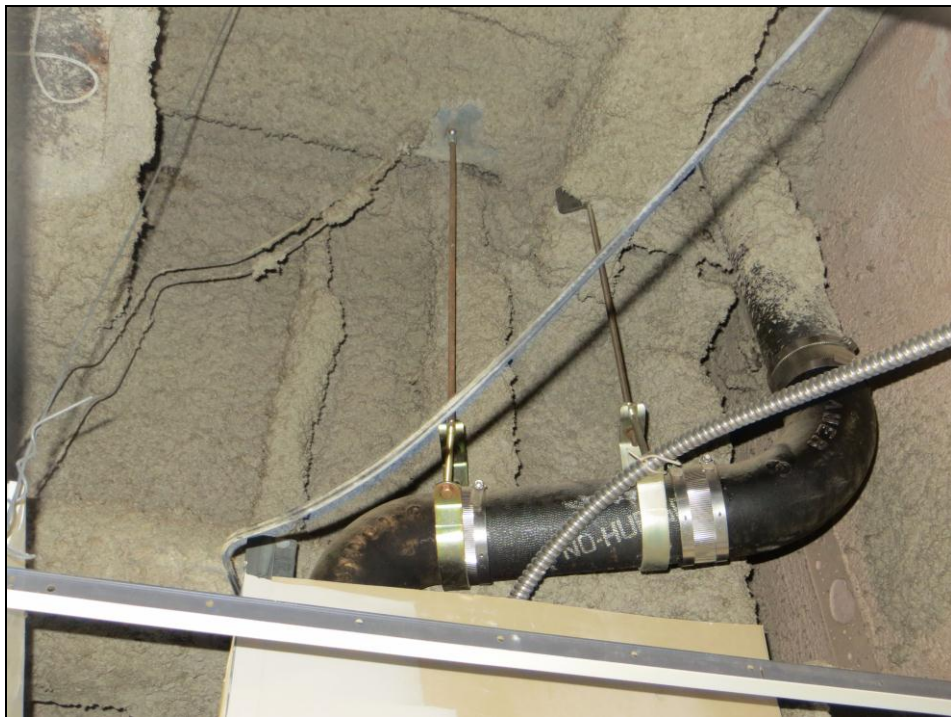
Photo 4 – Beam-to-Column Connection
