Re: *University of California Seismic Rating for 800 Fairmount Avenue, Pasadena*

Nabih Youssef & Associates (NYA) have performed an Independent Review of the four-story medical office building located at 800 Fairmount Avenue in Pasadena. The review consisted of a site visit to observe the existing condition of the exposed structural elements and identification of potential falling hazards that pose a significant life or safety risk to occupants.

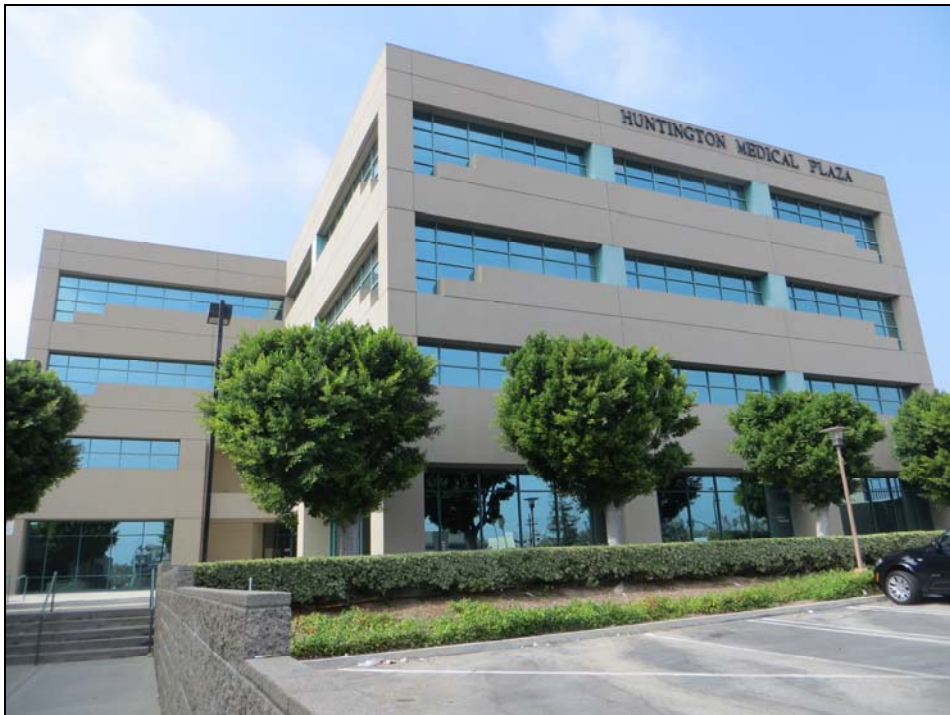
Photo 2 – East Elevation

Interior partition walls and piping systems were observed to be braced and rooftop mounted equipment anchored. The exterior of the building consists of cladding with ribbon windows. There are no canopies or signage that could pose a significant potential falling hazard.

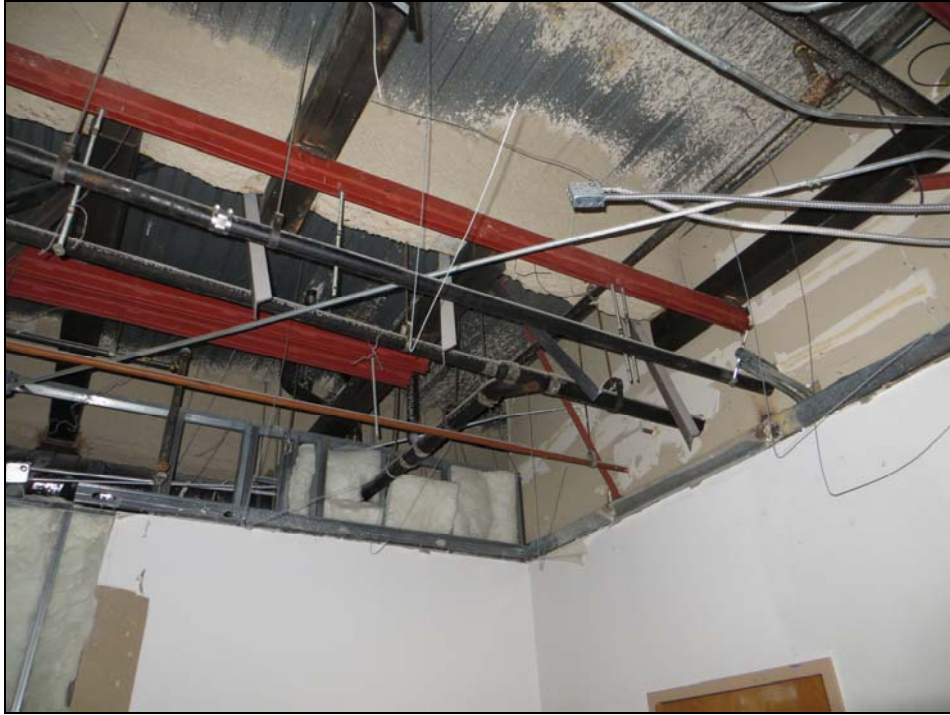
Photo 3 – Steel Framing with Braced Partition and Piping

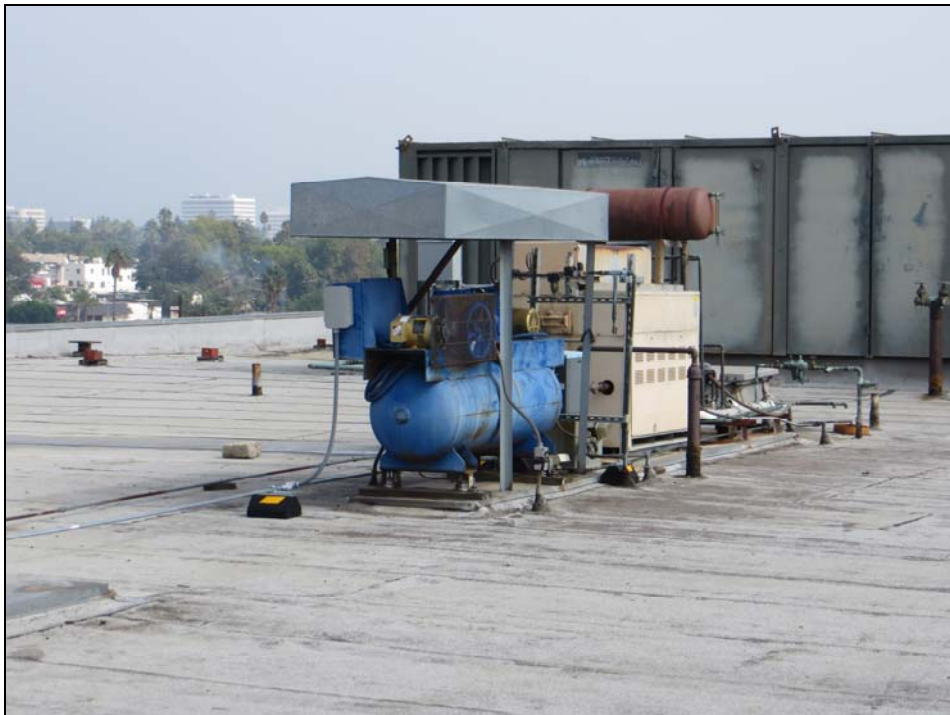
Photo 4 – Mechanical Equipment on Roof
