UC Campus: UCLA
Building Name: 8641 Wilshire Blvd.
Building CAAN ID:
Auxiliary Building ID:

March 11, 2022

Subject: 8641 Wilshire Blvd., Beverly Hills, CA 90211
ASCE 41 Tier I Seismic Evaluation Report
LFA Job no. 21000-24

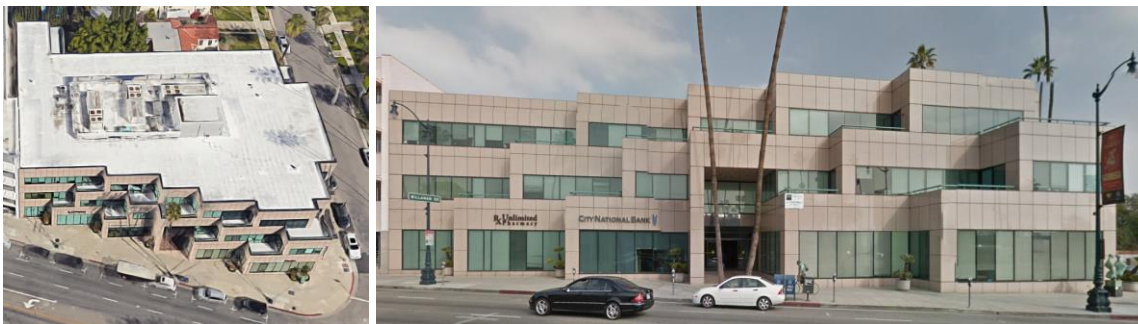
Figure 1 – Aerial Image of Overall Subject Existing Building Site and Exterior Elevation Photo
