Campus: [UCLA](#)
Building Name: [1336 16th Street](#)
CAAN ID: [42172](#)
Auxiliary Building ID:

FORM 1
CERTIFICATE OF SEISMIC PERFORMANCE LEVEL

UCLA – 1336 16th Street

FEMA 154 Rapid Visual Screening

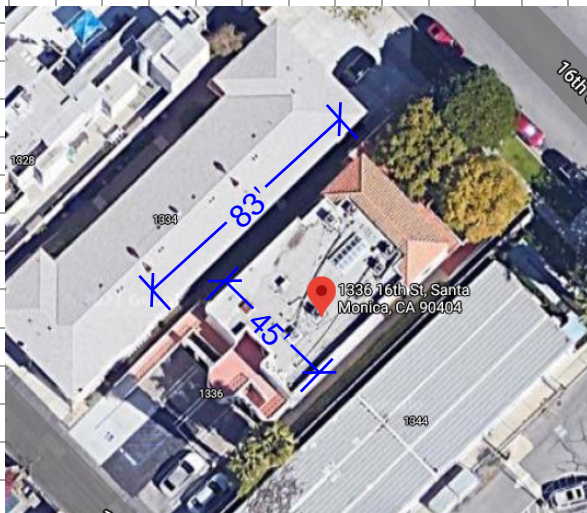
SKETCH

After further investigation, it is noted that the sill plates were anchored roughly 24" OC. It is also noted that the cripple walls were not sheathed and we therefore have a moderate vertical irregularity.

Add sheathing to cripple walls to provide better load path between shear walls and foundations.
