December 11, 2018

Subject: 2424 Wilshire Blvd, Santa Monica, CA 90043
Seismic Screening Report
JLA Job no. 18128-09

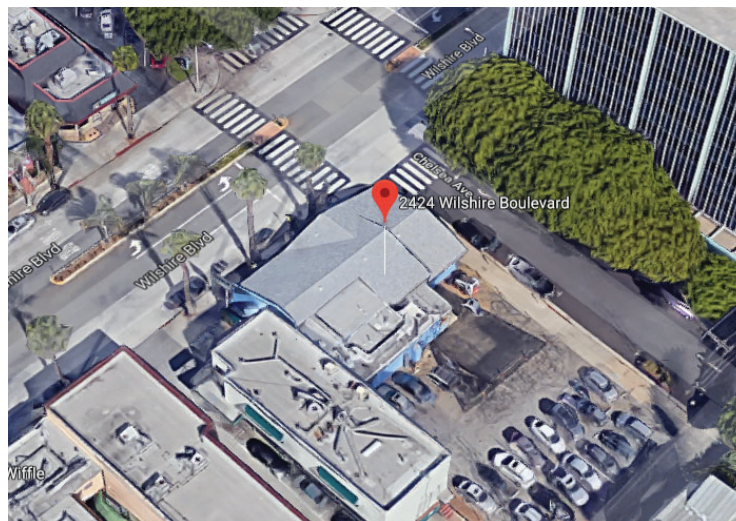
Figure 1 – Overall Building View
