UC Seismic Evaluation – Doris Stein Eye Research Center

Date: 4/26/2021
UC Campus: UCLA – on campus
Building Name: Doris Stein Eye Research Center
Building Address: 200 Stein Plaza, Los Angeles, CA 90024
CAAN ID: 4325
Auxiliary Building ID¹: N/A

Summary of information provided by Evaluator:
 Nabih Youssef Associates Structural Engineers

UCOP Seismic Performance Level² (or “Rating”) based on ASCE 41-17 Tier 1 evaluation findings: V

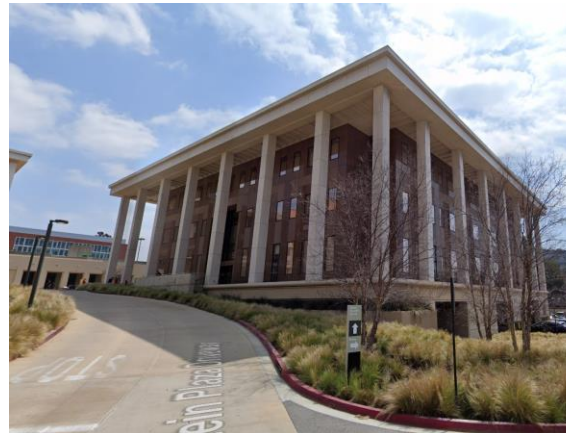
Exterior Photo

Falling Hazards Assessment Summary: No egregious falling hazards are present at the exterior of the building. There is a covered colonnade at the perimeter of the main building with a soffit at the overhang and column architectural covers, but these would pose no greater risk than typical building cladding.
