BUILDING REPORT REQUIREMENTS
ASCE 41-17 TIER 1 SEISMIC EVALUATIONS

BUILDING REPORT

- 1) UC Campus: Los Angeles
2) Building Name: Moore Hall
3) Building CAAN ID: 4250
4) Auxiliary Building ID:
5) Date of Evaluation: 12/9/2020
6) Evaluation by: Englekirk, AB
7) Seismic Performance Rating and Basis of Rating: V, ASCE 41-17 Tier 1

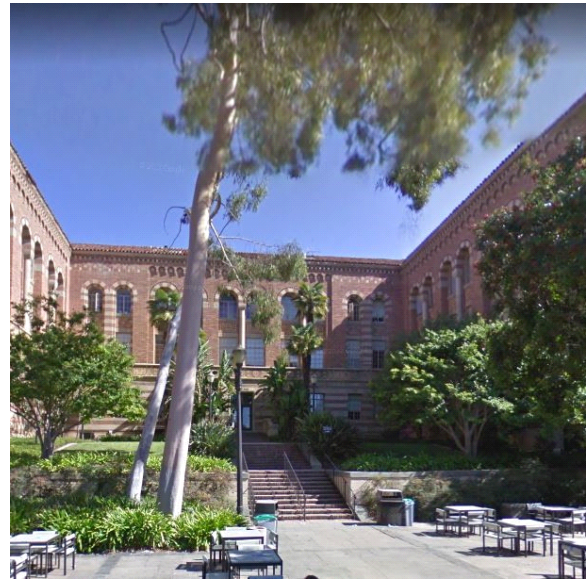
9) Exterior Elevation Photo

Comments: Moore Hall was originally constructed in 1928 and underwent a retrofit in 1992 for the addition of new lateral concrete shear walls to improve its seismic performance. Added shear walls were dowelled into existing floor and foundations and comply with adequate load path for seismic forces transfer. Hollow clay tile partitions, particularly along the exit corridors, have been identified as falling hazards; ornamental cast stone finishes around entrances were pinned back into the concrete structure

when main retrofit was performed and are not considered as serious falling hazards. Added 12" concrete shear walls in the 1992 retrofit provide a much better performance against seismic forces; however, level of forces under Collapse Prevention (BSE-2E) are still too high for compliant behavior of specific walls. A Tier 2 is suggested to provide precise shear wall and story level location of required FRP strengthening to achieve a Performance level Rating IV.

Increase confinement of concrete columns via FRP overlay, added shear walls strength using thickened cross-section or FRP overlay or energy dissipation to reduce drift.
