**UC Seismic Evaluation**

**Date:** 06/11/2021  
**UC Campus:** UCLA – on campus  
**Building Name:** Park Pool Locker Room  
**Building Address:** 111 Easton Drive, Los Angeles, CA 90024  
**CAAN ID:** 4205H  
**Auxiliary Building ID<sup>1</sup>:** N/A

**UCOP Seismic Performance Level<sup>2</sup> (or “Rating”) based on ASCE 41-17 Tier 1 evaluation findings: V**

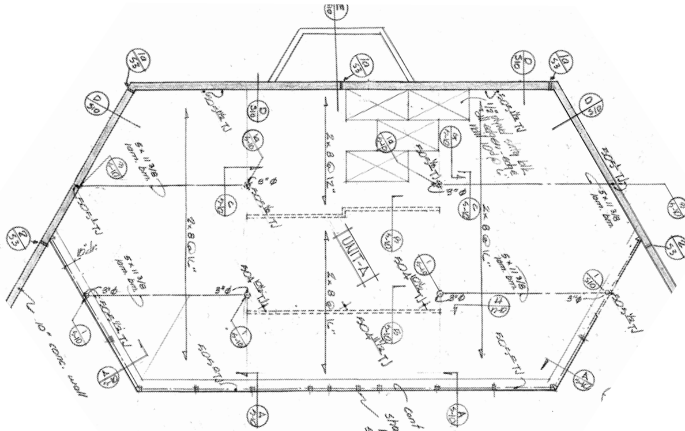
*Roof Framing Plan*

Note: Positive connection (out-of-plane wall anchors) between the concrete walls and wood framed roof is required.

Connection between the wood roof and concrete walls due to out-of-plane loading; and failure of wood shear wall.

Provide out-of-plane anchors between the concrete walls and wood roof.  
Provide wood sheathing and hold downs at 2, 7.6' long wood shear walls

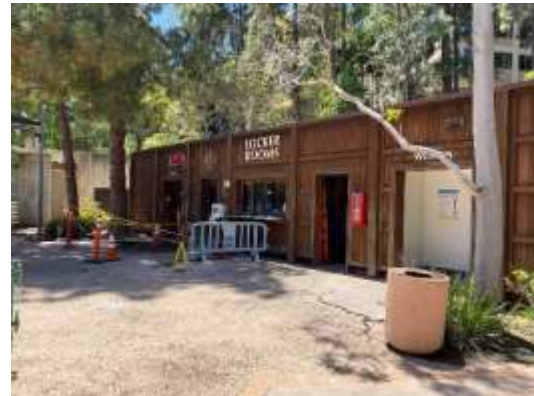
*Exterior Elevation Photo*

The 1-story building includes a 2600 sf locker room. The building is hexagonal in plan. The back side of the building retains about 9'-0" of soil against the hillside. The front side and the roof are wood framed.
