Seismic Ratings

UCLA Southern Regional Library Facility CAAN No. 4562

(Excerpt from 2017 UC Seismic Ratings Study Document)

June 30, 2017

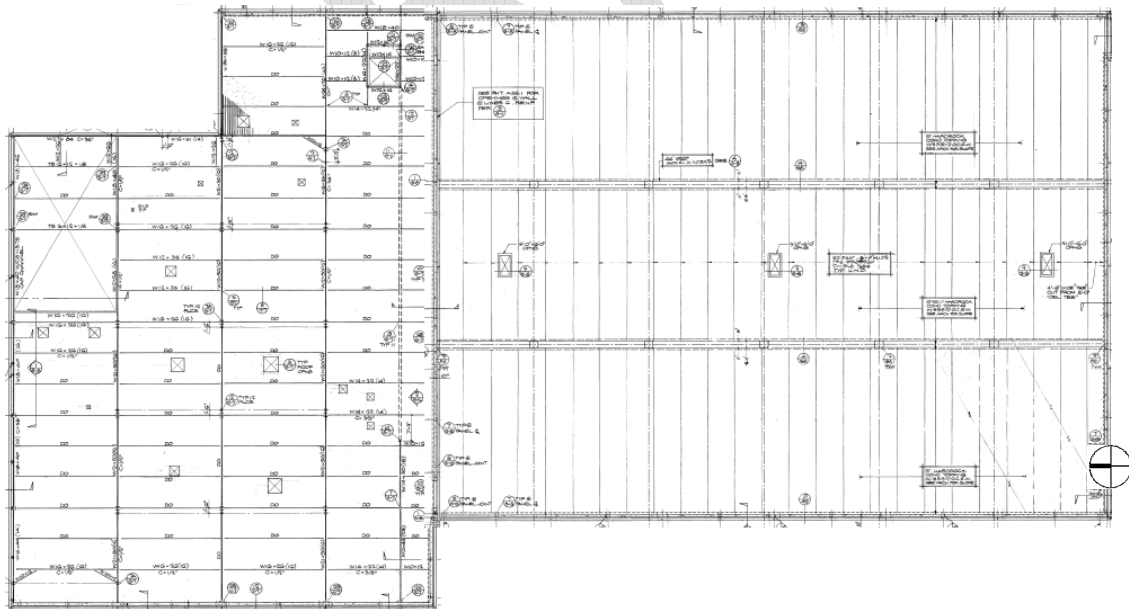
Figure 4.8.3 Roof Framing Plan, 1985 Construction

The northern half of the 1985 building is a two-story structure with perimeter shear walls, and a single subterranean level. Due to the sloping nature of the site, the northern part of the building has two levels above grade whereas the southern part has only one level above grade when they have almost similar roof elevation. The floor and roof are framed with metal deck with concrete topping spanning between steel beams, supported by steel columns at the interior and perimeter walls at the exterior. The north face of the structure is braced with steel concentric braced frames. The north and south parts of the building share a common concrete shear wall. The north part of the building is approximately 18,500 sq. ft. in plan area. Roof framing plans for 1985 construction are shown in Figure 4.8.3.

4.8.2 Seismic Rating: Tier 1 deficiency observed in the building was: Deflection Compatibility of secondary components due to insufficient ties in precast columns.

This building qualifies for a Seismic Rating of IV, as defined in Table 1.2, because, the Tier 1 stress checks demonstrate that the shear walls have sufficient capacity to resist the seismic demands imposed on the building due to a BSE-1E seismic event. Most of the building is subterranean, the drifts are expected to be less than that of a typical three-story shear wall building, therefore, the shear demand on the columns will not be significantly large and the Tier 1 deficiency does not cause structural concern.

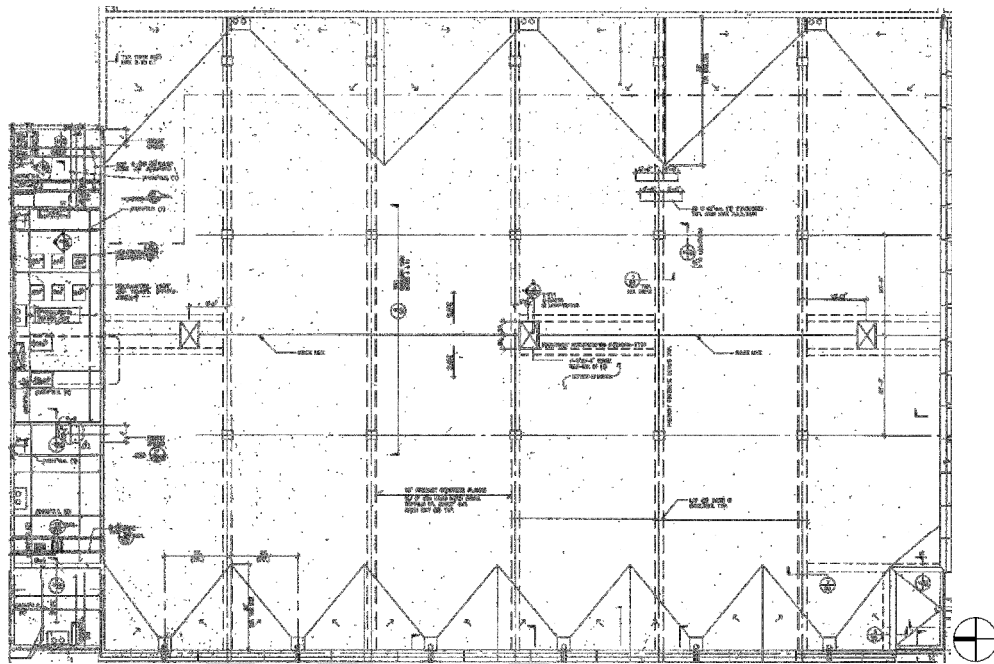
Figure 4.8.4 Roof Framing Plan, 1994 Construction

Phase II built in 1994, shares the western perimeter concrete wall with the southern half of the original construction. Phase II, is also a single-story building with two subterranean levels. The roof structure is framed with precast planks spanning to precast concrete beams, supported by precast columns and perimeter walls. Phase II is approximately 33,000 sq. ft. in plan area. Roof framing plans for 1994 construction are shown in Figure 4.8.4.
