Re: *University of California Seismic Rating for 10960 Wilshire Boulevard, Los Angeles*

Nabih Youssef Associates (NYA) have performed an Independent Review of the 23-story office building located at 10960 Wilshire Boulevard in Los Angeles. The review consisted of a site visit to observe the existing condition of the exposed structural elements, a review of the structural drawings, identification of potential falling hazards that pose a significant life or safety risk to occupants, and a seismic risk assessment.

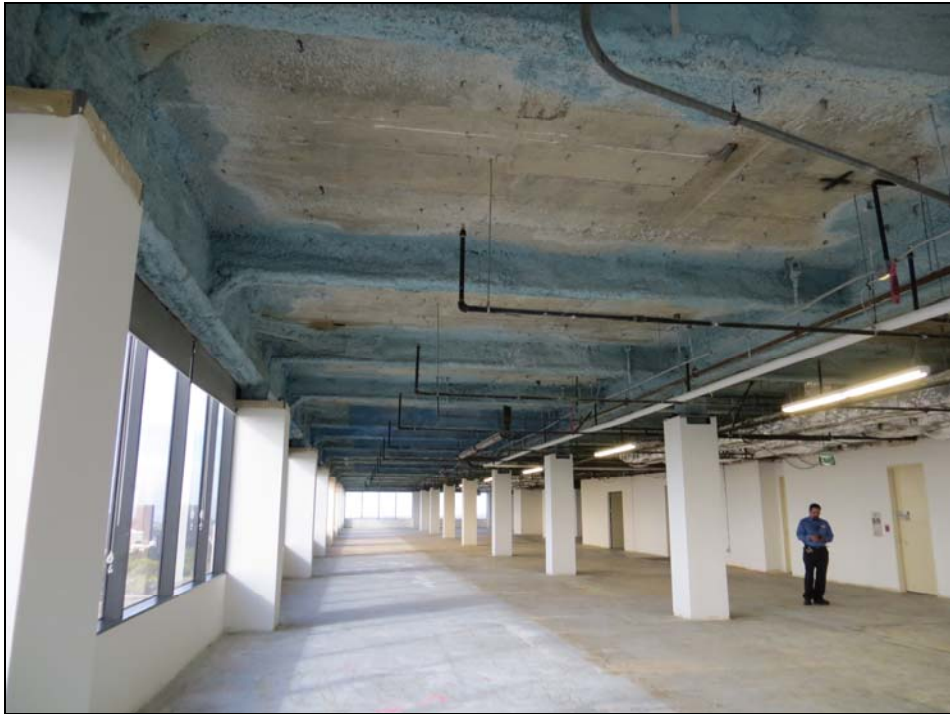
Photo 3 – Typical Floor Framing

The roof and typical floors are constructed of 4½" light weight concrete slab spanning to steel wide flange beams that are supported by steel wide flange girders. The steel girders are supported by steel wide flange columns that are continuous to the foundation. The foundation system consists of tapered concrete piles and pile caps connected by concrete grade beams. Reinforced concrete retaining walls form the perimeter basement walls.

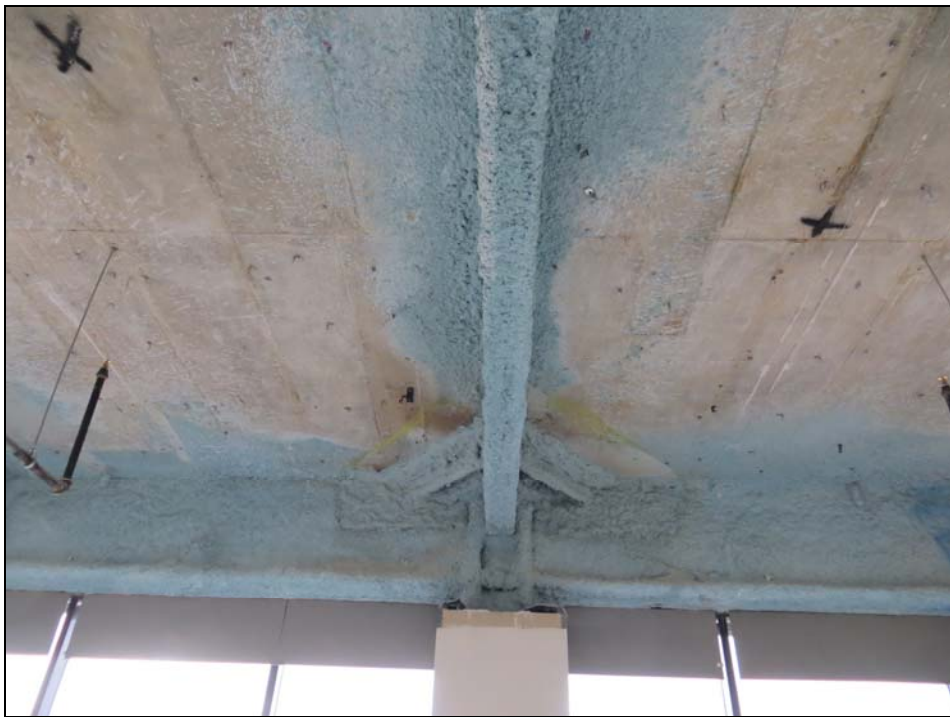
The beam-to-column moment connection is the typical “pre-Northridge” type connection that is susceptible to undesirable brittle/cracking damage. This type of connection was standard practice at the time of construction. A sampling (78 of 1300) of the beam-to-column moment connections were ultrasonically inspected in July and August of 1995, in conformance with City of Los Angeles Ordinance 170406, which mandated the inspection of the building’s welded moment connections. The inspection report indicates that the construction quality of the welds was considered standard for its time with weld cracks found in less than 4% of the connections tested. No cracks in base material were found and all identified damaged welds were repaired.

Photo 4 – Typical Beam-to-Column Moment Connection
