**Re: *University of California Seismic Rating for One Westwood
10990 Wilshire Boulevard, Los Angeles***

Nabih Youssef Associates (NYA) have performed an Independent Review of the One Westwood office building located at 10990 Wilshire Boulevard in Los Angeles. The review consisted of a site visit to observe the existing condition of the exposed structural elements, identification of potential falling hazards that pose a significant life or safety risk to occupants, a review of available structural drawings and an ASCE 41-13 Tier 1 evaluation.

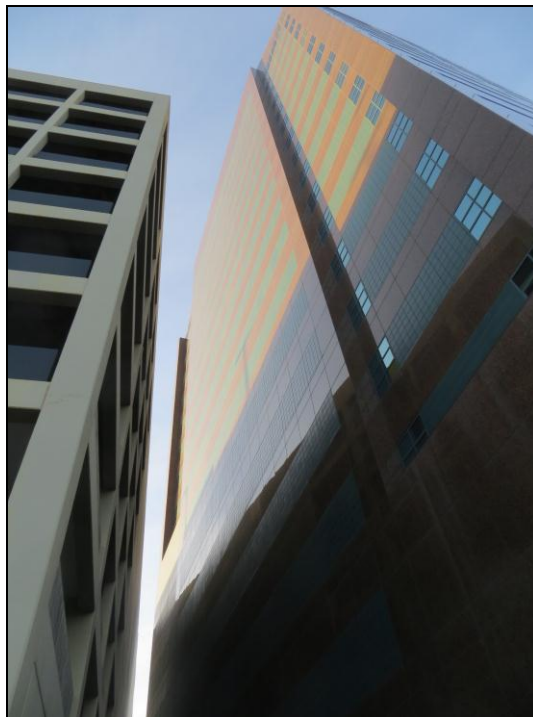
Photo 2 – Separation from Adjacent Parking Structure

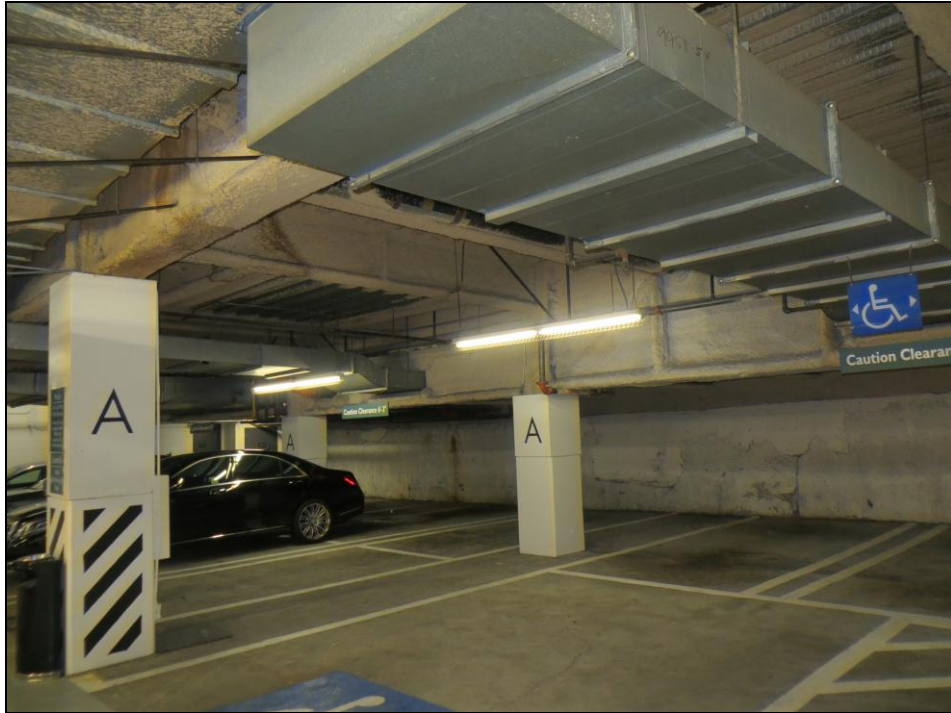
Photo 3 – Steel Framing in Subterranean Level

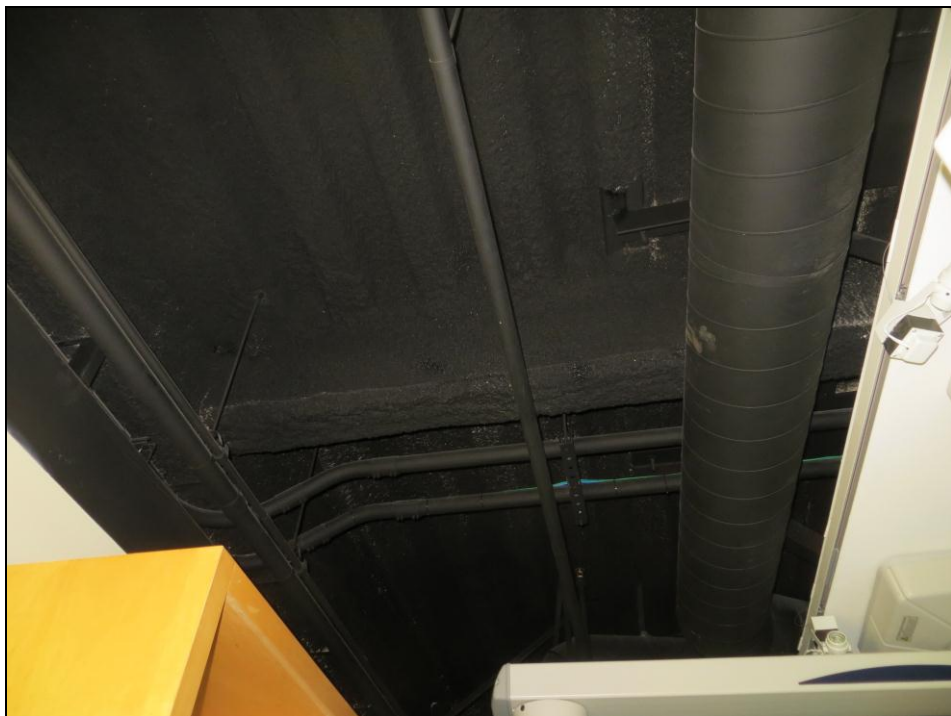
Photo 4 – Typical Steel Framing in Office Floor
