October 6, 2014

Re: *University of California Seismic Rating for 11150 West Olympic Boulevard, Los Angeles*

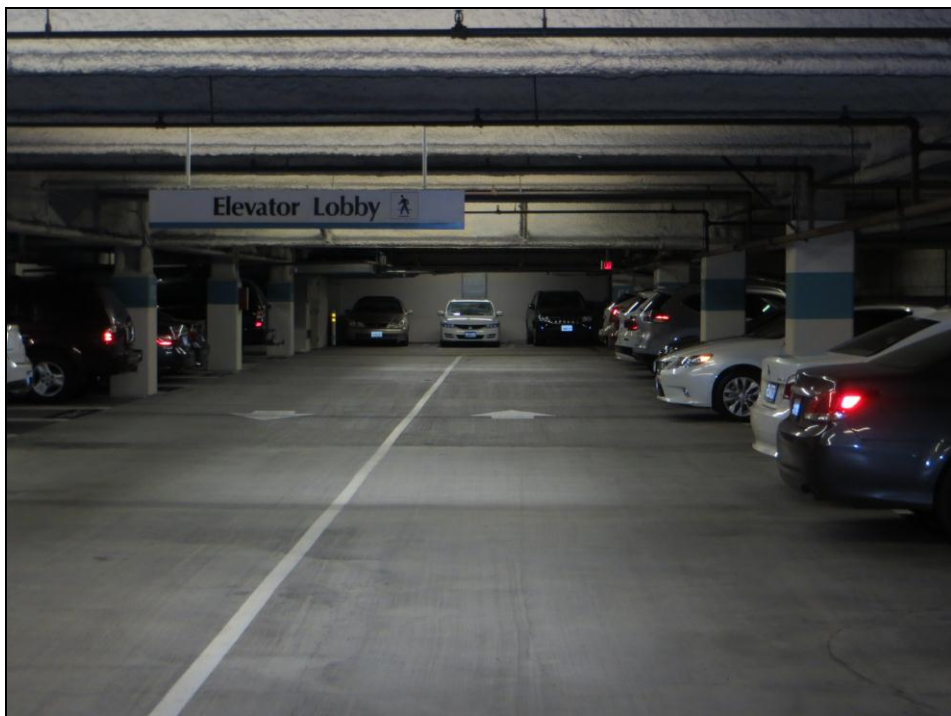
Photo 4 – Typical Steel Framing at Parking Level

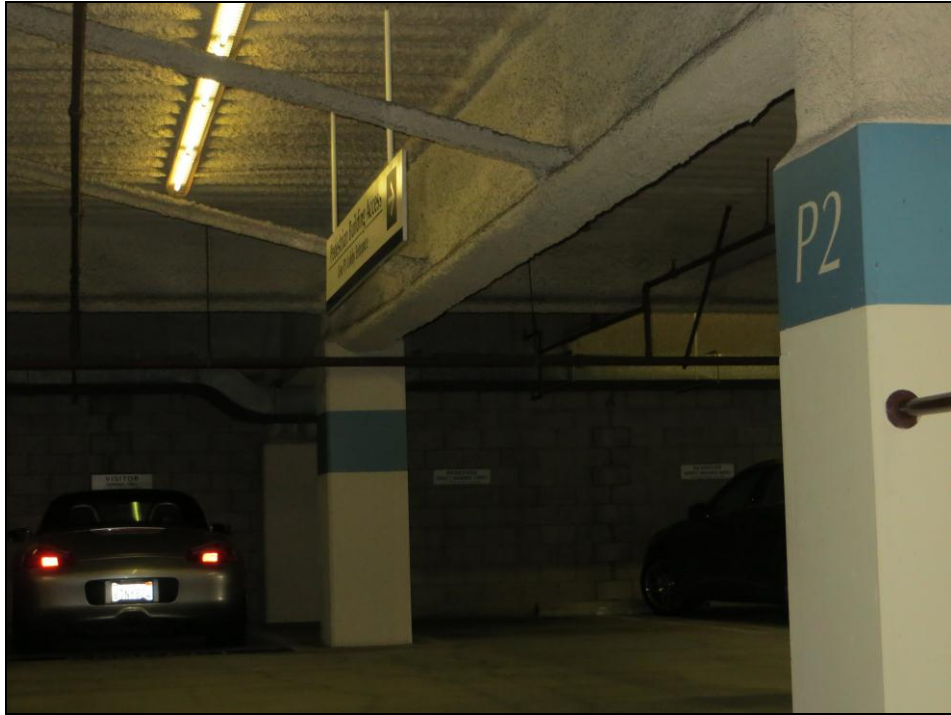
Photo 5 – Bracing of Moment Frame Girder Bottom Flange

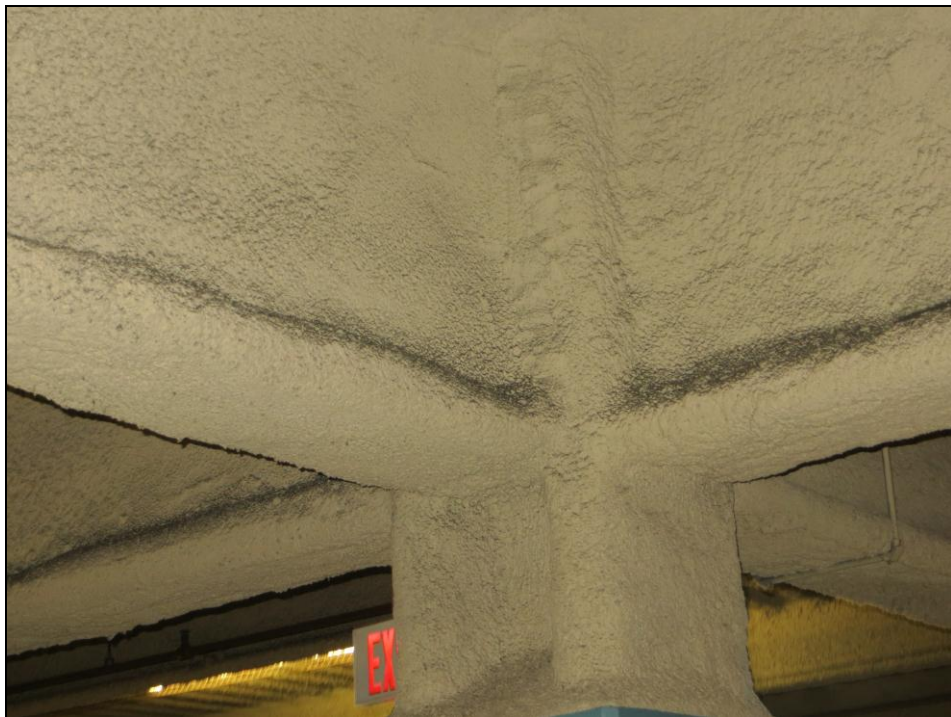
Our 2002 report cites a 1996 Steel Connection Survey by John A. Martin & Associates, which indicates that all of the building's 920 welded moment connections were visually and ultrasonically inspected after the 1994 Northridge Earthquake. The inspection identified 258 welded connections to be damaged or defective. All 258 damaged or defective welds were repaired. This work was inspected and approved by the City of Los Angeles Department of Building and Safety.

Photo 6 – Typical Welded Moment Connection
