March 14, 2014

Re: *University of California Seismic Rating for 11600 Wilshire Boulevard, Los Angeles*

Nabih Youssef Associates (NYA) have performed an Independent Review of the 5-story office building with basement located at 11600 Wilshire Boulevard in Los Angeles. The review consisted of a site visit to observe the existing condition of the exposed structural elements, on site review of the structural drawings, identification of potential falling hazards that pose a significant life or safety risk to occupants, and a seismic risk assessment.

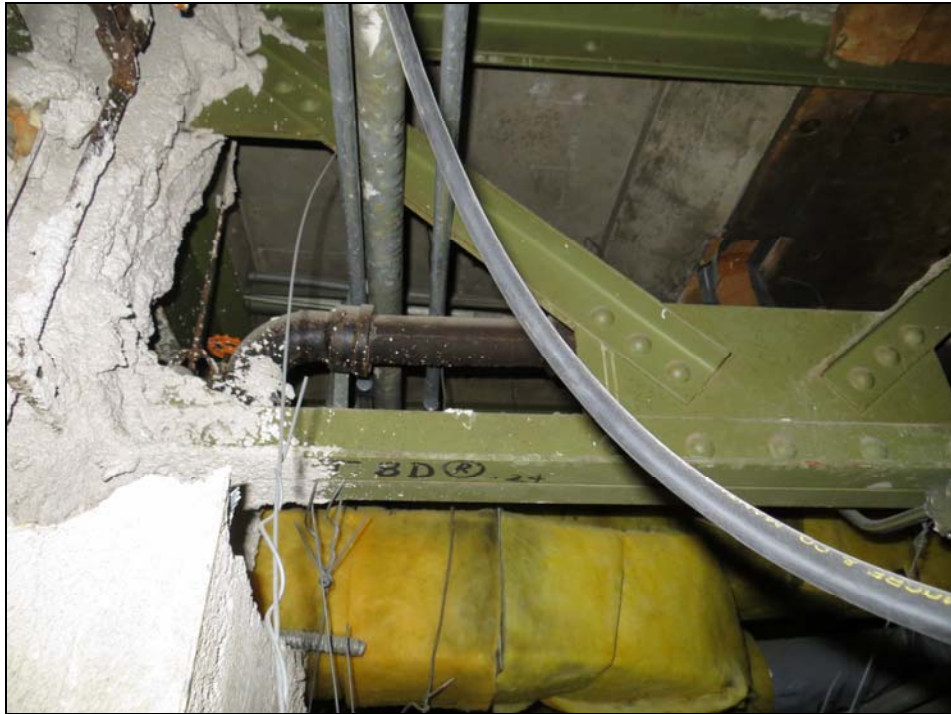
The lateral-force-resisting system consists of the concrete slab roof and floors acting as structural diaphragms to transfer seismic inertial forces to distributed steel truss moment frames. The trusses are constructed of double angle chords and braces with welded connections. The trusses are typically bolted to the flange or web of the columns. The truss moment frames are continuous to the first floor level where seismic forces are transferred to the concrete walls below.

Photo 3 – Typical Steel Truss to Column Connection

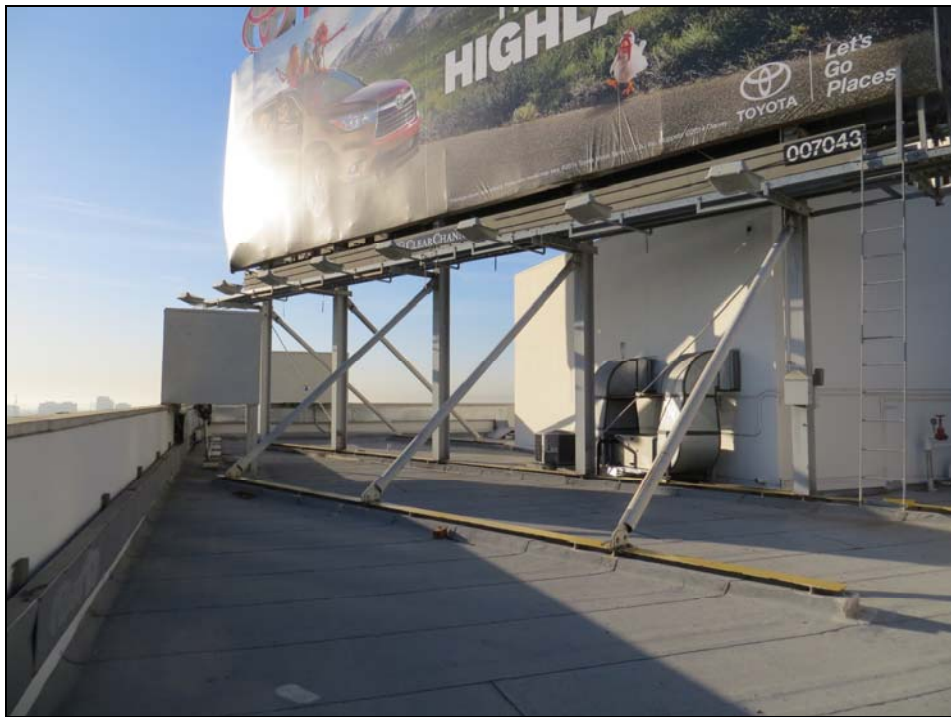
The suspended ceiling frames were braced by diagonal splay wires with a compression element. The exterior of the building consists of pre-cast concrete cladding with glazed windows. There is a canopy over the east building entrance and limited signage on the exterior of the building. The canopy and signage appear to be adequately anchored. There is a billboard on the roof of the building that appears to be adequately braced by steel pipes and rods. Rooftop equipment was anchored to steel framing that was positively anchored to the roof. No elements were observed that pose a significant potential falling hazard.

Photo 4 – Bracing of Billboard Frame on Roof
