October 14, 2014

Subject: 11980 San Vicente Blvd, Brentwood, CA
Seismic Screening Report
JLA Job no. 14110-15

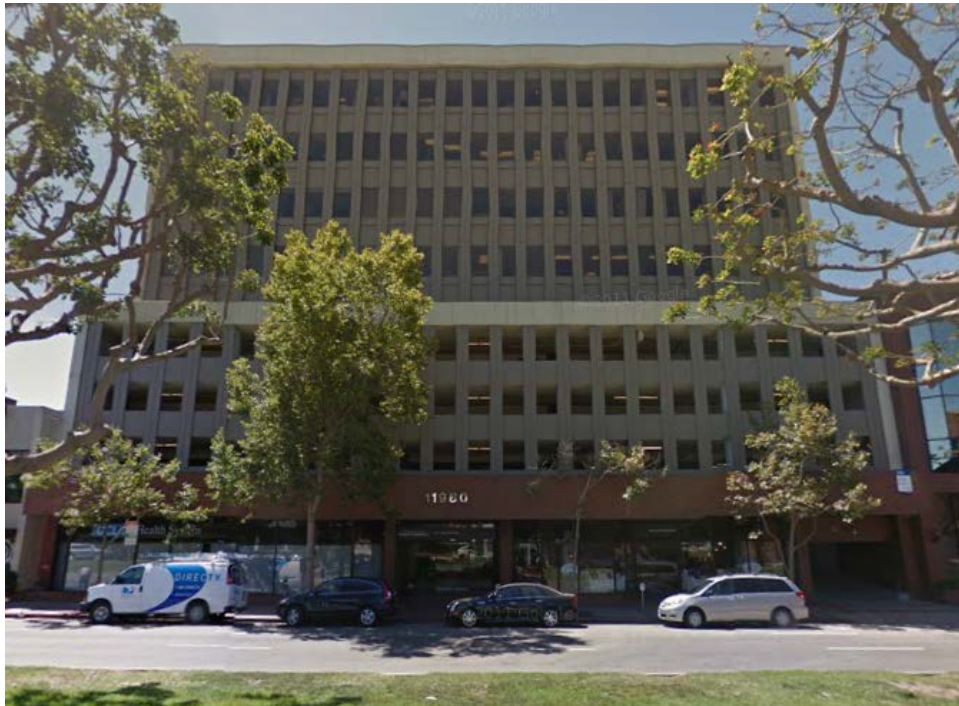
Figure 1 – North Elevation of 11980 San Vicente Blvd in Brentwood, CA
