January 10, 2015

Subject: 1399 S. Roxbury Drive, Los Angeles, CA  
Seismic Screening Report  
JLA Job #14110-20

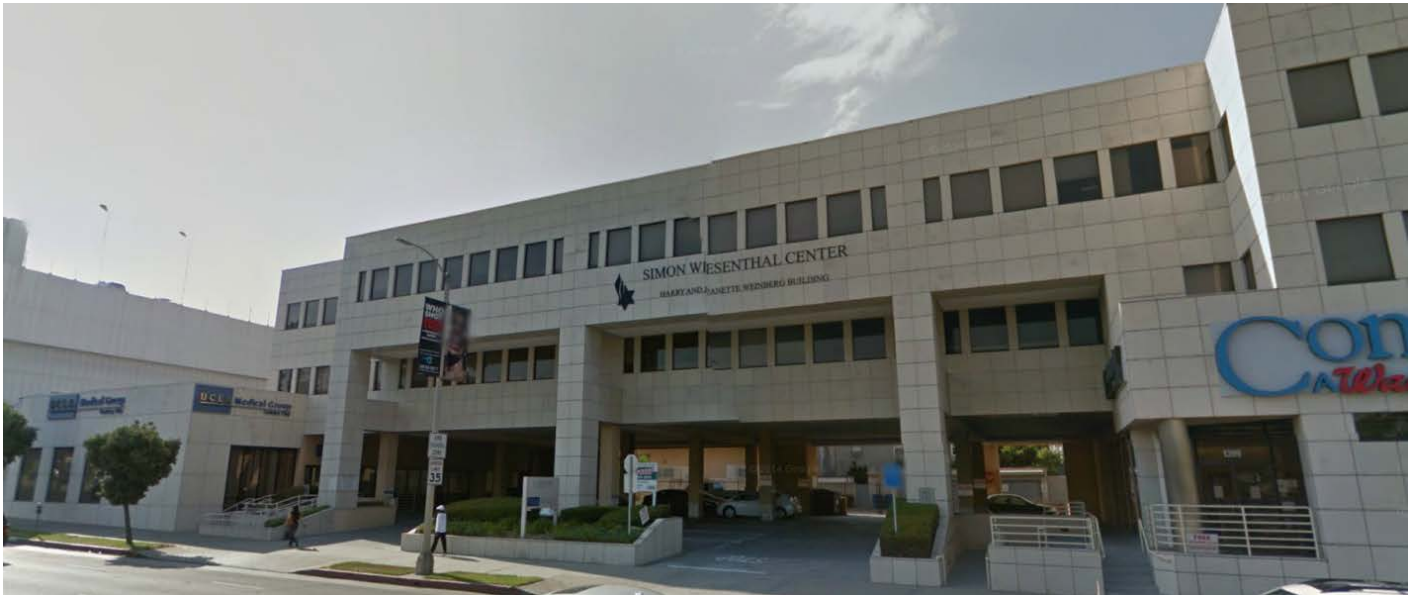
Figure 2 – South elevation of 1399 S. Roxbury Drive in Angeles, CA. Note portion occupied by UCLA on left (west) side in one story portion.

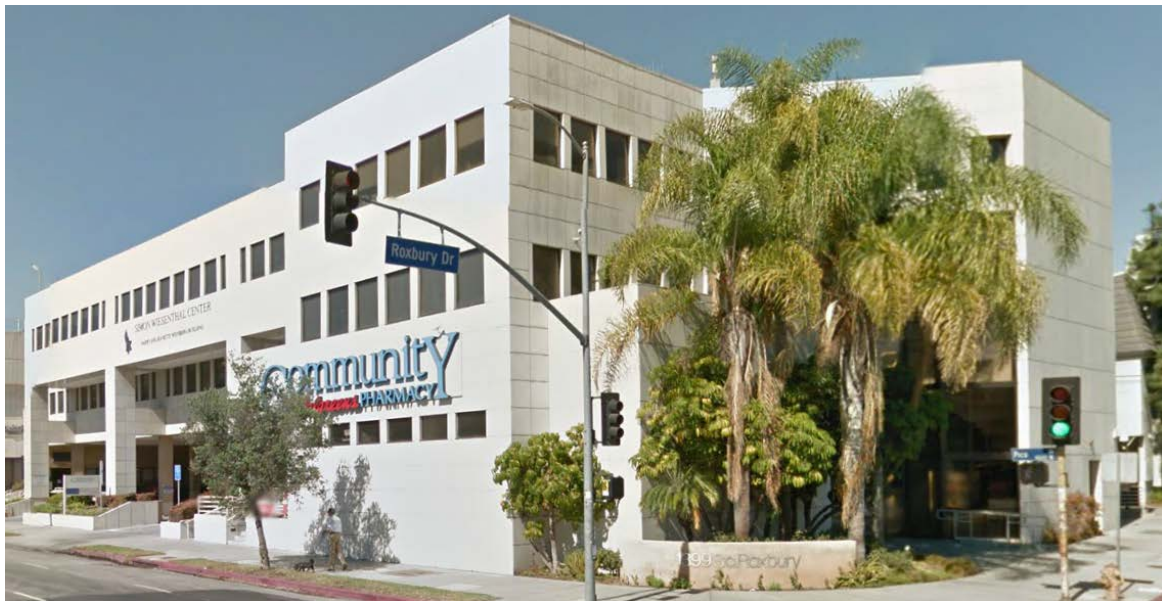
Figure 2 – South east elevation of 1399 S. Roxbury Drive in Angeles, CA.
