December 18, 2013

Subject: 1920 Colorado Blvd  
Santa Monica, CA  
Seismic Screening Report  
JLA Job no. 13110-27

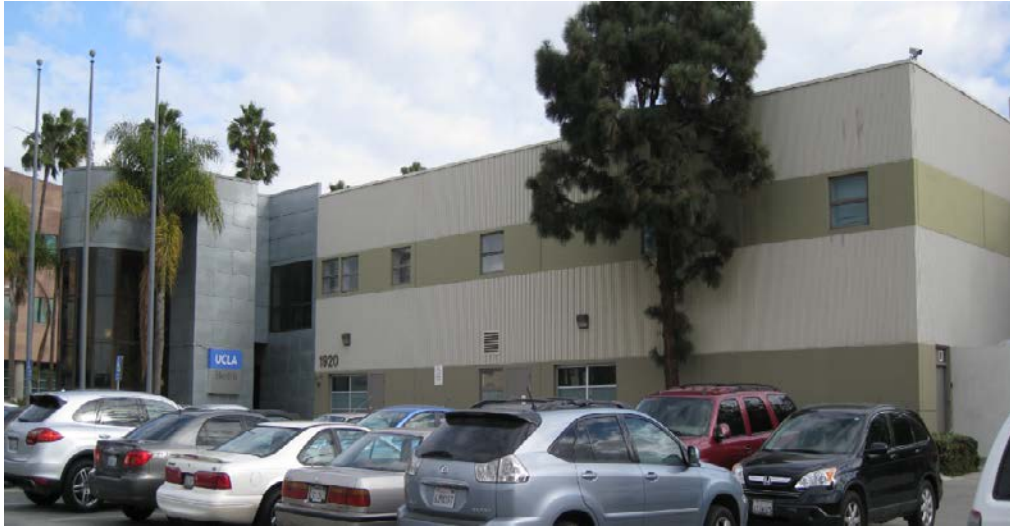
*Figure 1 – Exterior View of Two Story Portion*
