Subject: 309 W. Quinto St., Santa Barbara, CA 93105  
Seismic Screening Report  
JLA Job no. 19001-06

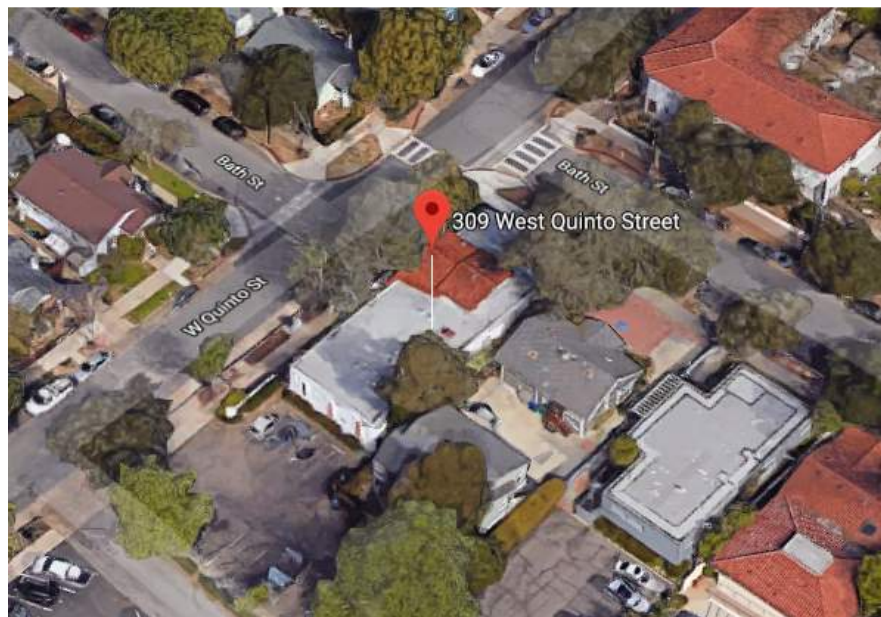
Figure 1 – View of Overall Subject Existing Building Site

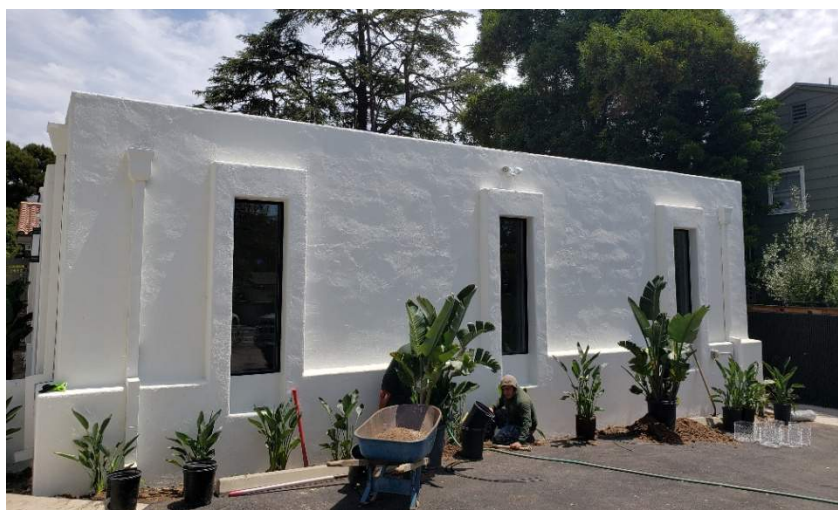
Figure 2 – Southwest Building Elevation (View from Main Parking Lot)

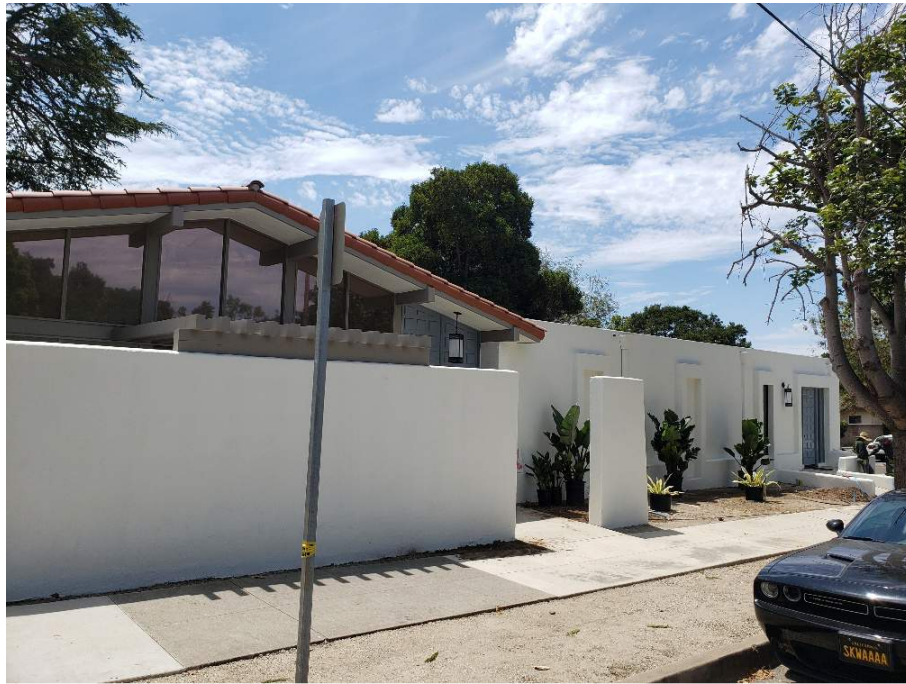
*Figure 3 – Northwest Building Elevation (Front Main Entrance - Northernmost Corner View)*

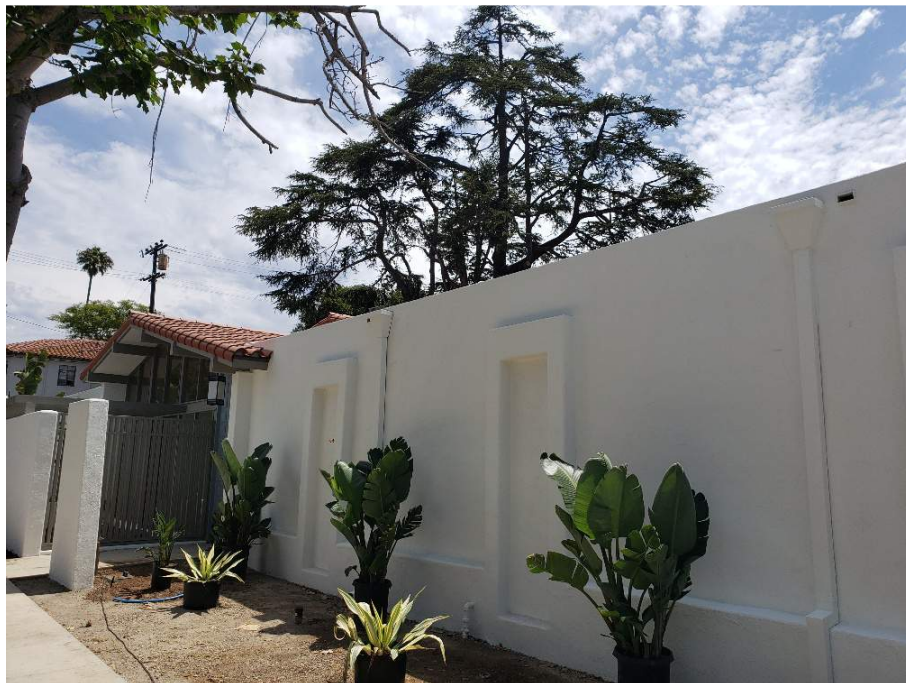
*Figure 4 – Northwest Building Elevation (Front Main Entrance - Westernmost Corner View)*

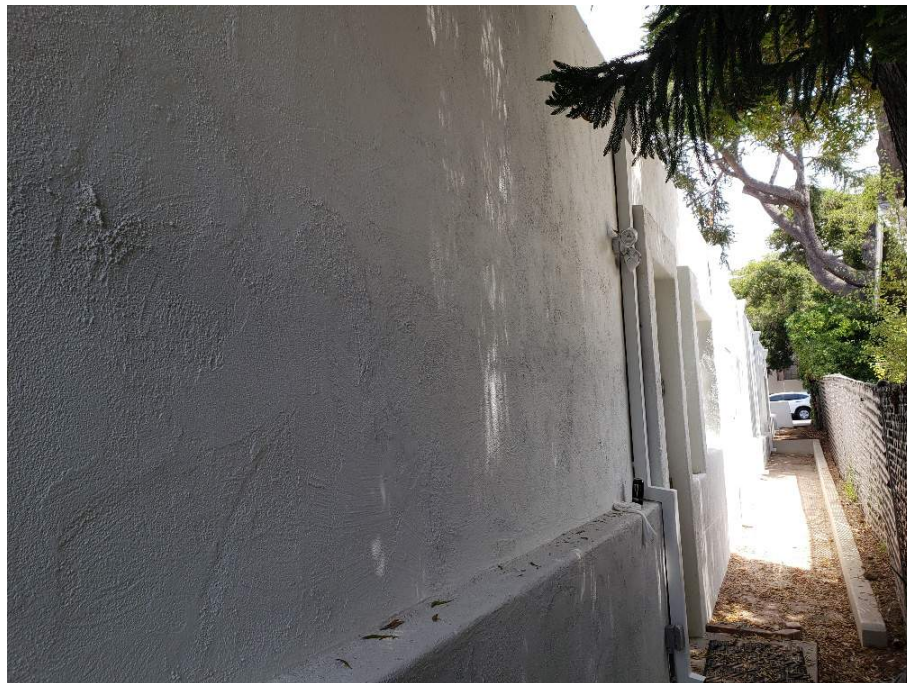
*Figure 5 –Southeast Building Elevation (Building Rear)*

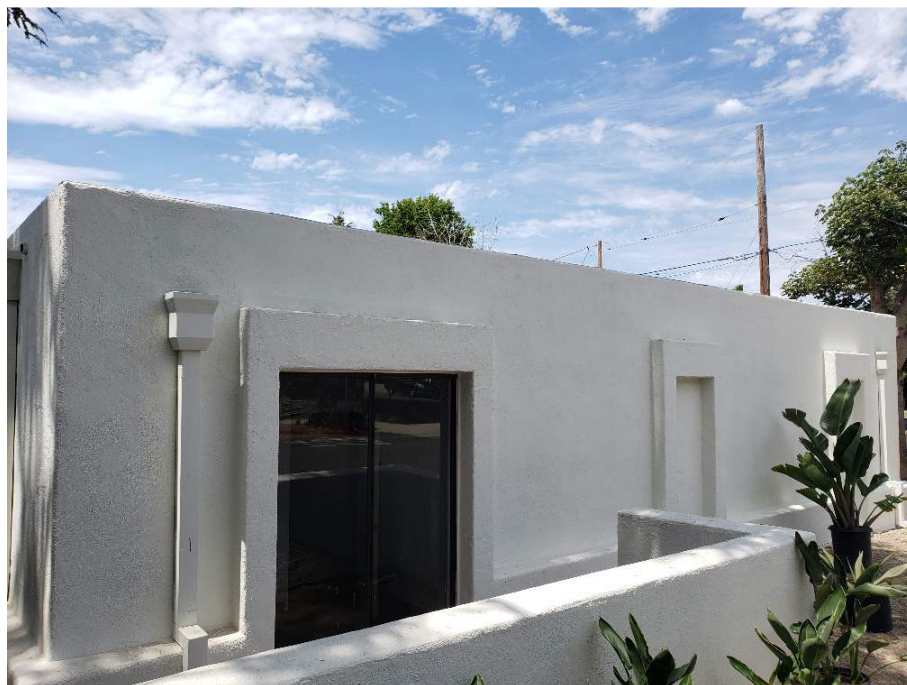
*Figure 6 – Northeast Building Elevation (Easternmost Corner View)*
