Re: *University of California Seismic Rating for 3500 Lomita Boulevard, Torrance*

Nabih Youssef & Associates (NYA) have performed an Independent Review of the 3-story medical office building located at 3500 Lomita Boulevard in Torrance. The review consisted of a site visit to observe the existing condition of the exposed structural elements, review of prior engineering reports, identification of potential falling hazards that pose a significant life or safety risk to occupants and a seismic risk assessment.

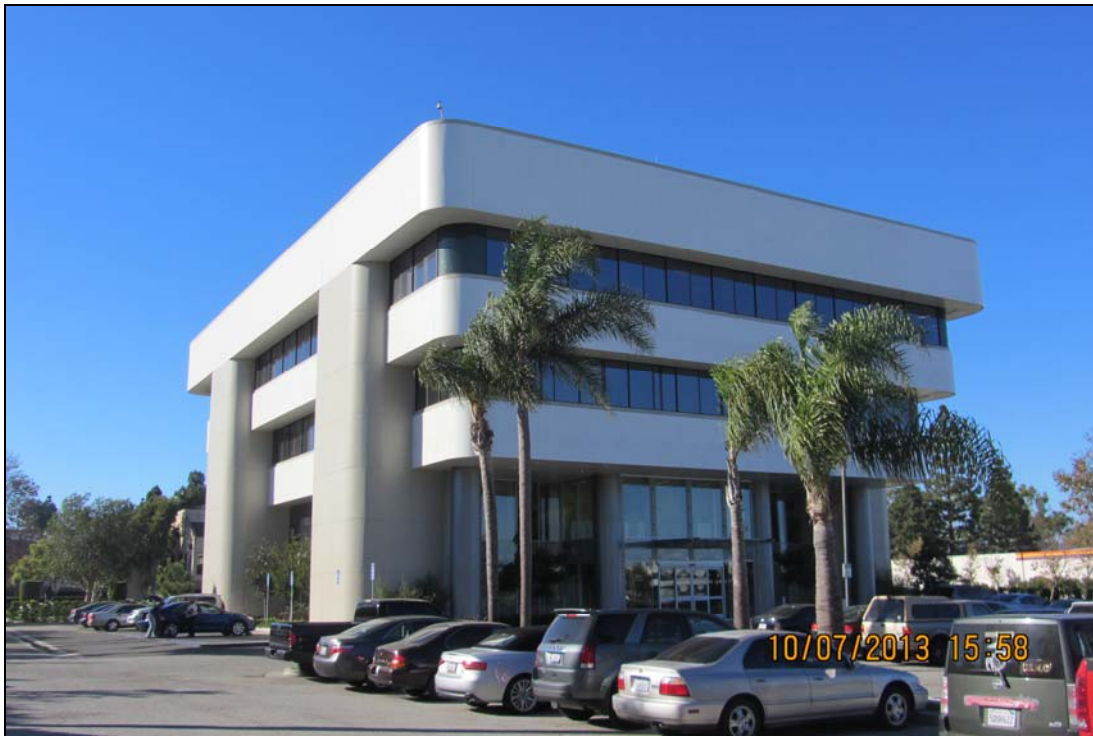
Photo 1 – Southeast Elevation

A site visit was performed by Owen Hata of NYA on October 7, 2013, to observe the condition and characteristics of the building. The majority of the structure was covered and was not visually observable. Observations were limited to visible areas of the structure. The building appeared to be in good condition and there were no signs of deterioration or distress.

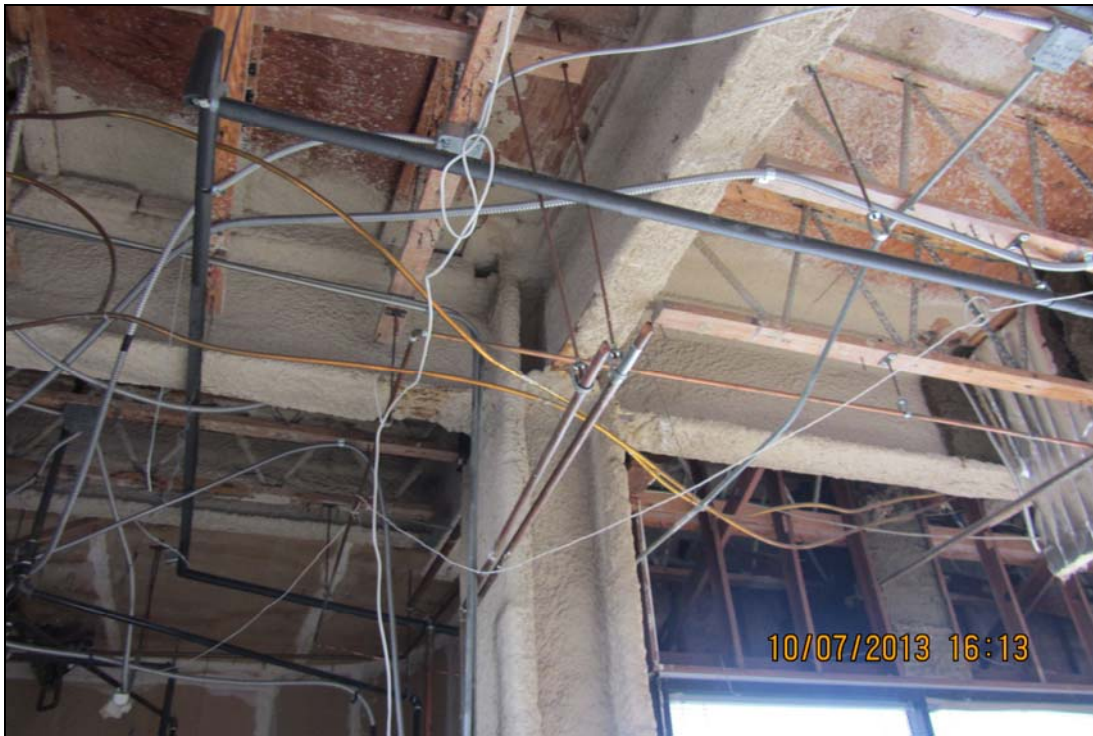
Photo 3 – Typical Steel Framing

The roof and floor are constructed of plywood sheathing supported by open-web truss joists spanning to steel wide flange beams. The steel beams are supported by steel wide-flange columns that appear to be continuous to the foundation. The foundation was not observed, however, buildings of similar construction and vintage typically have concrete spread footings under columns connected by concrete grade beams.

The lateral-force-resisting system consists of the wood roof and floor acting as structural diaphragms to transfer seismic inertial forces to perimeter welded steel moment frames.

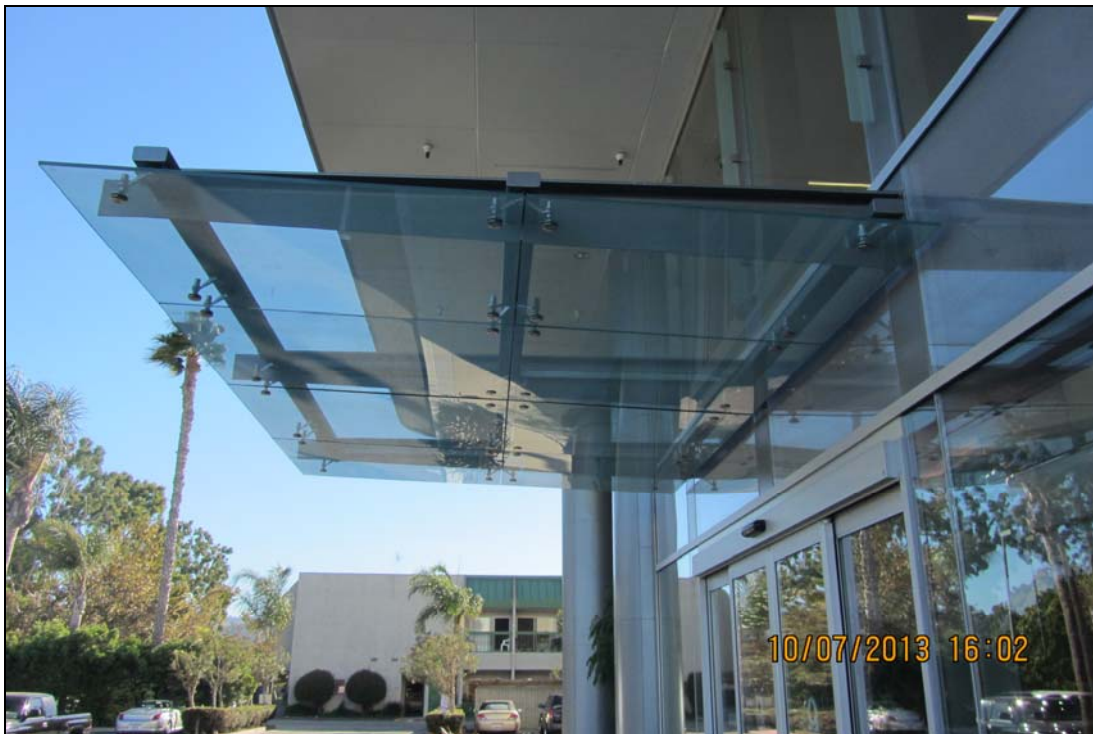
Photo 4 – Canopy at Building Entrance

The exterior of the building consists of aluminum cladding with ribbon windows. There is a canopy over the main entrance of the building. The framing of the canopy is welded to the mullions of the storefront framing. There were no potential falling hazards that pose a significant life or safety risk to occupants.
