April 20, 2018

Subject: 4910 Rivergrade Road, Irwindale, CA 91706
Seismic Screening Report
JLA Job no. 18128-02

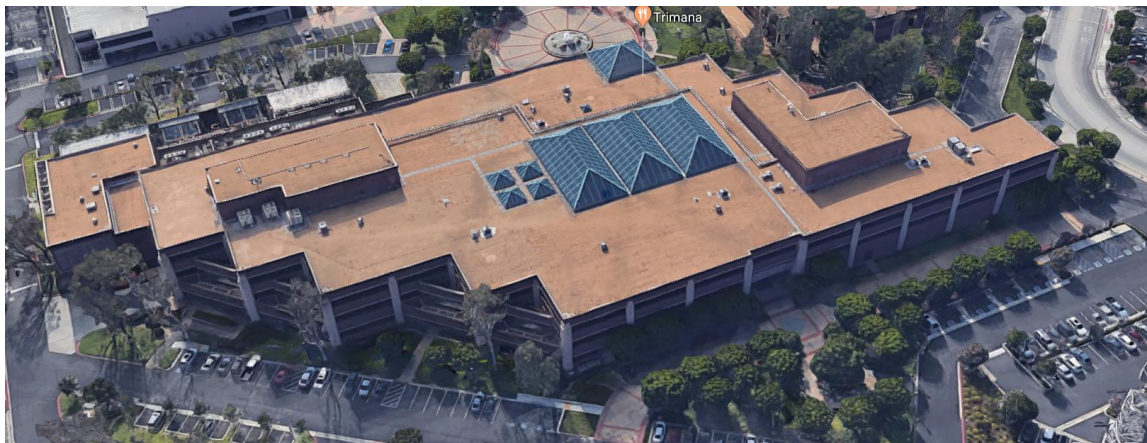
Figure 1 – Overall Building View

The building site is relatively level. The structure is composed of three stories of office space. The building perimeter appears to consist of non-load bearing steel stud with glass and CMU veneer, with some masonry walls.
