June 26, 2014

Subject: 5757-5767 W. Century Blvd Blvd, Los Angeles, CA

Seismic Screening Report JLA Job no. 14110-13

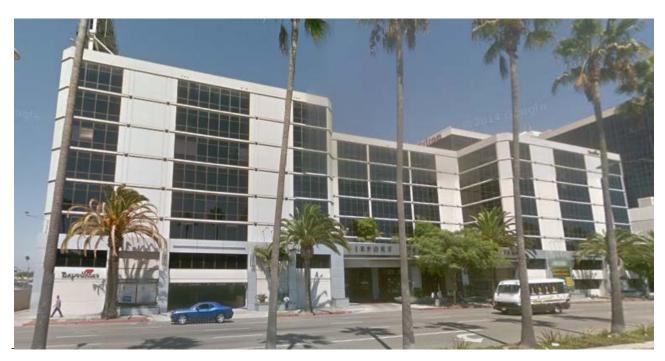
Figure 1 – 5757-5767 W. Century Blvd, Los Angeles, CA; Office Building #1 (South Building) South Elevation
