October 30, 2013

Subject: 622 West Duarte Rd
 Arcadia, CA 91007
 Seismic Screening Report
 JLA Job no. 13110-21

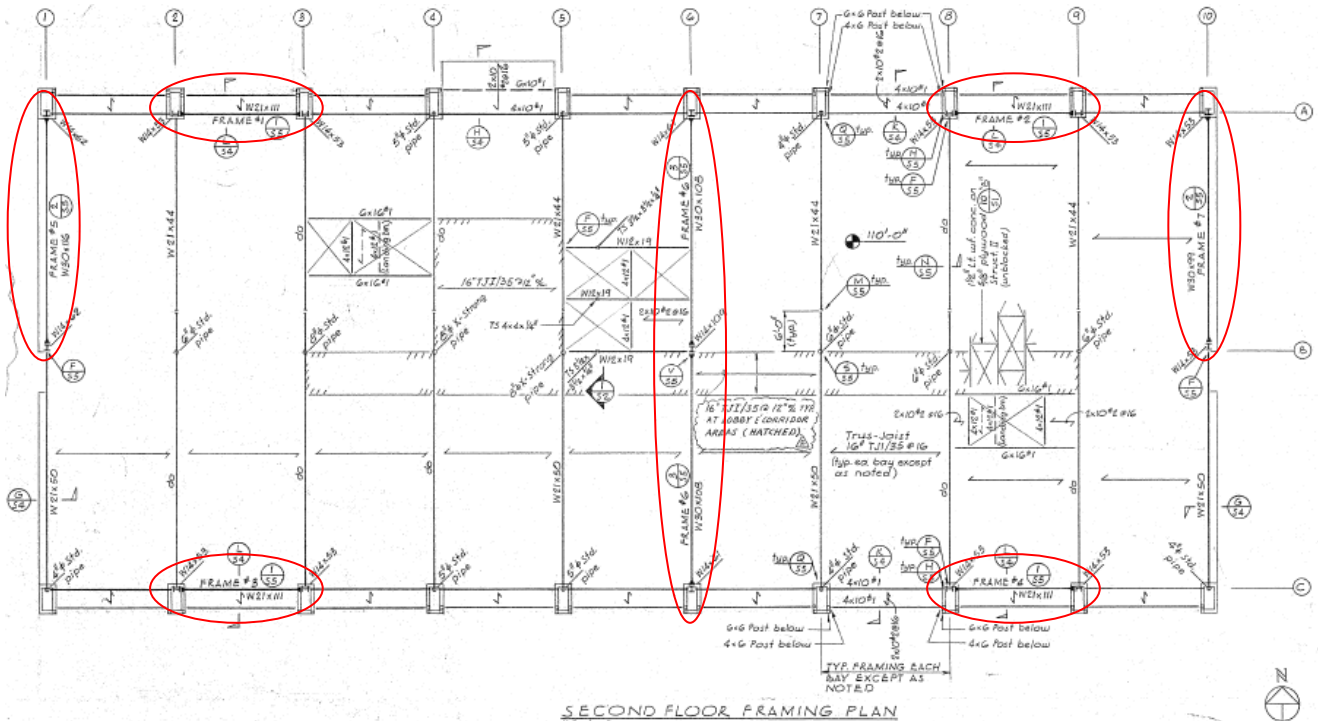
Figure 1 – Steel Moment Frame Layout

The lateral-force-resisting system consists of the plywood diaphragms that transfer seismic loads to welded steel moment frames. The base of the steel moment frame columns are embedded in concrete grade beams at the foundation level.
