January 30, 2014

Subject: 1950 Sawtelle Boulevard, Los Angeles, CA Seismic Screening Report JLA Job no. 14110-03

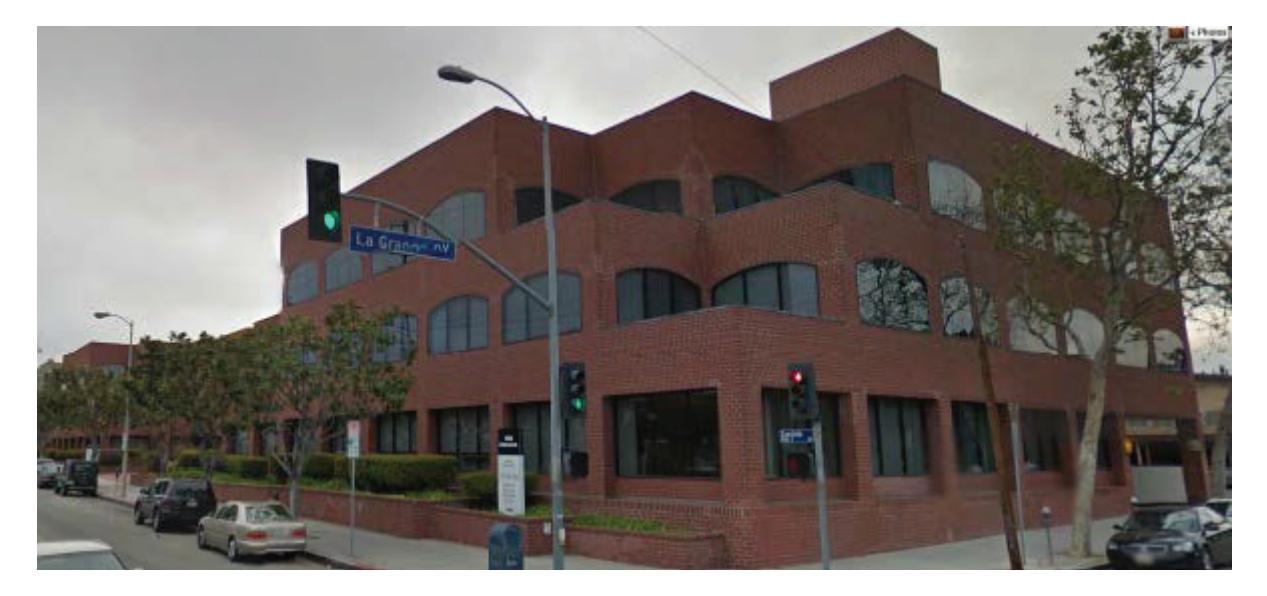
Figure 1 – Exterior View of 1950 Sawtelle Boulevard in Los Angeles, CA
