January 13, 2014

2211 Magnolia Blvd Burbank, CA Seismic Screening Report JLA Job no. 14110-01

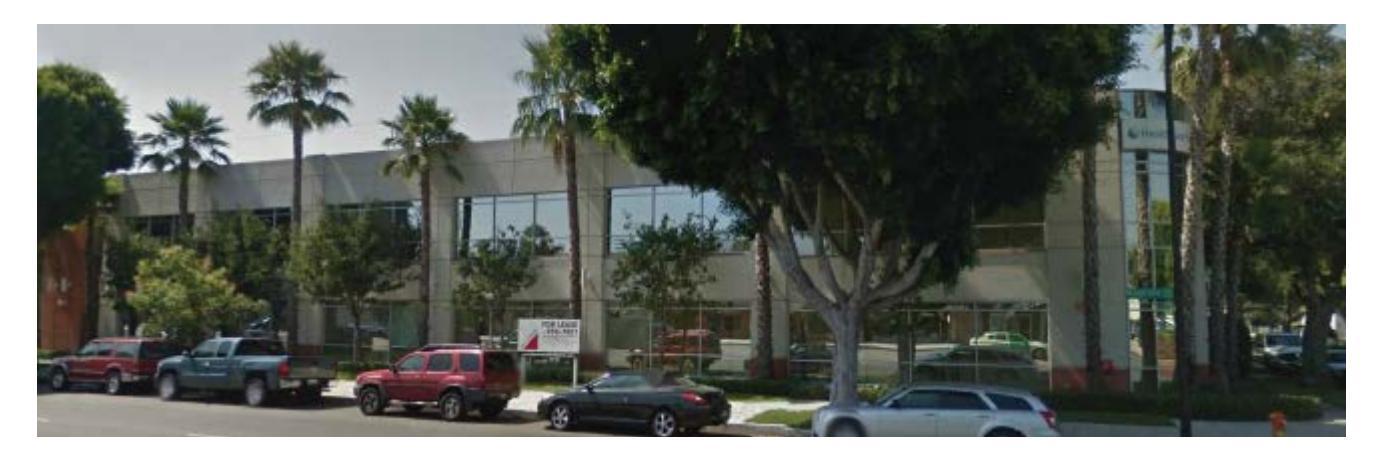
Figure 1 – Exterior View of 2211 Magnolia Blvd Building in Burbank

The building site is relatively level. The building is 87.5 feet by 199 feet in plan and consists of a basement floor below grade, first floor at grade, second floor, and roof. The perimeter above grade consists of non-load bearing steel stud and insulated architectural finish with reinforcing mesh wall panels with spandrel windows between the column areas.
