January 27, 2014

25751 McBean Parkway, Valencia, CA Seismic Screening Report JLA Job no. 14110-02

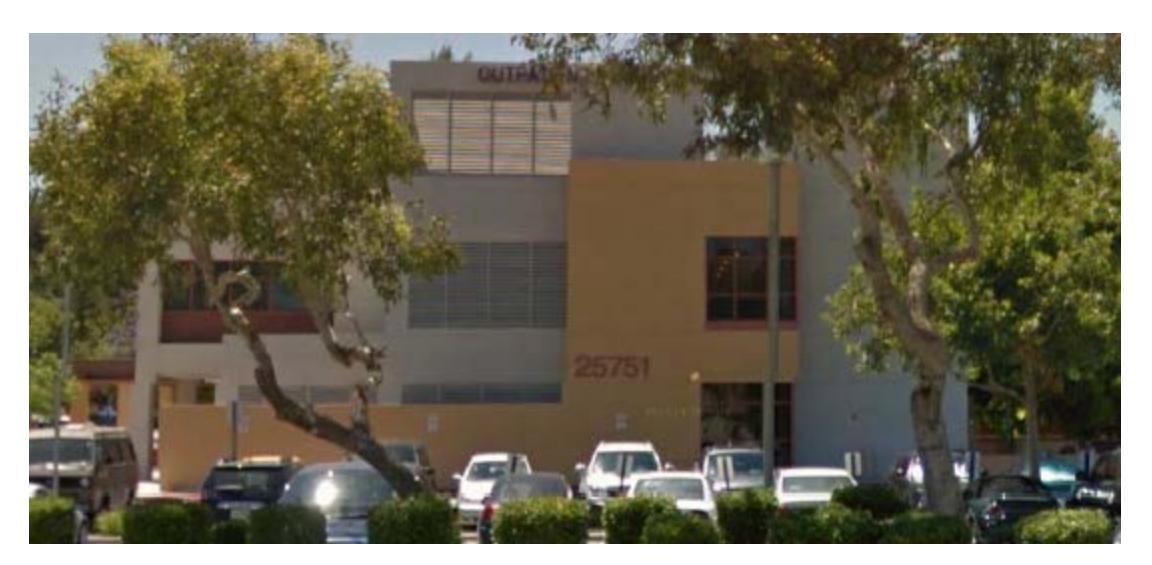
Figure 1 – Exterior View of 25751 McBean Parkway in Valencia, CA
