Krieger CTR - C

ASCE 41-17 Tier 1 Seismic Evaluation
Minimum Building Report Information

Building Name: Krieger CTR-C

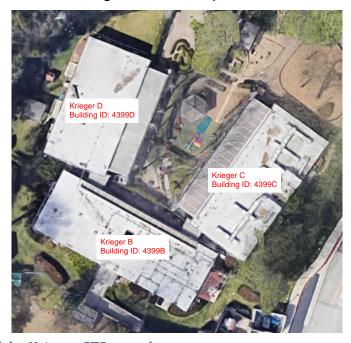
Figure 1 Key Plan of the Krieger CTR complex

The Kriger CTR complex is composed of three buildings. Shown below is a key plan of the complex along with the distribution of Building ID's at the complex.
