UC Seismic Evaluation – 675 Park View

Date: 2/10/2020
UC Campus: UCLA – off campus
Building Name: X675 PKVIEW
Building Address: 675 S. Park View Street, Los Angeles, CA 90057
CAAN ID: 404A
Auxiliary Building ID: N/A

Summary of information provided by Evaluator: Nabih Youssef Associates Structural Engineers

UCOP Seismic Performance Level (or “Rating”): V based on ASCE 41-17 Tier 1 evaluation.

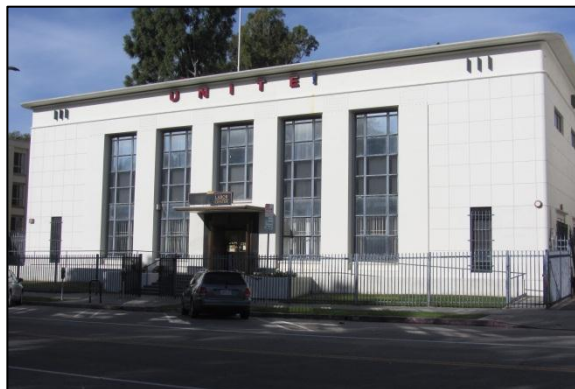
Exterior Elevation Photo

2-story reinforced concrete building with partial basement and approximately 15,000 square feet built in 1941. The building is generally regular-shaped in-plan with overall dimensions of approximately 100' by 60'.
