UCLA Seismic Rating Study

11075 Santa Monica Boulevard

September 8, 2017

Job No. 17-G132

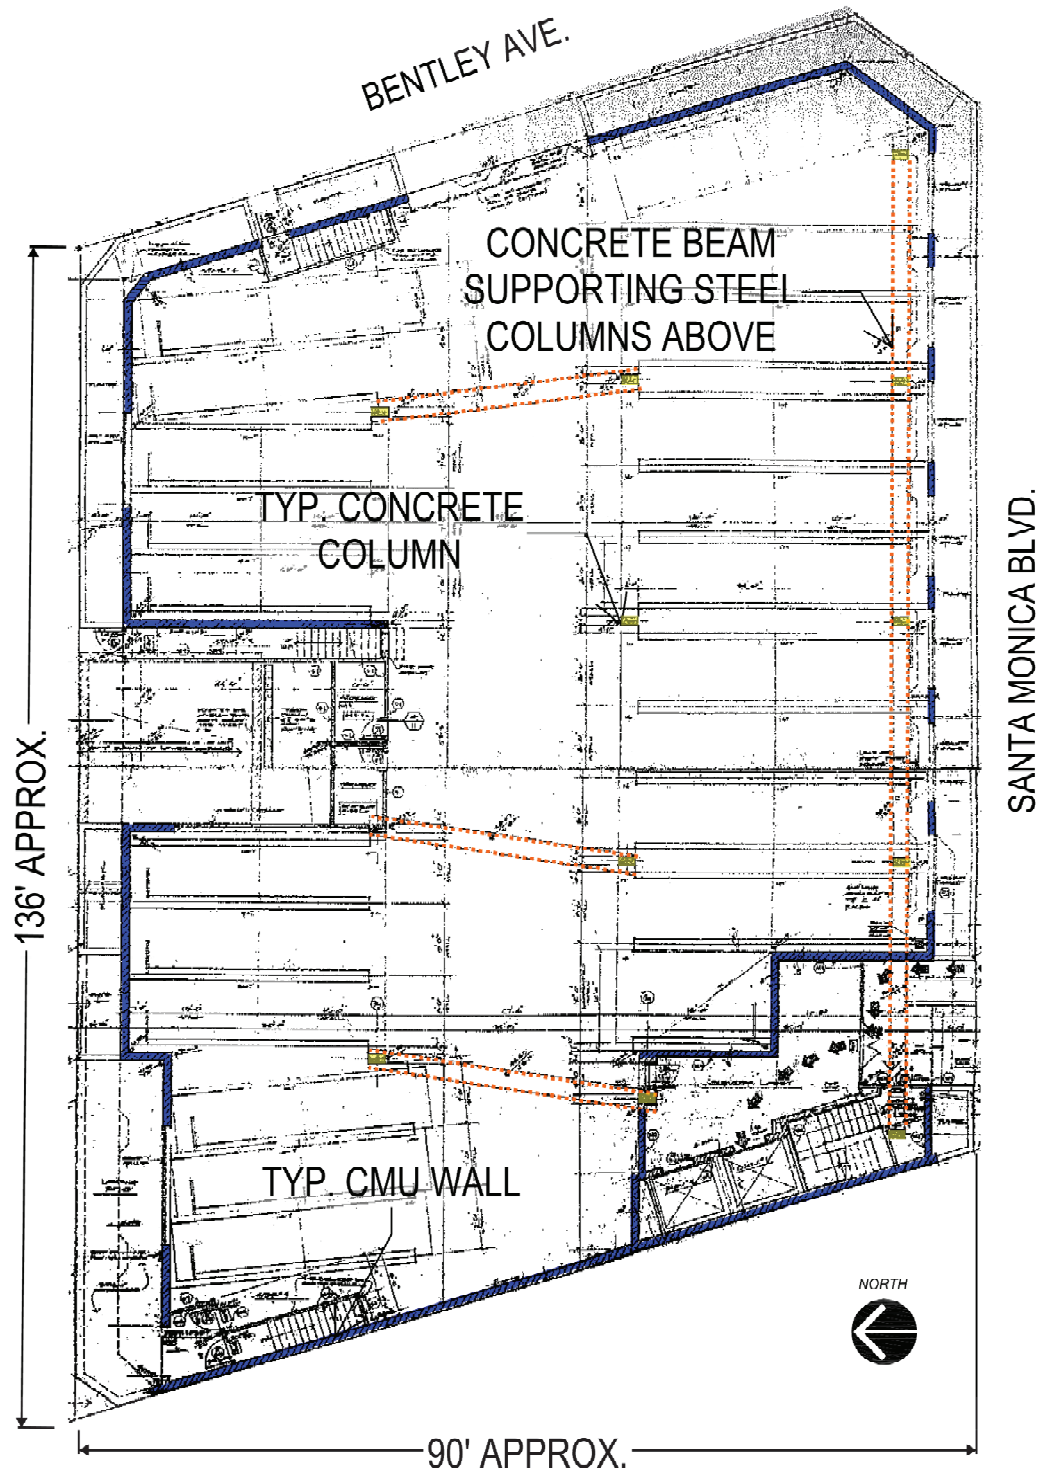
Figure 2.1 - At-Grade Parking Level Floor Plan

The building has a rhomboid shape with an approximate footprint of 13,100 ft². Although complete record drawings were not available for the building, a floor plan of the at-grade parking level is shown in Figure 2.1, based on information obtained from public records. A representative photograph of the building's exterior elevation is shown in Figure 2.2.

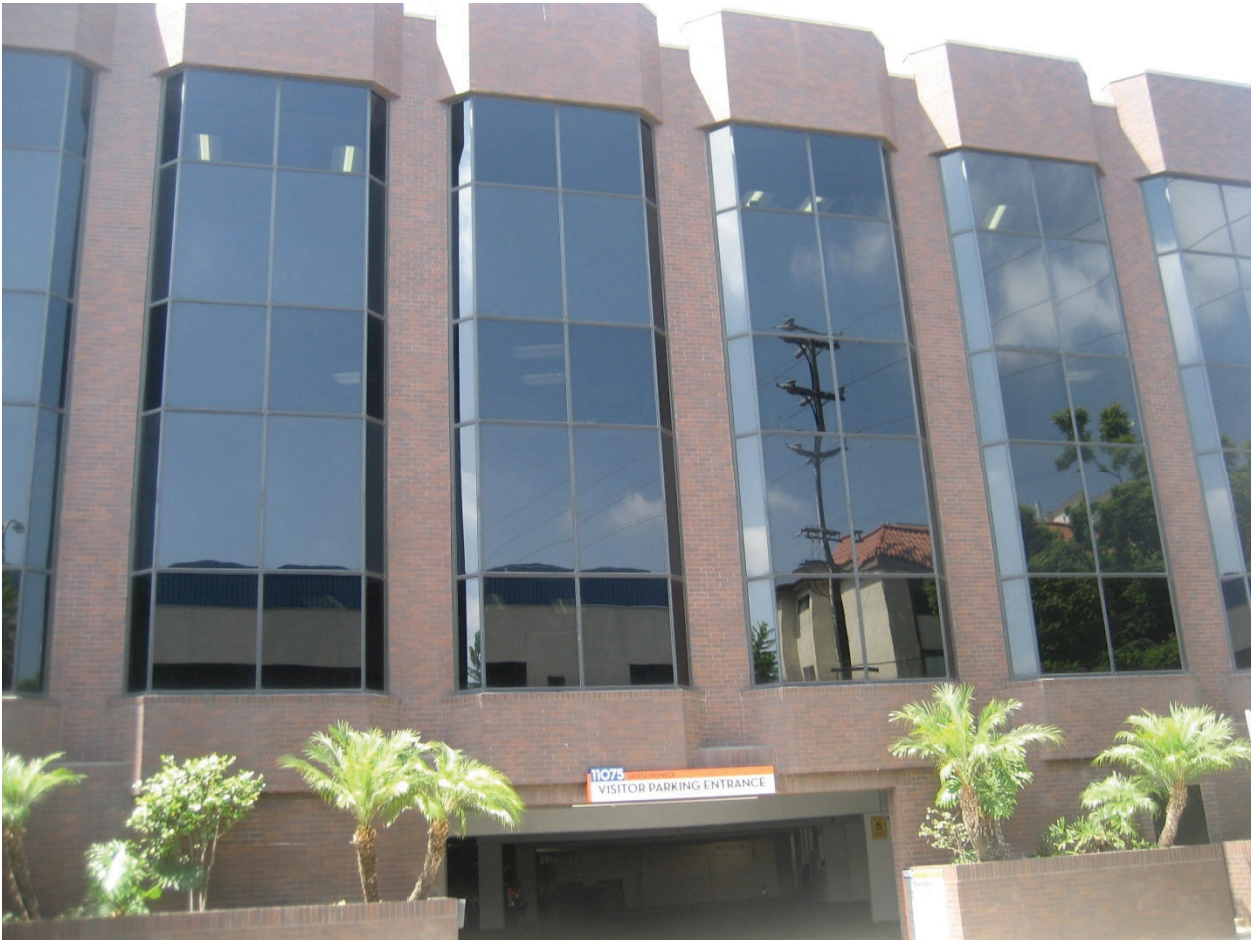
The lateral framing system for the building, based upon observations made during our site visit, consists of reinforced concrete (RC) diaphragms that span to CMU walls at the first elevated level (first floor of office space). Subsequent levels consist of flexible wood plywood panel diaphragms that span to steel moment frames along the north, south and east perimeters and a CMU wall along the west perimeter. The CMU wall is continuous to the foundation. The steel moment frame columns are supported at the first elevated level by concrete transfer beams and columns along the south perimeter and by CMU walls adjacent to the steel column bases at the north and east perimeters. At the south perimeter, the CMU shear walls are directly adjacent to the concrete beam and columns supporting the moment frames.

Figure 2.2 - Partial South Elevation
