Seismic Evaluation

Lake Arrowhead Conference Center Facility 1

Lake Arrowhead, California

October 23, 2020

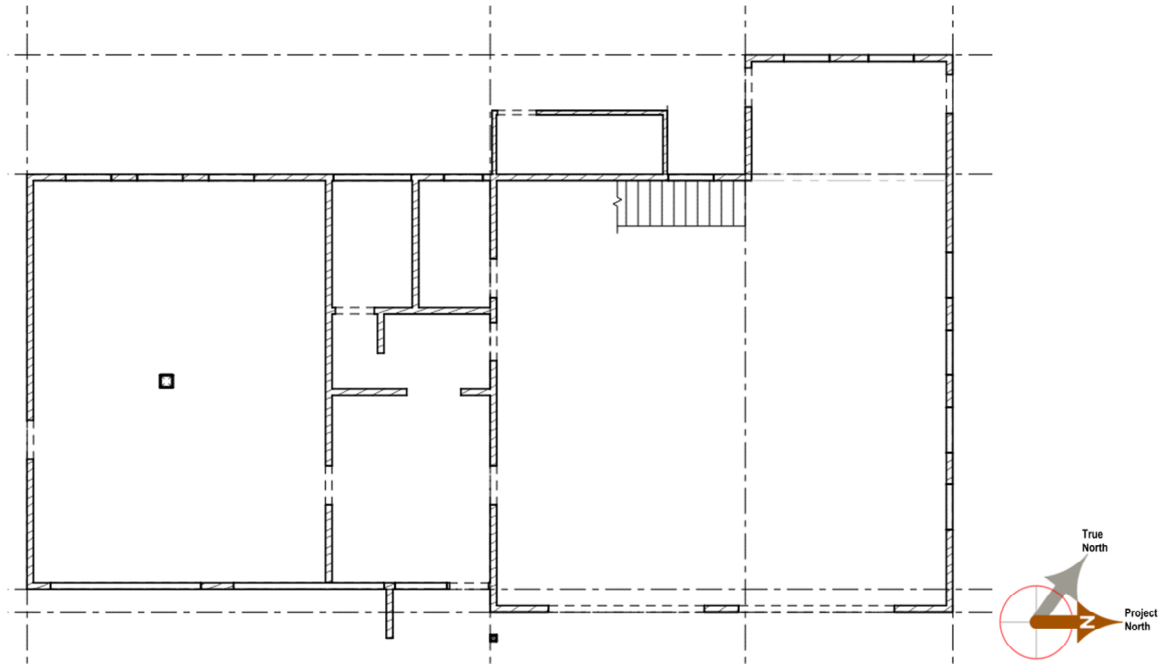
Figure 2.1: First Floor Plan

UCLA LACC Facility 1 is a one-story wood structure with a mezzanine level at the southwest portion. The building was originally built under the 1970 Uniform Building Code based on a title report provided by the University. The building has an approximate footprint of 2,600 ft.² with a mezzanine of 540 ft.². The overall building height is approximately 30 ft. The first floor and mezzanine plans are presented in Figures 2.1 and 2.2.

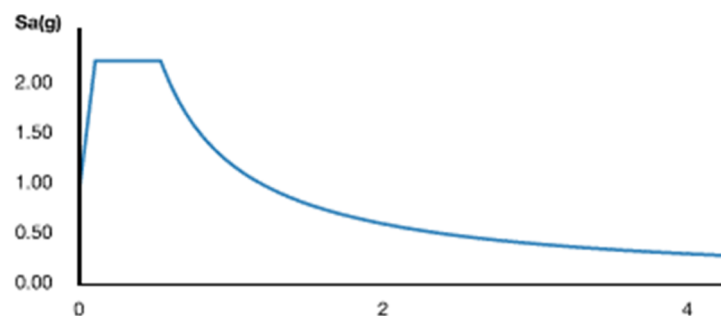
Figure 4.1: Horizontal Response Spectra for the BSE-C Hazard Level

Figure 4.1 presents the response spectra for the BSE-C hazard level using the spectral ordinates per the *ATC Hazards website*. Based on the 0.2 second and 1.0 second spectral accelerations, the level of seismicity at this site is “High” per ASCE 41 Table 2-4.

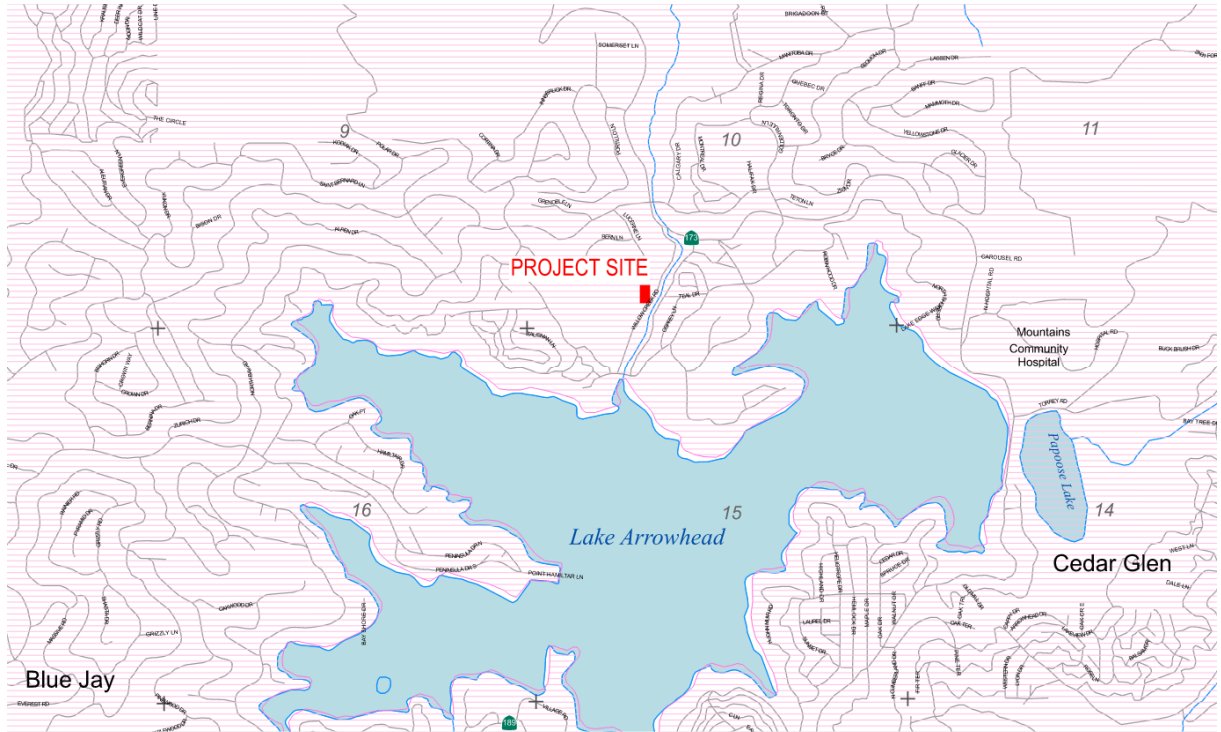
The State of California has issued a set of regulatory maps detailing regions of potential liquefaction, landslide, and ground fault rupture. The *California Geological Survey* (CGS) maps were consulted to determine whether the building was constructed within an earthquake fault zone or in an area that would require evaluation of liquefaction or landslide potential. *San Bernardino County Land Use Service Geologic Hazard Maps* identifies the closest active fault to UCLA Lake Arrowhead Conference center as the San Andreas fault mapped at a distance of about 7.5 miles from the site. According to the hazard map, the LACC Facility 1 does not appear to be within a liquefaction zone per the partial map shown in Figure 4.2, and the landslide risk is low to moderate.

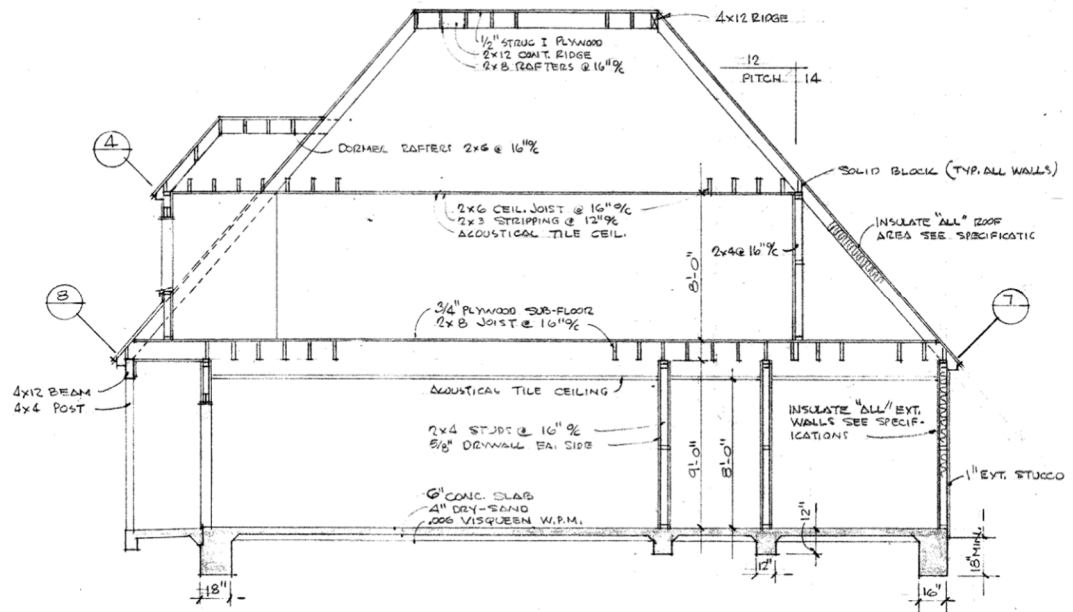
Figure 5.2: Adjacent Facility 2 Building Section

Based on the potential deficiencies outlined in Section 5.1, a linear static analysis (equivalent lateral force method) was performed to assess their significance on the seismic performance of the structure. The evaluation was performed using the ASCE 41 Tier 2 Deficiency-Based Evaluation. The roof diaphragm consists of plywood sheathing nailed to the discrete flat 1x members nailed to the roof joist or truss members as previously described. All exterior shear walls are assumed to have 3/8" thick plywood sheathing on both sides and all interior walls are assumed to have gypsum sheathing with edge and field spacing to be 4" and 12", respectively. The layout of the assumed different types of shear walls is shown in Figure 5.1 The mezzanine diaphragm is assumed to have plywood nailed to the floor joist. The assumptions are made based on the record drawings of the Facility 2 building nearby and our professional judgment. Considering the similarity in appearance between the two buildings and the assumed similarity in construction dates, it is our opinion that it is reasonable to assume that they have similar construction attributes. Figure 5.2 shows a typical building section of the adjacent Facility 2 building.
