September 14, 2017

Subject: 28291 Geneva Lane, Lake Arrowhead, CA  
Seismic Screening Report  
JLA Job no. 17101-06

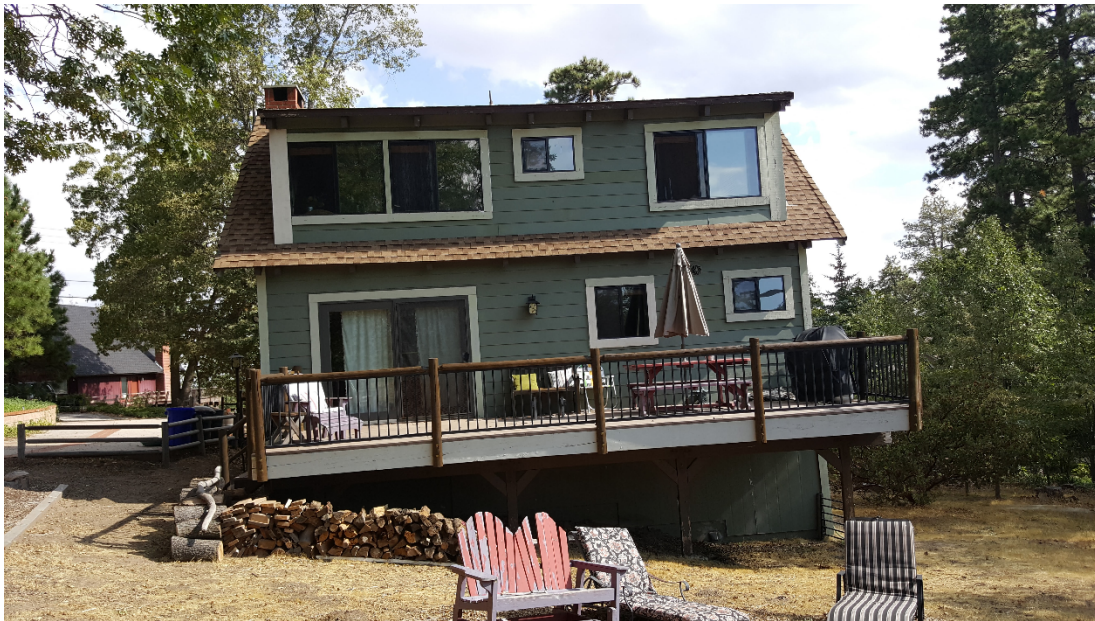
Figure 4: Rear Balcony / Deck

In general construction of non-structural elements do not pose any risk to safety. Two issues were identified, however, that require attention and repair. Figure 5 shows the underside of the exterior balcony / deck. Note the main girder running at the edge parallel to the length of the deck. This element appears to be twisted and has a horizontal crack running longitudinal to its main axis. This element needs to be replaced (or repaired with strapping). Figure 6 shows a brick chimney. Anchorage of this chimney at the floor and the roof is required to ensure life safety. These could be added and/or the Chimney could be replaced with a conventionally framed chimney.

- Based on our observations and our conceptual evaluation of the lateral-load-resisting system, the lateral system is adequate for the size, configuration, and age of the building. A major seismic disturbance is likely to result in structural and non-structural damage that would represent low life hazards. Improvements to the rear deck and chimney should be pursued to further enhance building performance.
