Address: 403 Hilgard Ave
Los Angeles, CA Zip: 90024

Building Name: Bus Shelter

FEMA P-154 Data Collection Form

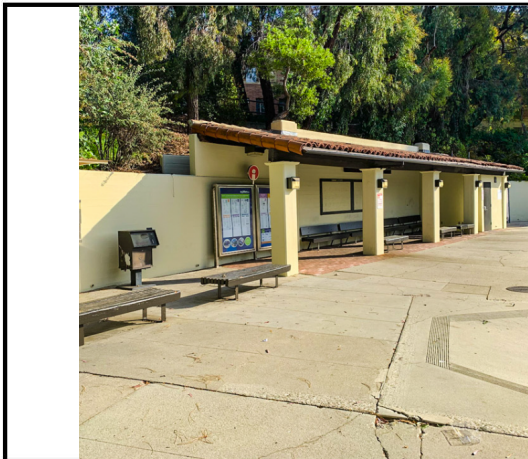
COMMENTS:
Code year is assumed as no drawings were provided. North line is a retaining wall with approximately 7' of retained earth. There is a moderate upslope to the west of the wall. Site was not considered to be sloping. South line consists of four RC columns; it is likely they are not well-confined. Roof framing is large timber; connections between columns and framing members is unknown. Roof tiles are badly damaged and do not appear to be anchored. East bay has been enclosed with nonstructural infill material. UC Seismic Rating: V
 Additional sketches or comments on separate page
