SEISMIC EVALUATION  
Of

**UCLA Clark Library Gatehouse**  
University of California  
Los Angeles, CA

**Nabih Youssef & Associates**  
*Structural Engineers*  
550 Hope Street, 17<sup>th</sup> Floor  
Los Angeles, California 90071  
NYA Job # 12101-00  
November 24, 2014

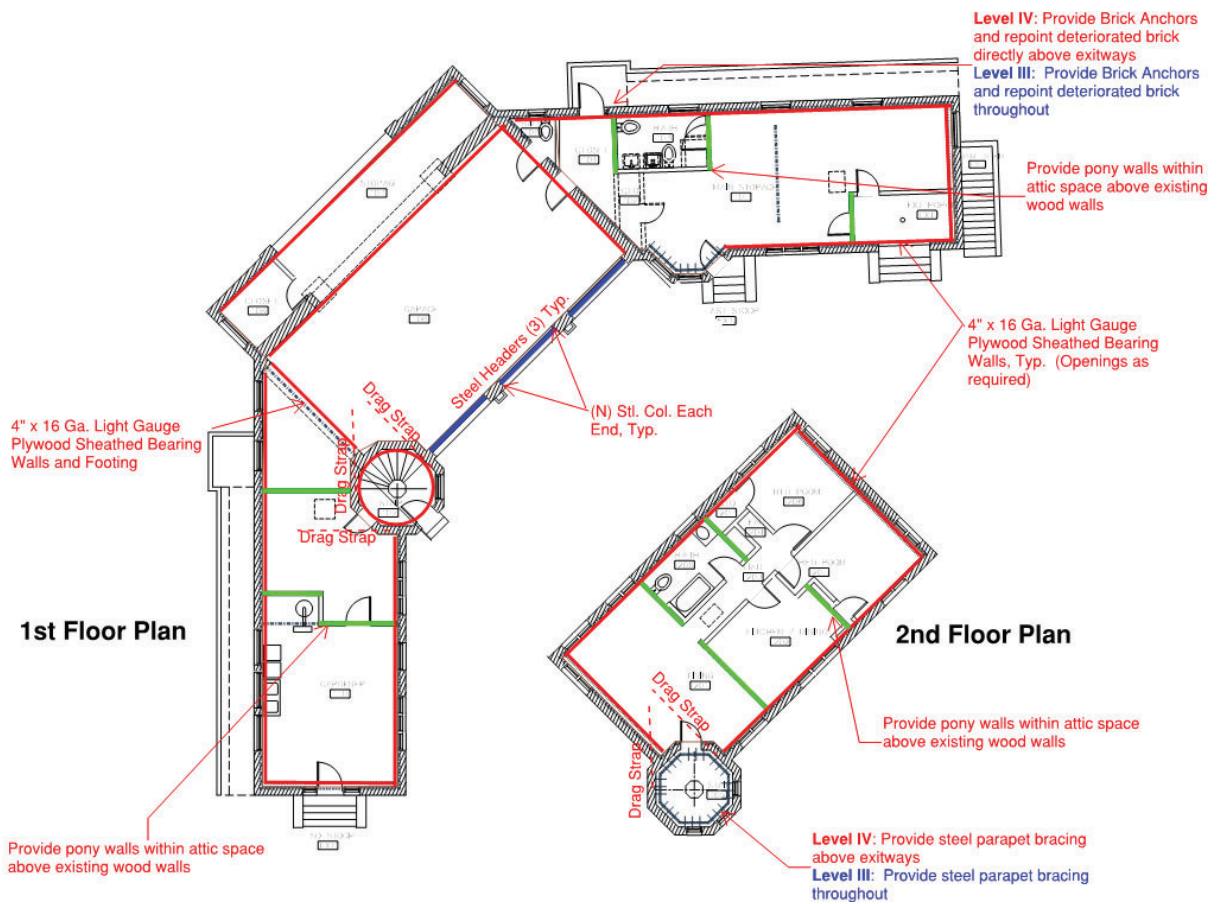
Figure 5.2: Proposed Strengthening Scheme

- Strengthening required for Level IV performance rating.
- Provide retrofit anchors between the façade brick to the new light gauge framed walls and repoint deteriorated brick mortar throughout building.
- Provide steel backing framing at all unbraced parapet walls.

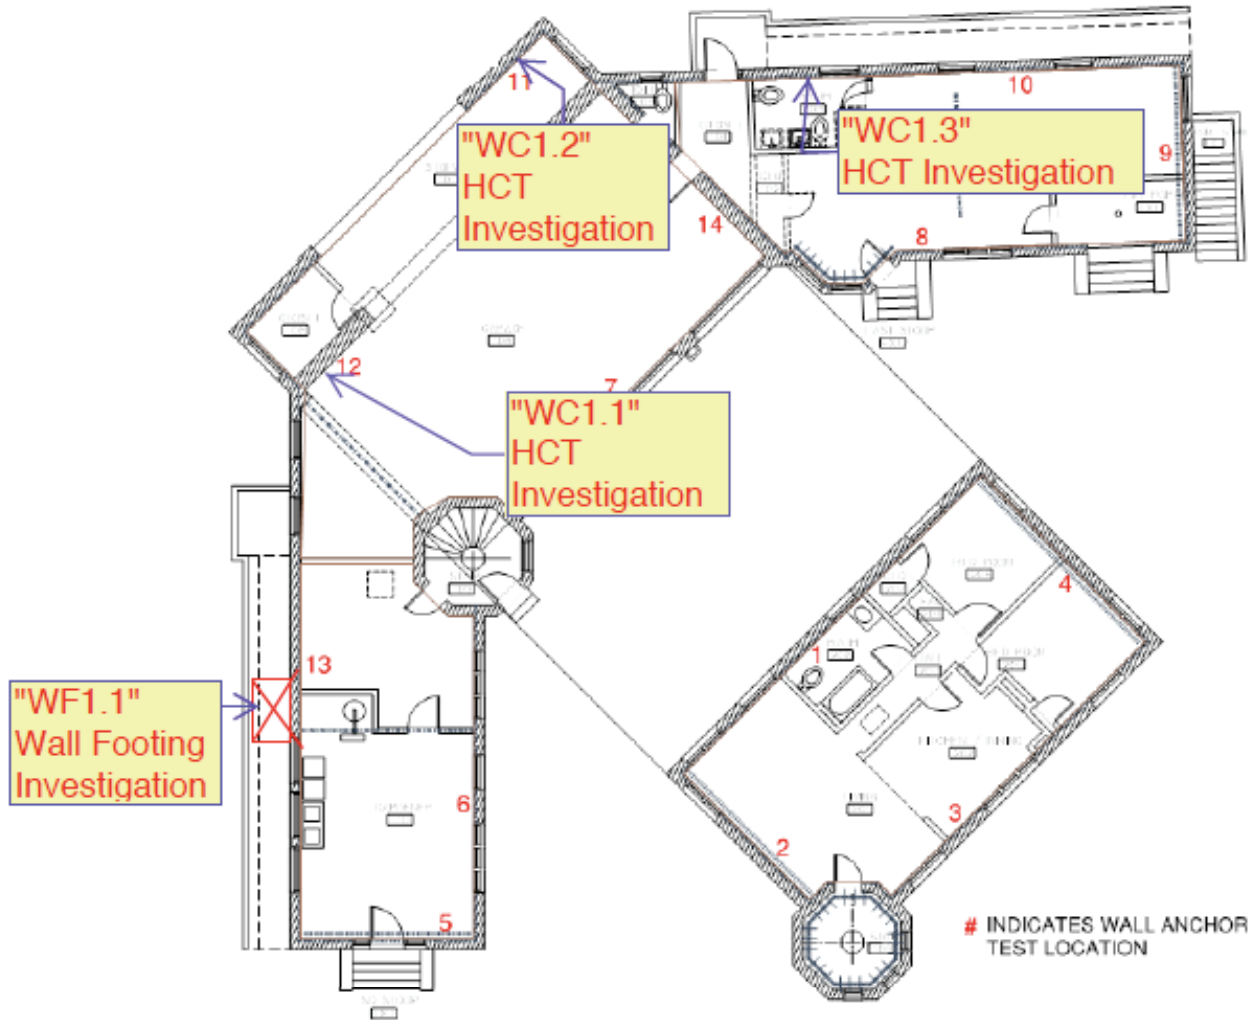
Figure A.1 Structural Investigations Test Locations

<b>Subject:</b> Results of Structural Footing Investigations UCLA Clark Library Gatehouse, 2520 Cimarron St., Los Angeles	<b>Test ID:</b> Test locations
<b>Report By:</b> Robert M./AA/DP/gu,s	<b>Test Dates:</b> 7/24 – 8/6/2012
	<b>Checked By:</b> S. Sethee, Ph.D.
